LANGLEY GATEHOUSE

History Album

BASIC DETAILS

Built	c1610, adding to an early 14th-century building
Listed	Grade II*
Owner	Langley Estate
Landmark tenure	Long lease
Let for first holiday	1993
Repaired	1992-1993
Architect	Andrew Thomas
Builders	Treasure & Son
Site Foreman	Mervyn Higgins
Quantity Surveyors	Bare, Leaning and Bare

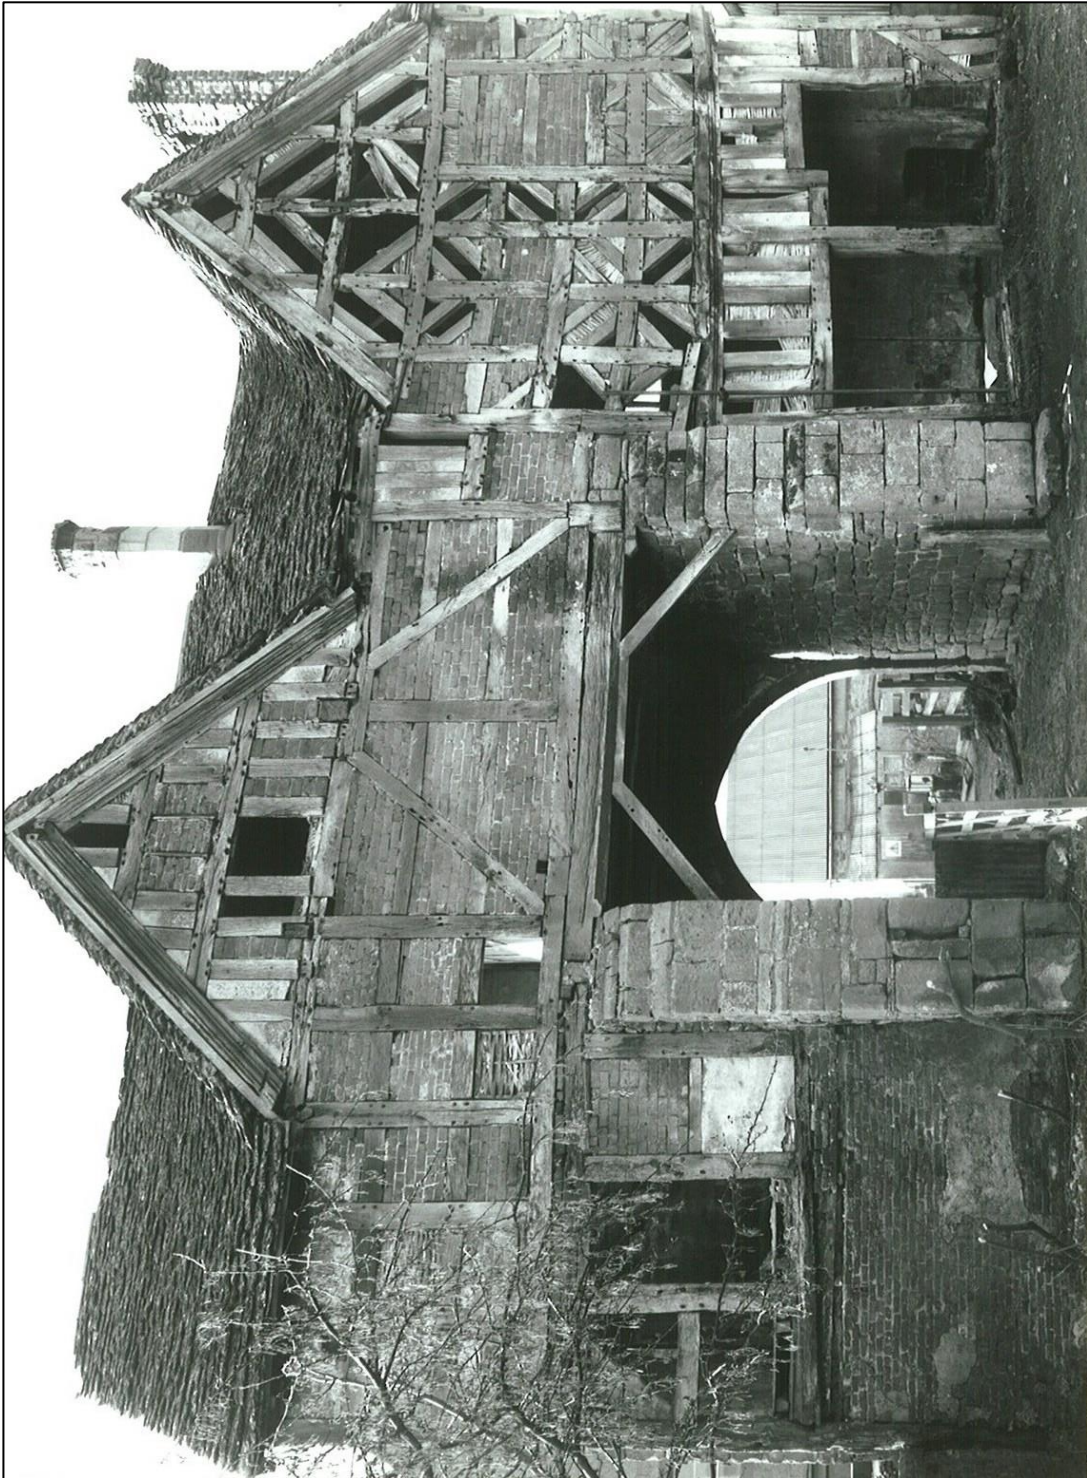
The east front before repair

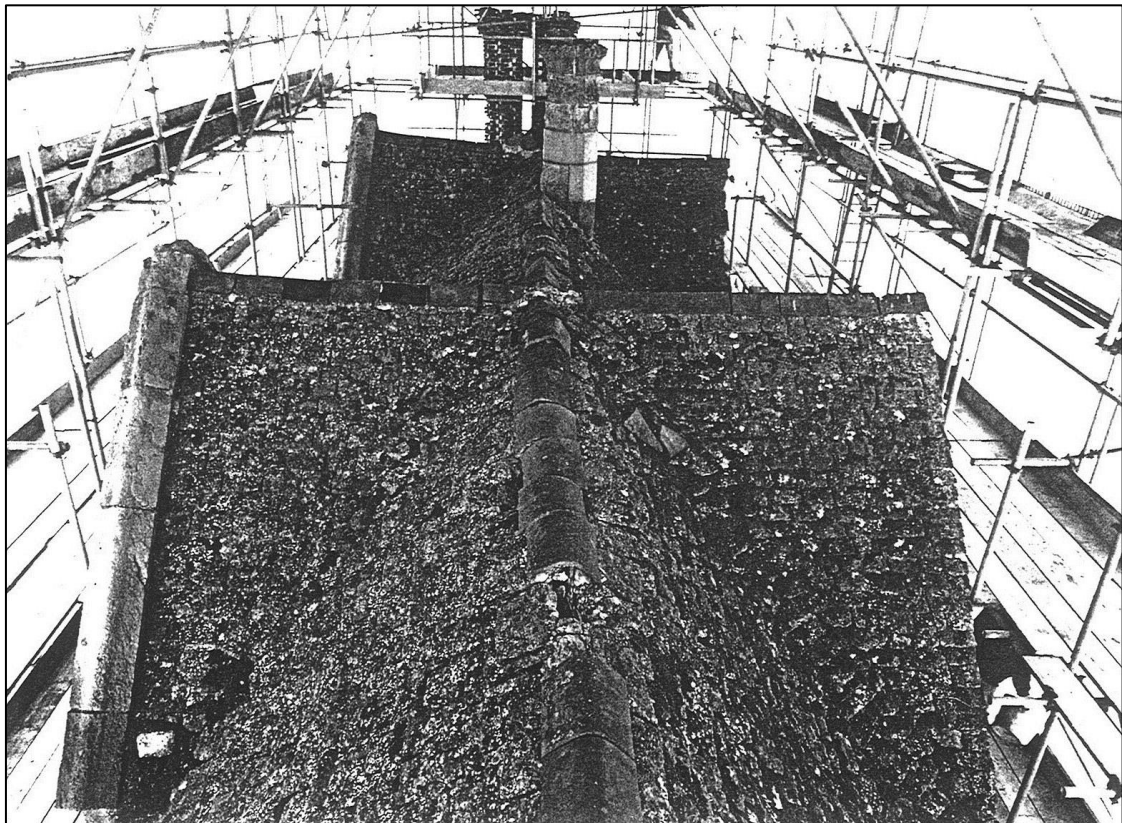
The roof before repair

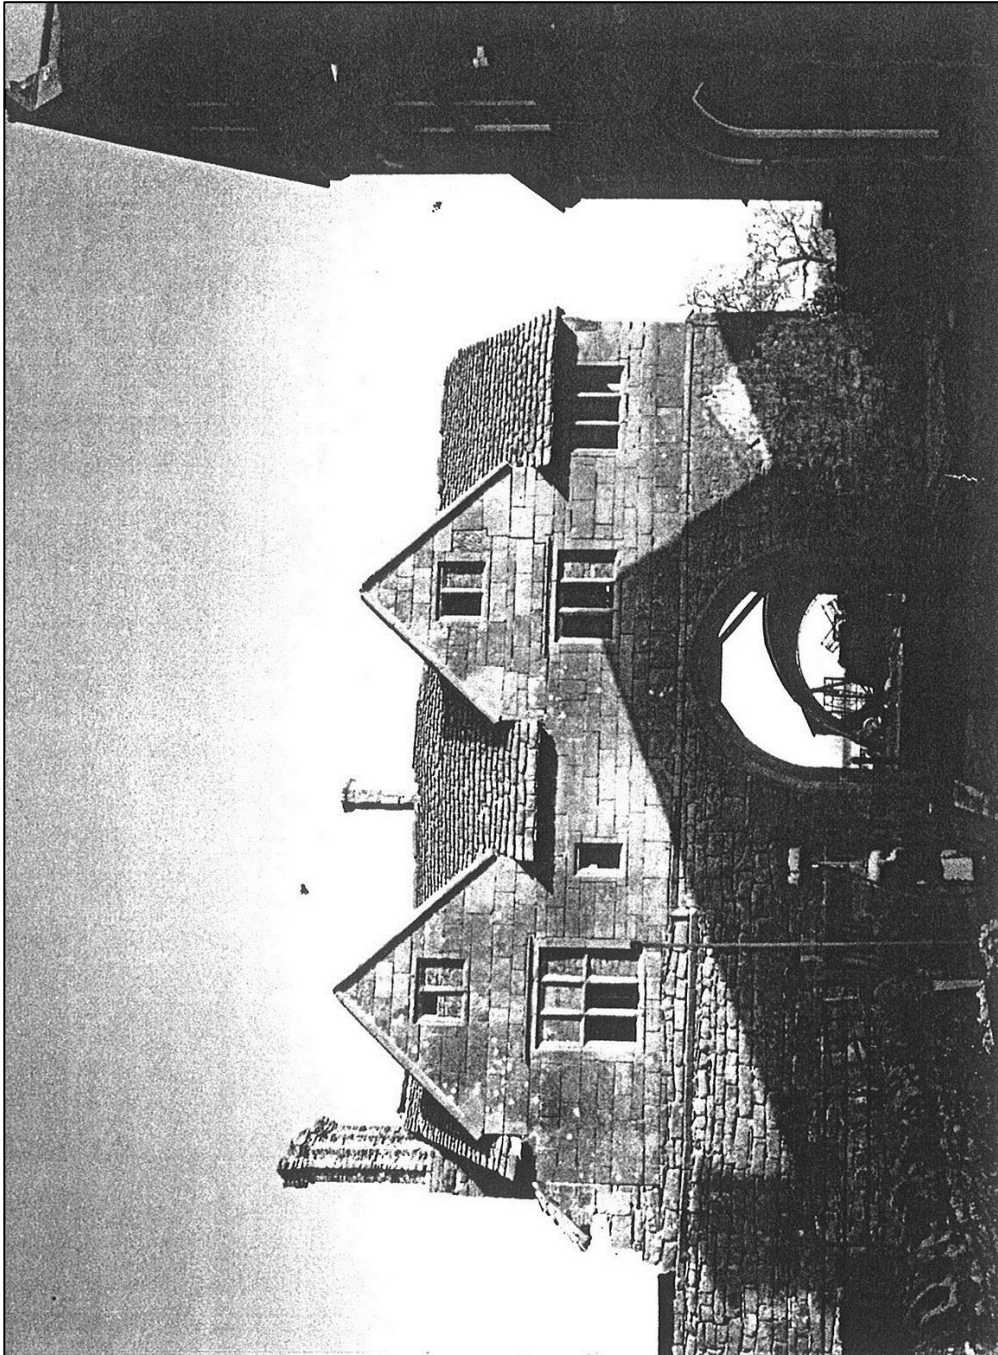
The west front before repair

Reroofing did not take place until the autumn. Meanwhile much activity had been going on below. On the west, or stone, front, repairs began with some drama. Following the cautious removal of one facing stone where the wall was bulging badly to the north of the gate arch, there was a deluge of rubble, leaving a hole the size of a man. Luckily no one was hurt. Happily, the two skins of which the wall was constructed had already been temporarily tied together, the danger of collapse having been suspected. The wall was rebuilt with new rubble bedded in lime mortar, and additional steel ties for strength. No attempt has been made to straighten up its profile.

South of the arch was a garage which was taken down. This revealed another, lesser bulge, but this proved less volatile and the repair here was straightforward. Following these repairs, the west wall was repointed, using a lime mortar mix that matched the old mortar in the wall. A similar mortar was used in the side walls of the gate passage, where the joints had all been raked out in 1978. When it came to the upper parts of the wall, and the more finely-dressed masonry of the Jacobean gatehouse, a mix containing brick dust was used, again matching old mortar that survived at this level. (Small brick chippings have a strengthening effect on the mortar, in fact.)

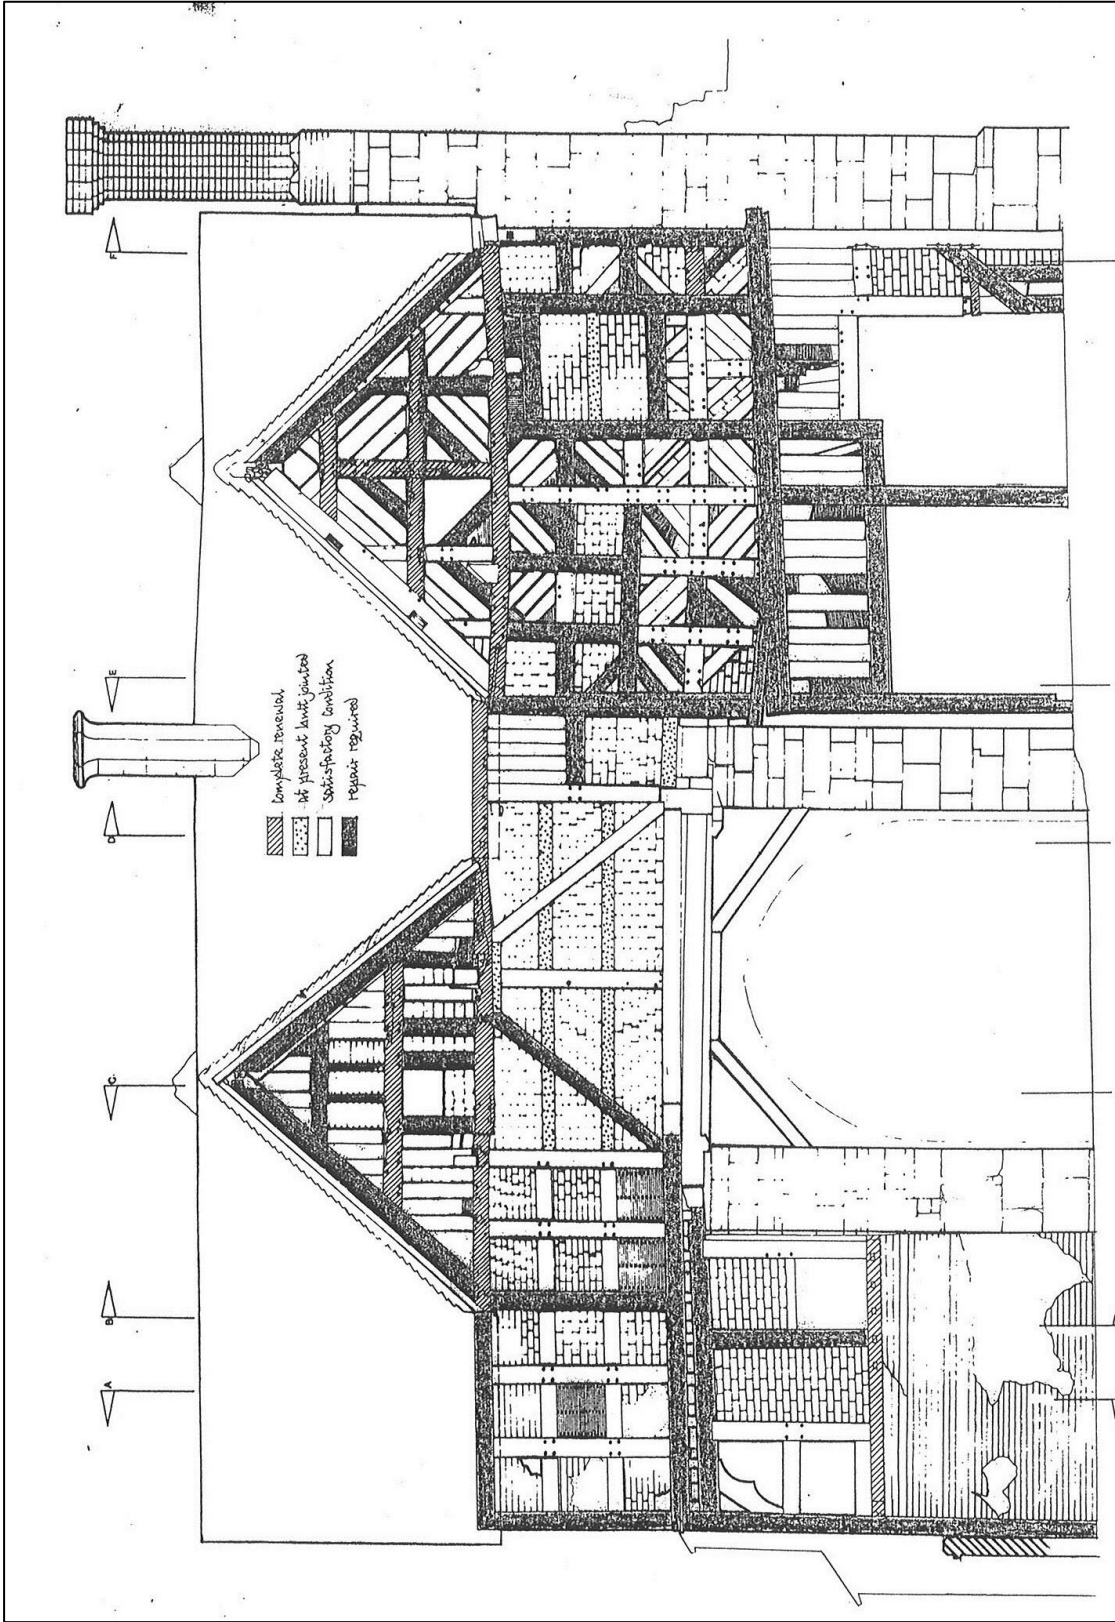
A survey of the condition of the timbers

The lifting operation complete, work could start on repair. The detail of this had been meticulously worked out. Every timber was numbered, to match a drawing on which the remedy for each had been detailed. Some needed new ends, others a piece in the middle. As much of the frame as possible was repaired in situ, but some sections had to be dismantled first. Seasoned oak was used for small repairs, but where a major timber was to be renewed, green oak was used, as it would have been in the original construction.

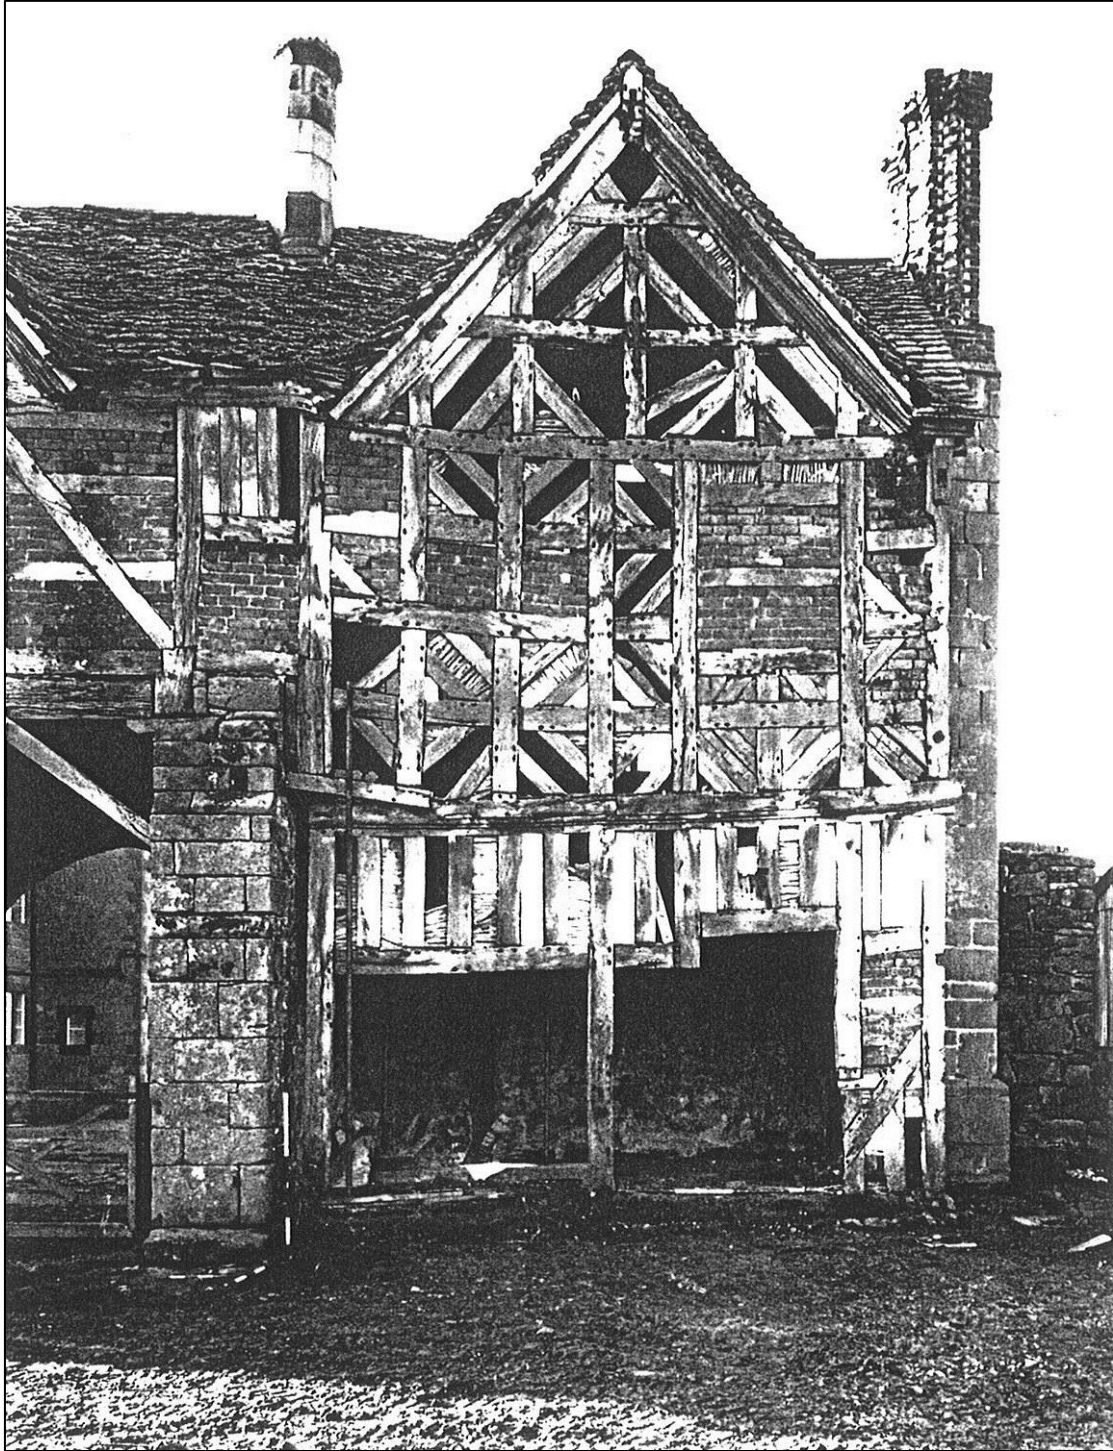
The east front before repair

The repair of the east side, while less eventful, also had its tense moments. The plan was for the whole structure to function properly again, as it was designed to do, instead of using lots of metal ties to support a decaying frame. But before this could happen, the sagging structure had to be brought back to its true level: only then would each post and rail and brace work together, and resume their proper job of mutual support.

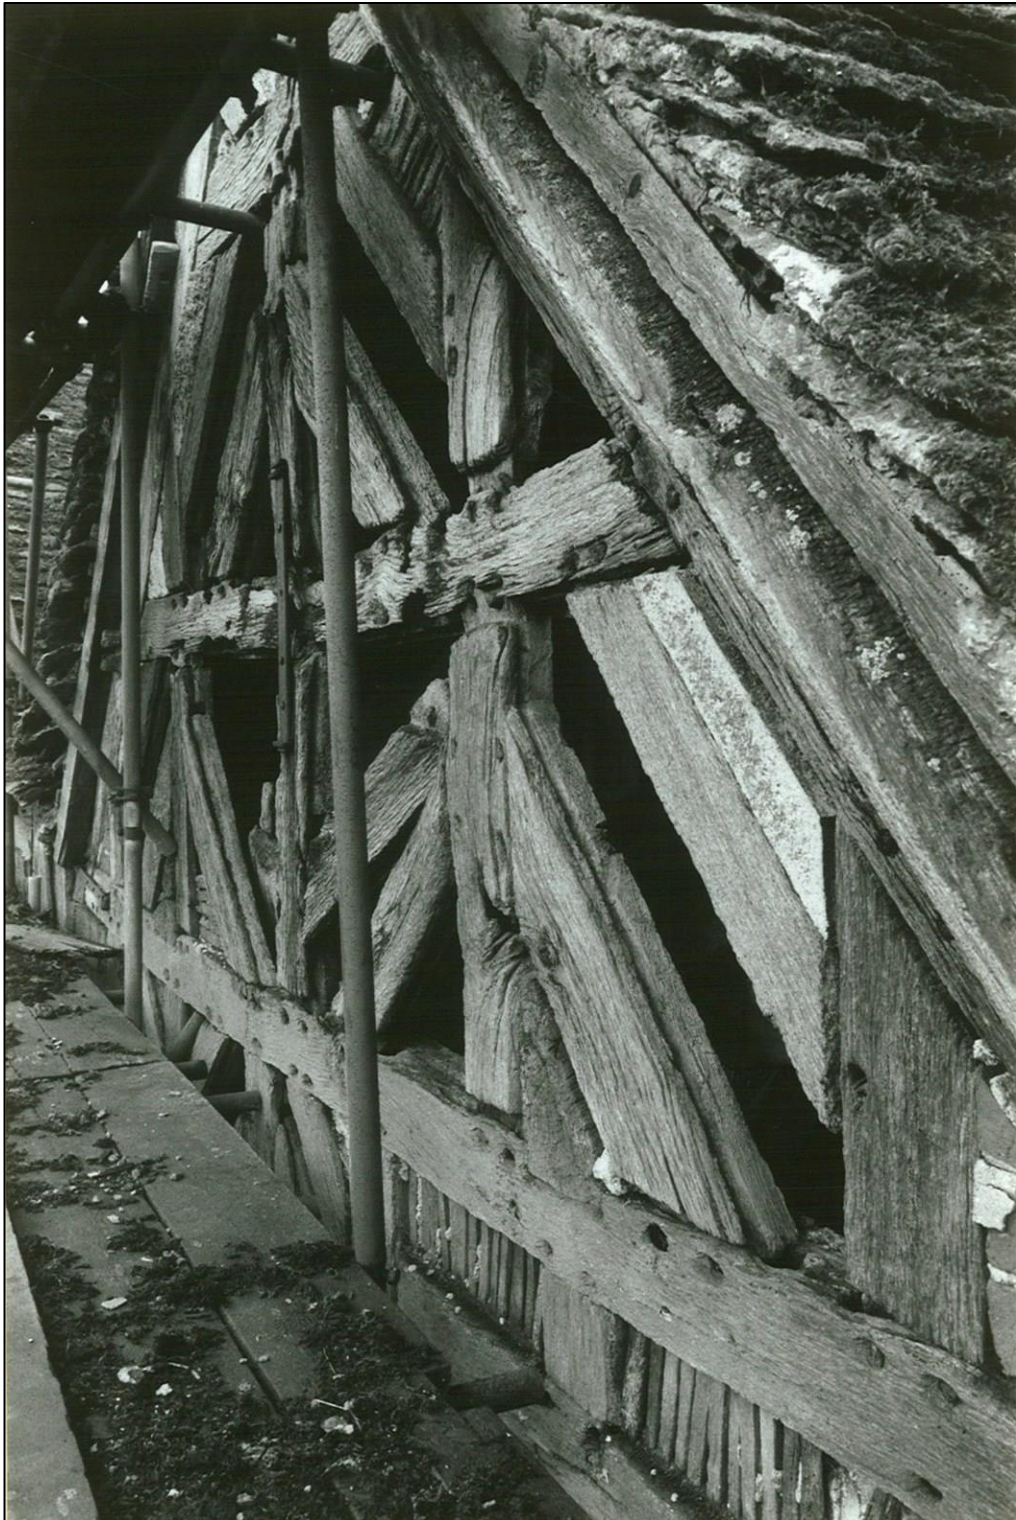
The condition of the north east gable

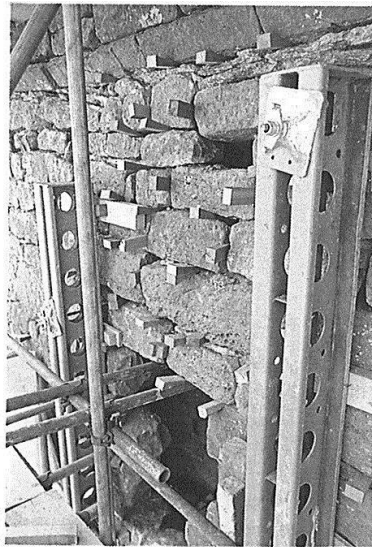
The mediaeval defensive wall was found to be heavily voided and bulging prominently in one area. The two leaves of walling were temporarily tied together and the joints propped open with hardwood wedges. This is a vital prerequisite to work on walls which exhibit symptoms of instability. The core was reinstated by bedding rubble and clay tile in lime mortar incorporating stainless steel lathing and 'Spirotite'. The wall was repointed and grouted in stages by gravity pressure.
CORE REPAIR MIX. 3 sand : 1 hydrated lime
RUBBLE WALL POINTING MIX. 1 white cement : 3 lime putty : 6 sea sand : 4 yellow sand : 2 concreting sand.
GROUT. 1 lime : 1 1/2 PFA supplied by 'Pozzament' in 25 kg bags.
