IONA II DIVE TRAIL

Wreck Investigations & Monitoring

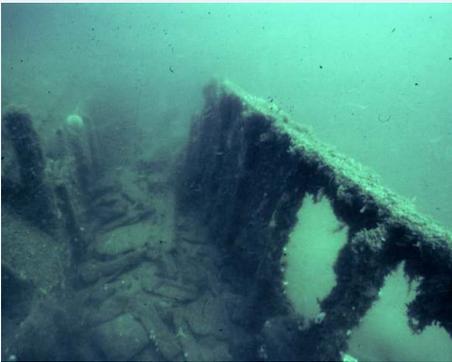
Hull remains (ADU)

The ADU divers noted that the main threat to the wreck was from divers who had already removed some brass fittings from the engine and had left a hammer behind.

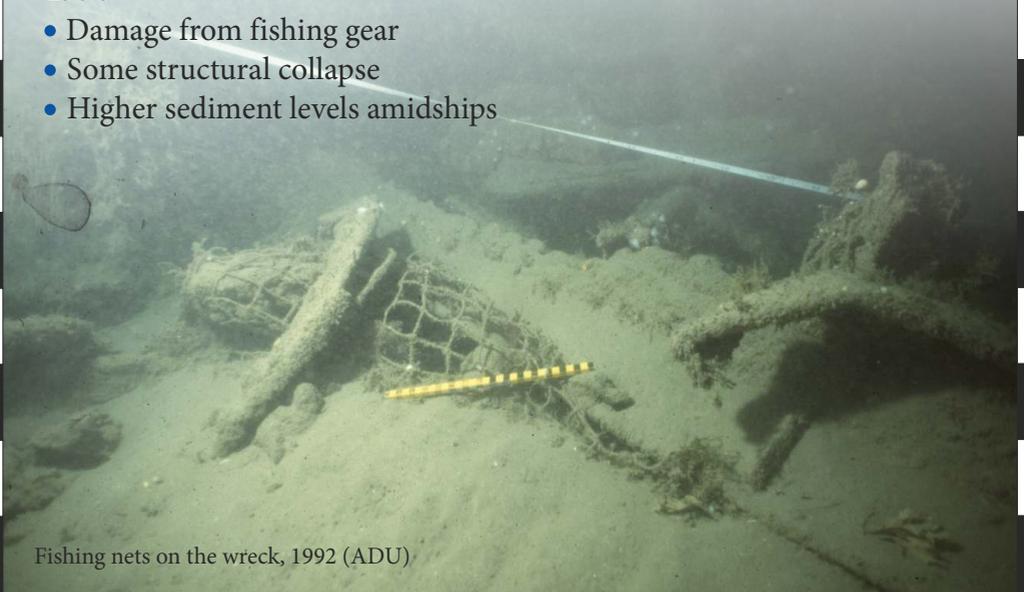
- Increase in hull corrosion
- Crankshaft elements deteriorated
- Paddle wheel assemblies crumbled
- Damage by fishing nets and divers

Fishing nets on the wreck, 1992 (ADU)

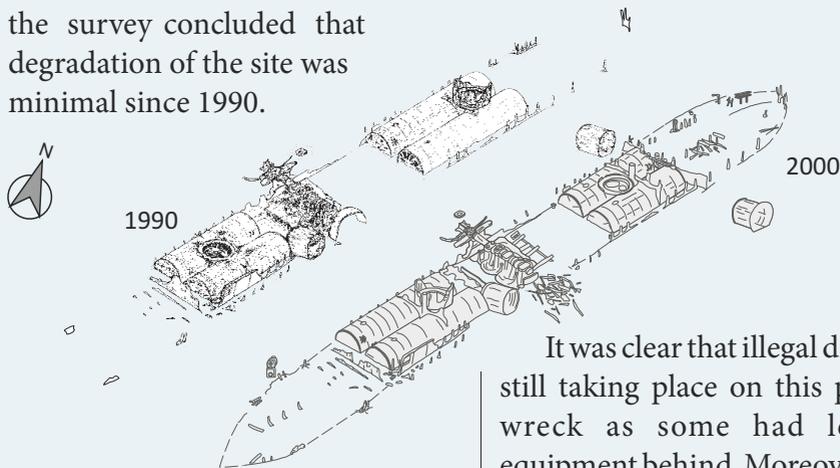
Isometric drawings of the *Iona II*

The major discovery of this survey was that the boilers in Rule's isometric drawing were depicted in a transposed position with the larger boilers recorded in the aft of the vessel rather than in the forward section. This error had not been

picked up for 10 years possibly due to the typically poor visibility on the site making navigation quite difficult.

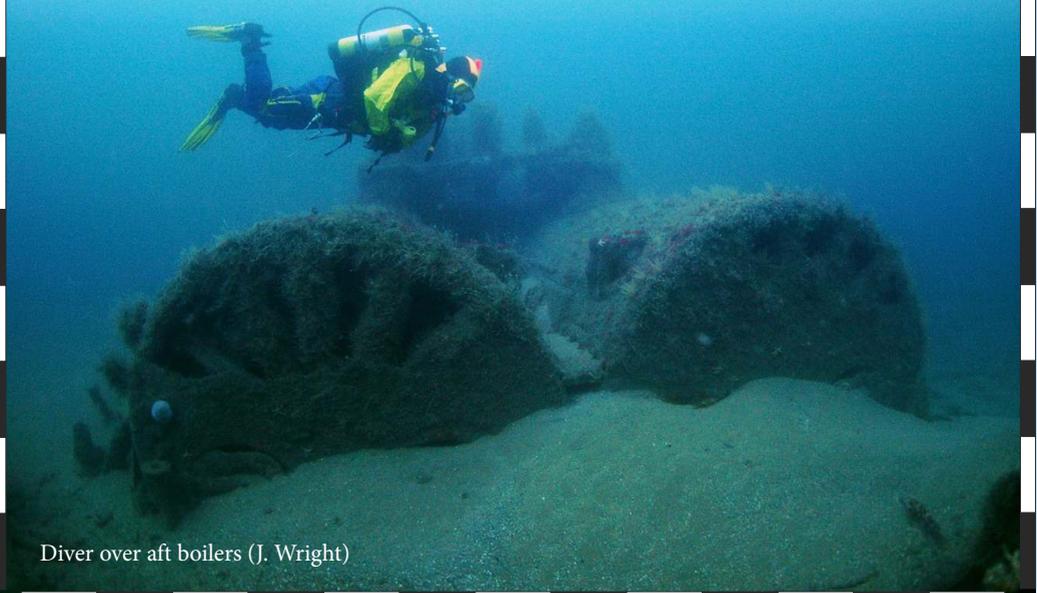
A visitor licence was granted in June 2011 to eight divers from this club to carry out a photographic survey. Wessex Archaeology's monitoring points were divided between the four buddy pairs to ensure all features would be recorded. Divers noted that there was a general increase in sediment over the whole wreck, while certain wreck features had degraded. Notably, the curved horizontal section of the sternpost was lost as well as the forward funnel base cowling.

Diver over aft boilers (J. Wright)
