# The Landmark Trust

## MARGELLS

### History Album

**1976, updated 1998**

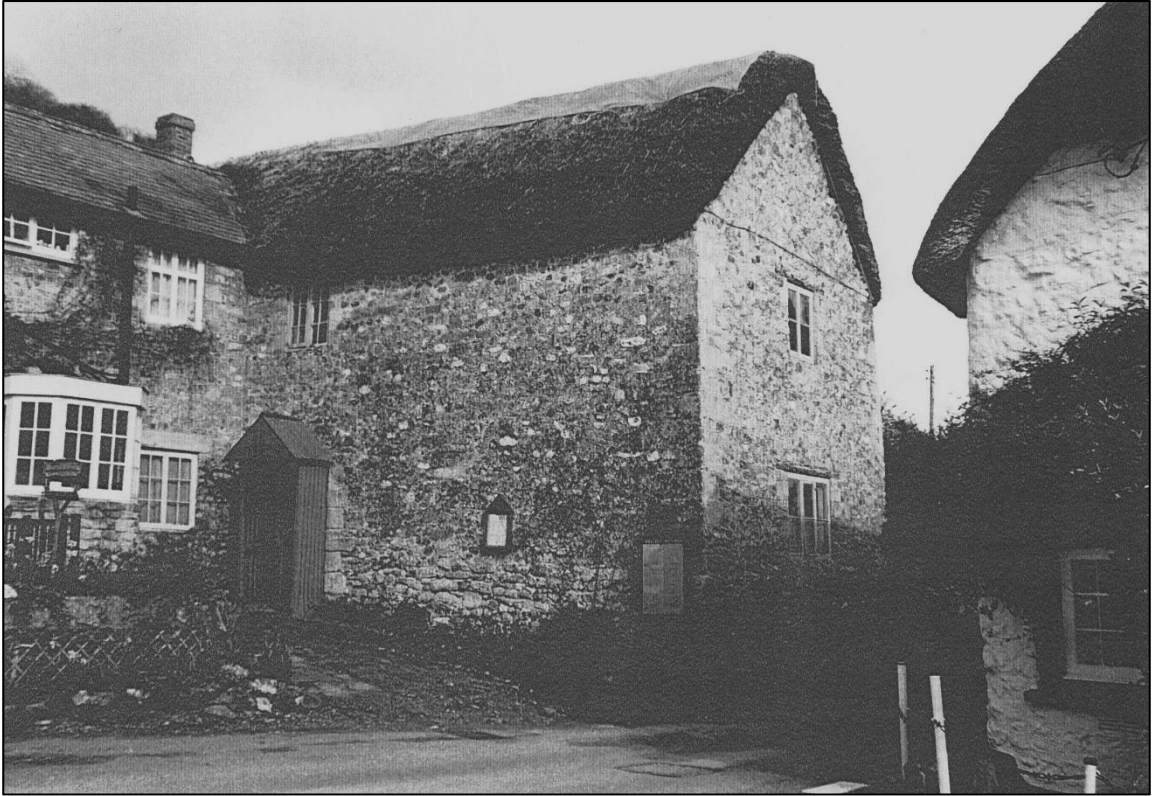
From the north west. The corrugated iron porch was removed.

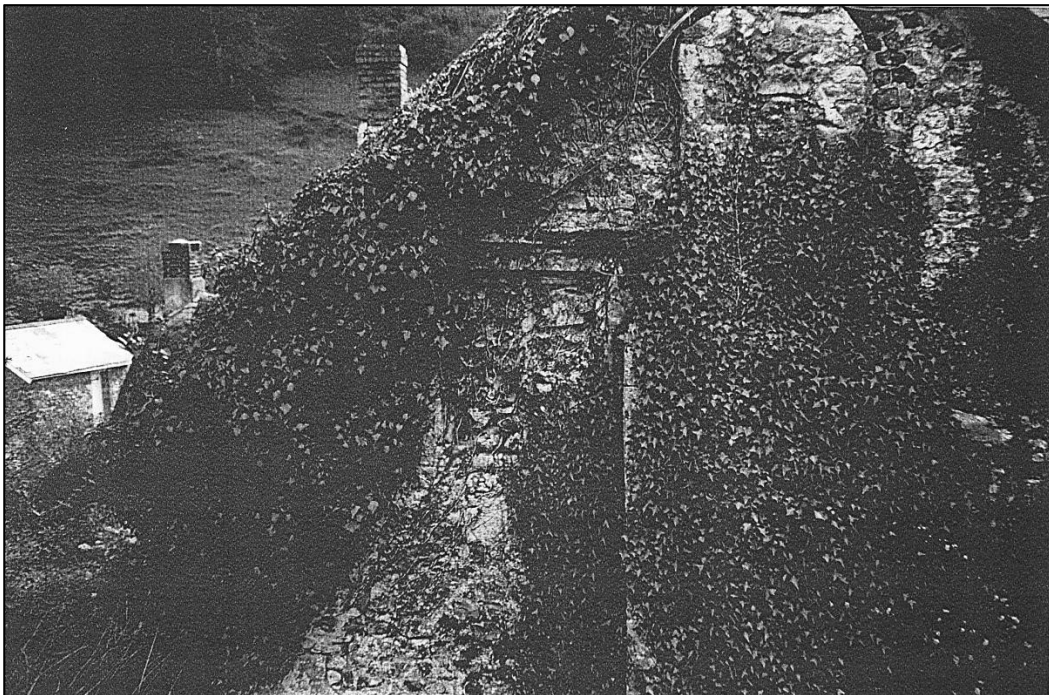
**The blocked up east window**

But most of the work was concerned with masonry repairs, including stabilisation of the wall by underpinning, repair of the timber screens and roof trusses, opening up of the fireplaces, treatment of timber infestation and inserting an electro-osmotic damp-proof course. The small window in the east bedroom wall was reinstated. The existing ground floor, of lime-ash construction, was in poor condition and in spite of the architects' extensive researches it was not found practicable to repair and reinstate in to match the existing. Instead, second-hand paving slabs of Blue Lias (a local stone) was brought from a farm nearby and laid on a new base, retaining the lime-ash finish as an edging. The link between Margells and the adjoining cottage was found to be open in the roof space, and

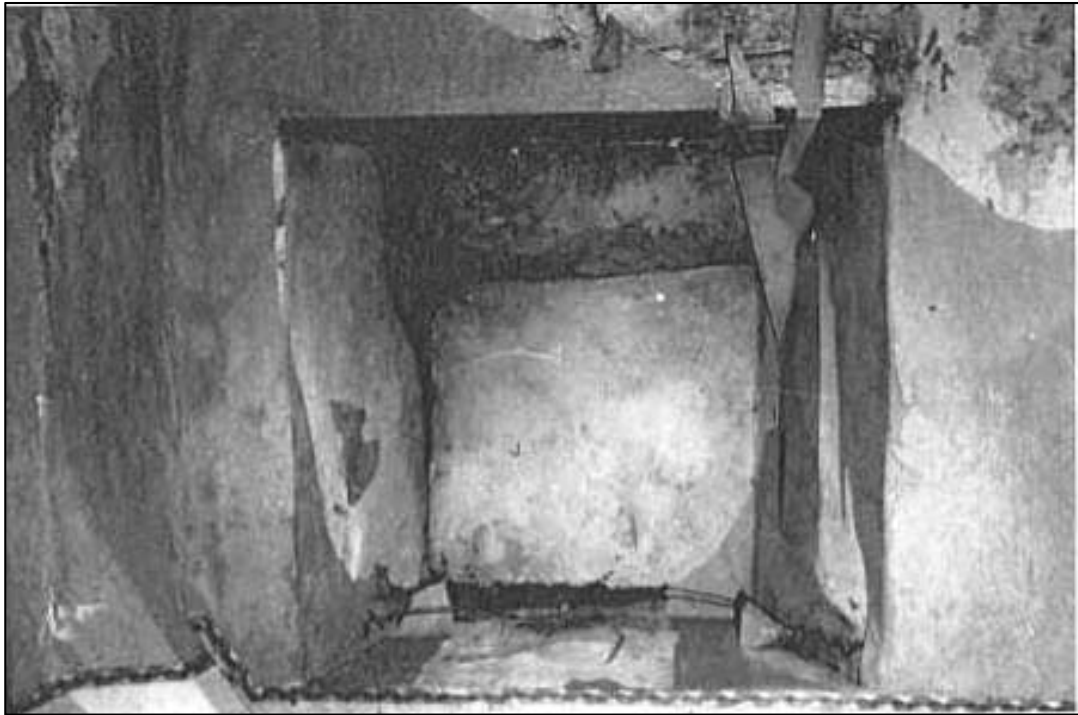
**The blocked up east window from inside**

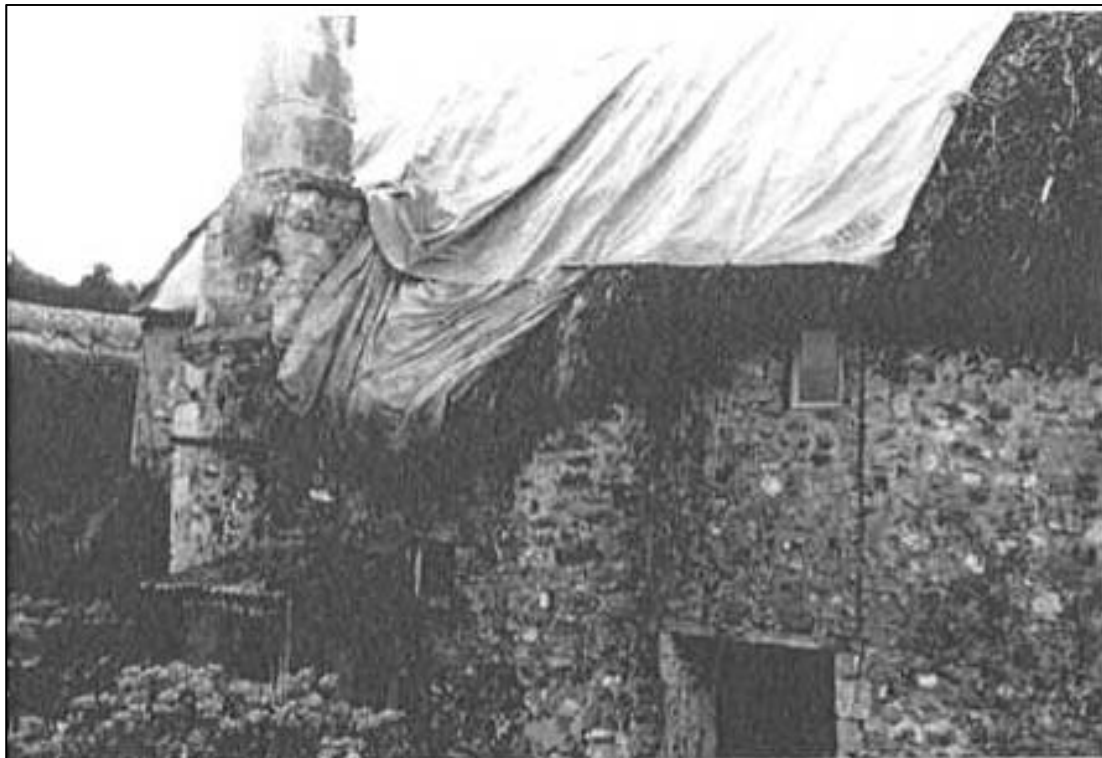
**This lean-to hut (the WC) was removed**

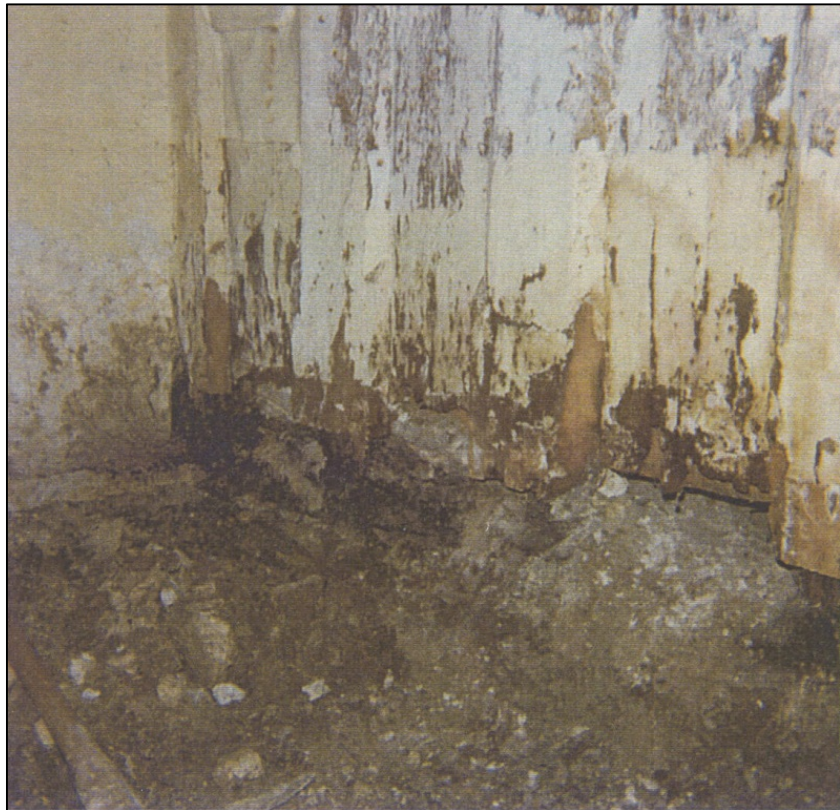
**The bottom of the plank and muntin screen had rotted.**

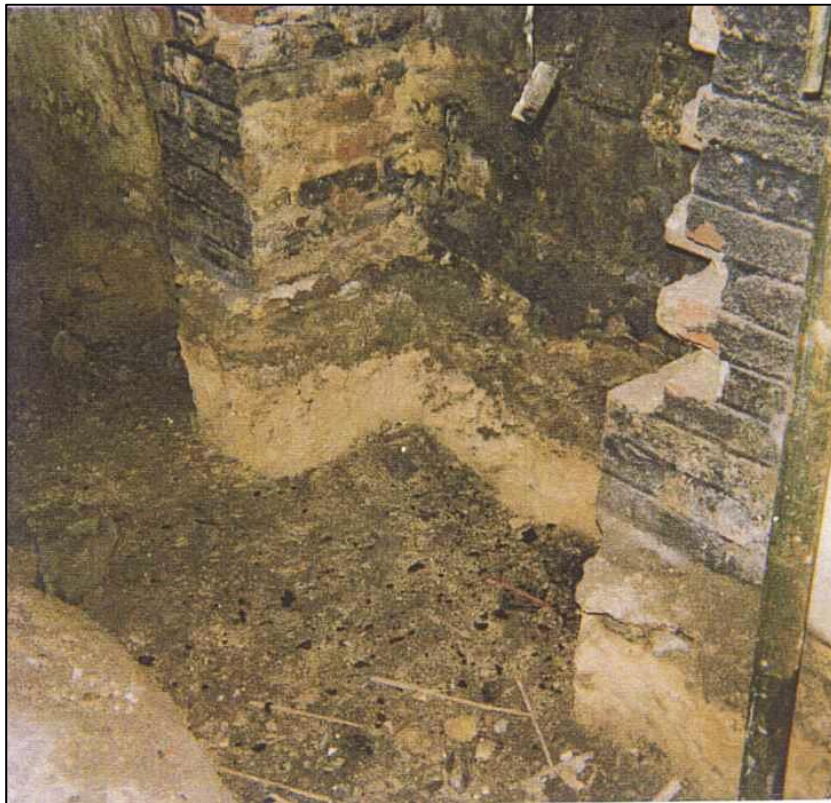
**Opening up the kitchen fireplace.**

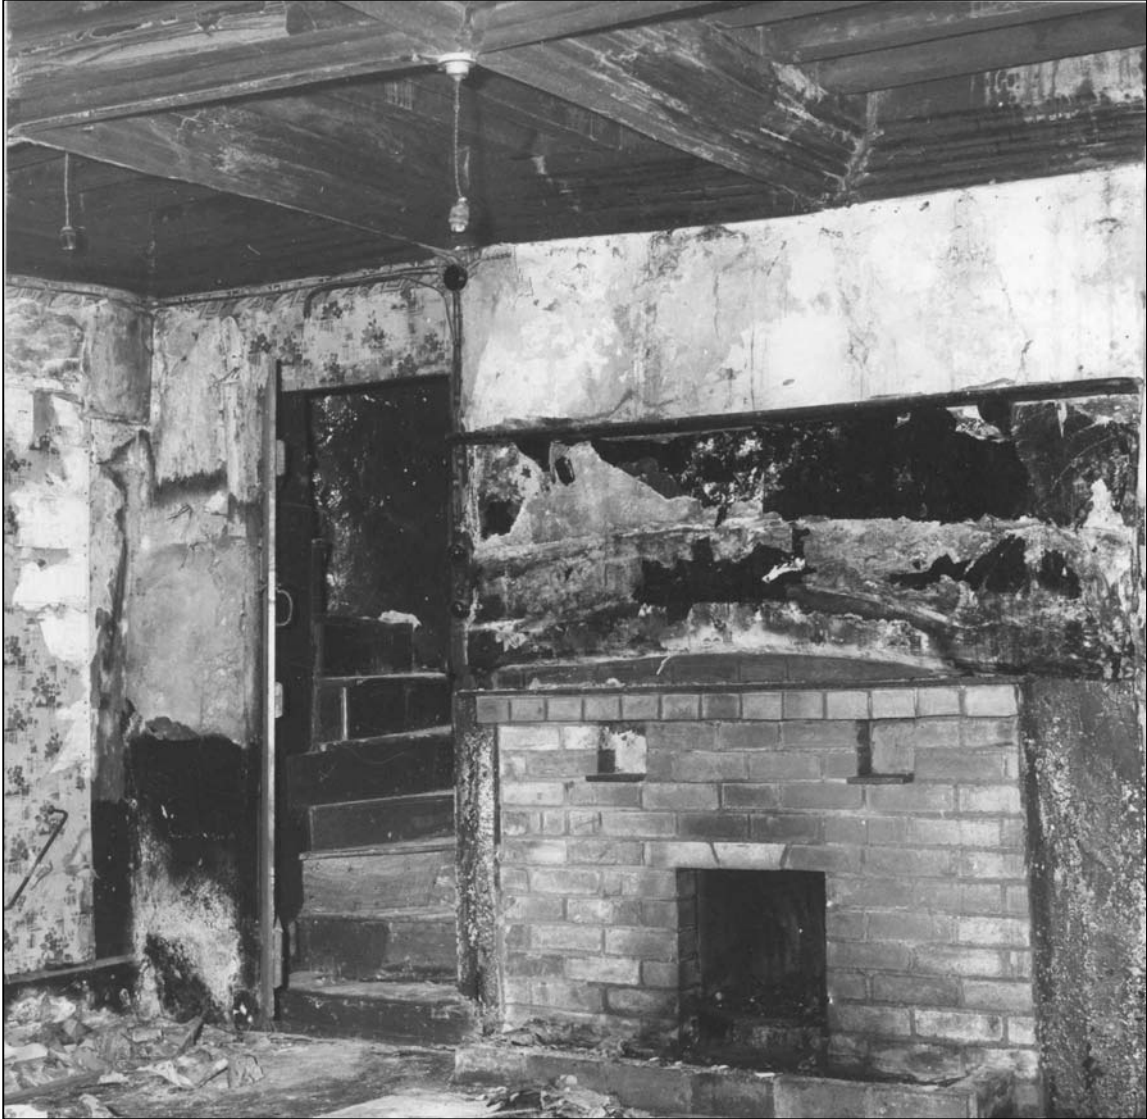
**The bricked up fireplace in the sitting room.**

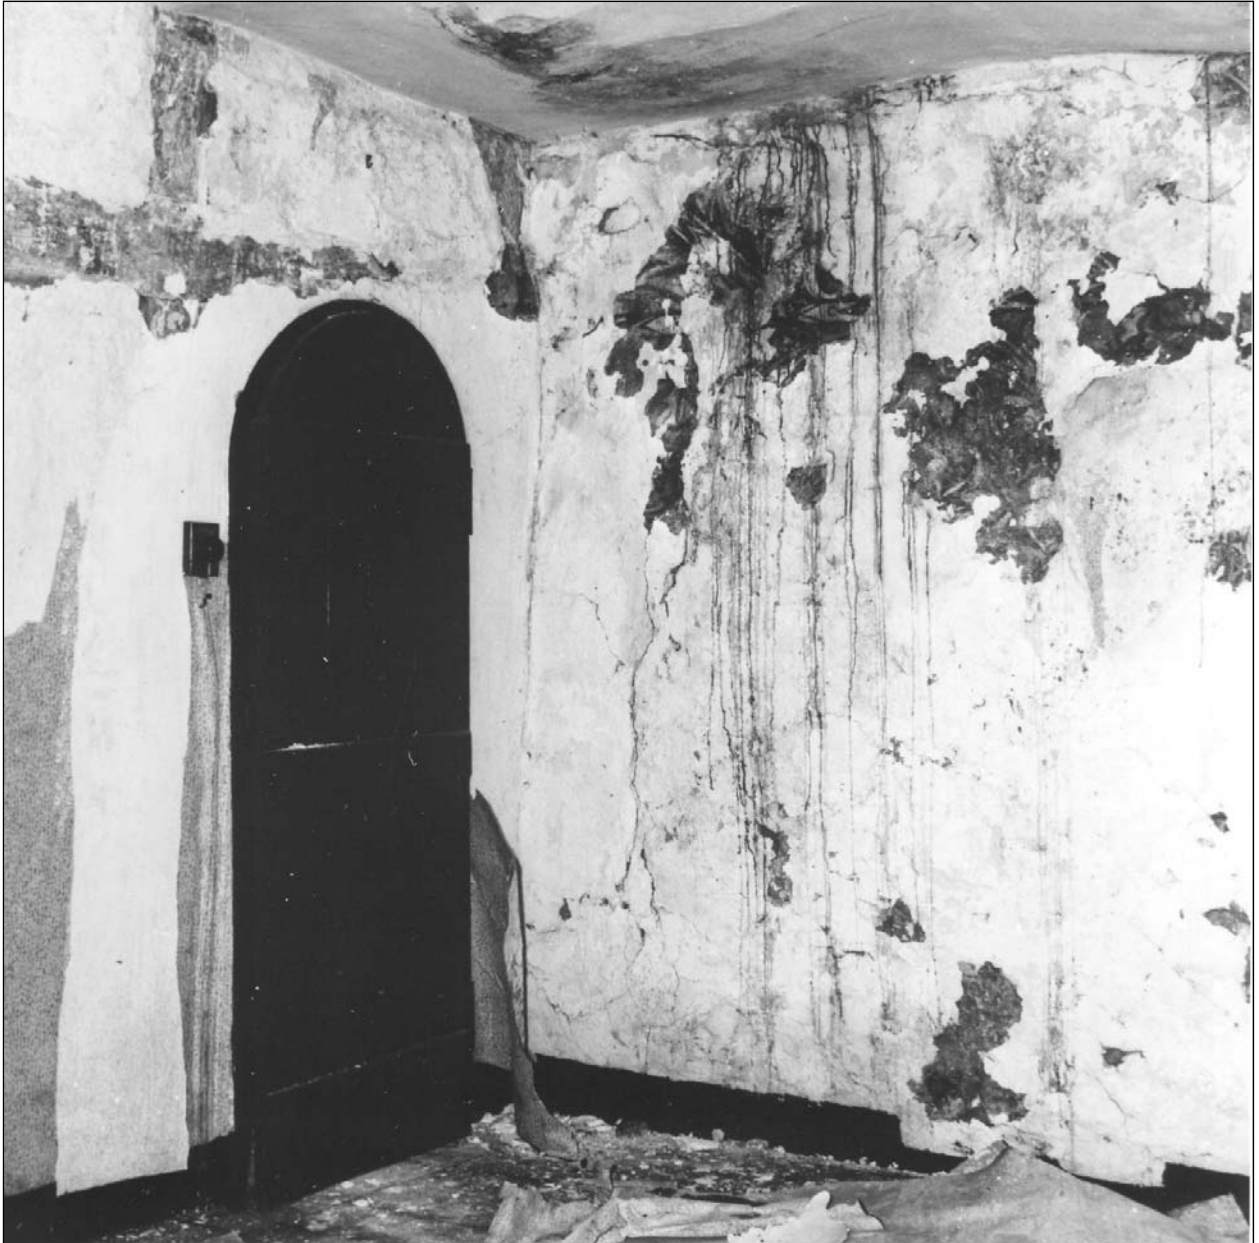
The painting in a first-floor room is painted in a lime and skimmed milk medium with dry colour directly on to the lime and sand support of the wall, covering an area of approximate 7 feet square. It has been covered by a number of layers of colour wash and finally by layers of wall paper. The painting, which is typical of the late sixteenth century, consists of a foliated pattern in several colours including red, black, green and white, with a chevron patterned border and frieze. There are some badly damaged areas at the bottom near the floor level and several cracks which need attention, also one or two places where the facing layer of plaster has become detached from the main support of the wall.

The painting is in reasonably good condition and the removal of the layers of colour wash etc. would reveal a large proportion of the painting in good condition. It is possible that the whole room was decorated in this way, but the remaining areas of wall surface appear to have been re-plastered at some later date.

**Traces of the wall painting in the south bedroom before restoration. The ceiling is visible at the top. (C L Hines).**

I feel that this area of most interesting painting of the period should be restored and made a feature of the room.

The wall painting was restored in 1976 for the Landmark Trust by Mrs. Krystyna Barakan, in such a way as to ensure that the new infill pieces can be clearly distinguished from the original.

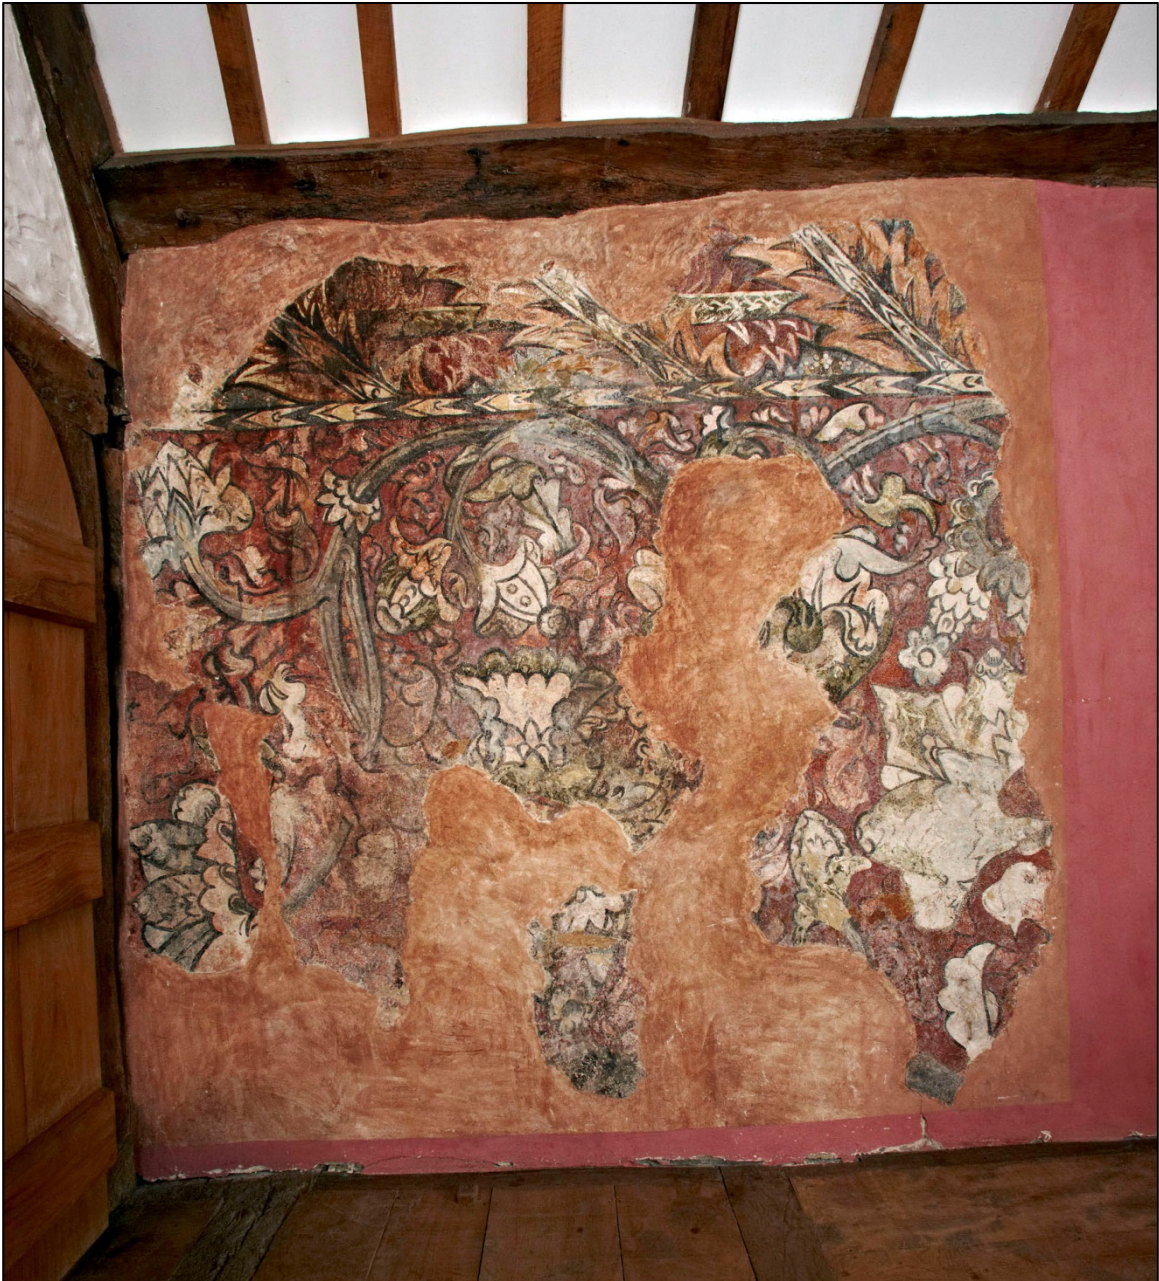
The wall painting after restoration and with the ceiling removed.
