ASTLEY CASTLE History Album

Volume II: Conservation & Conversion

Written by Alastair Dick-Cleland & Caroline Stanford
June 2012

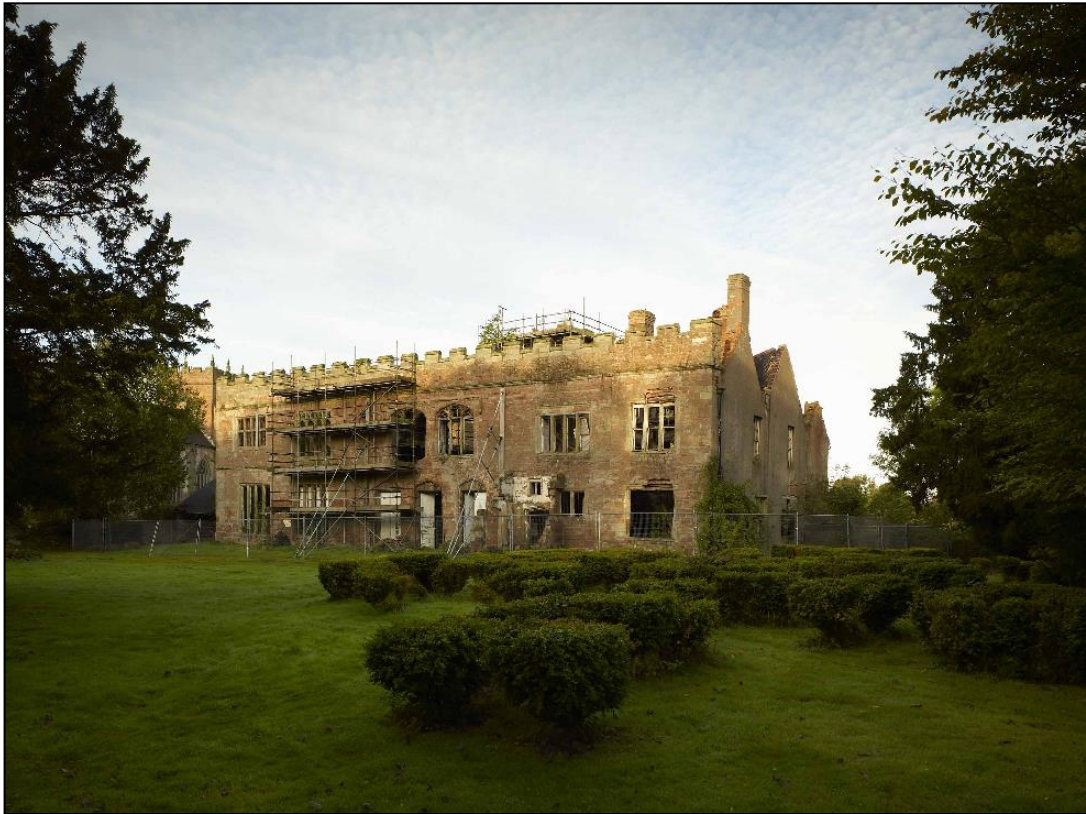
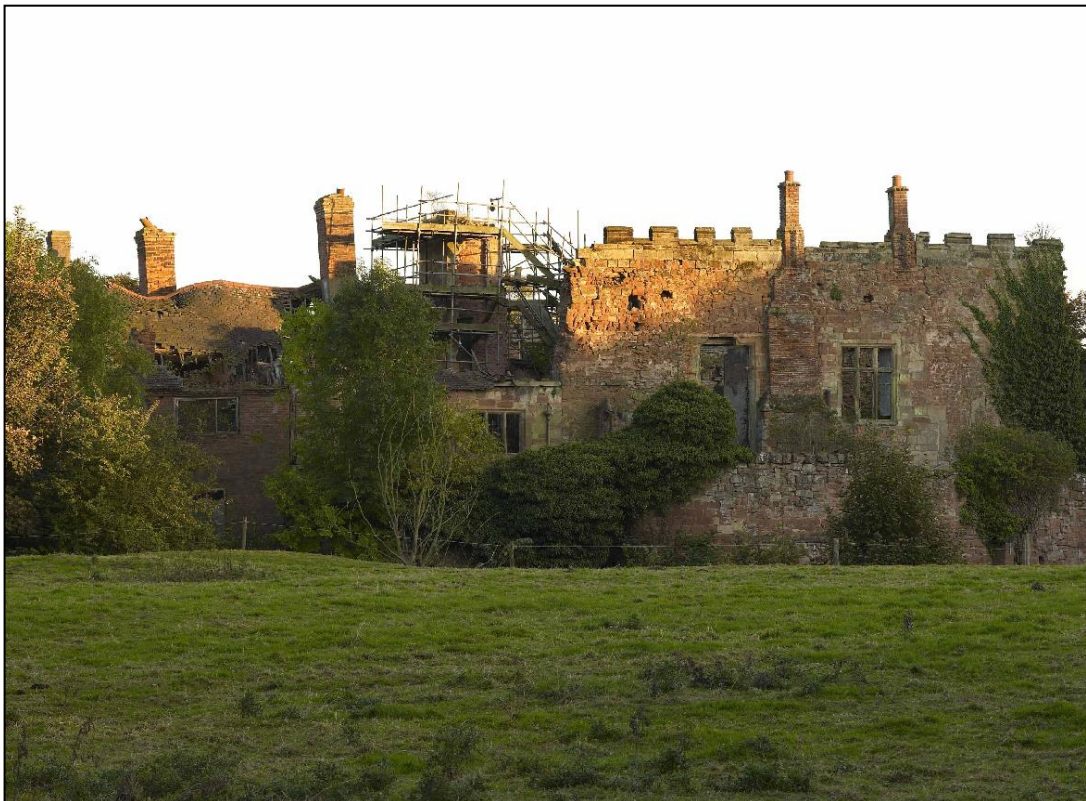
East (top) and west elevations of Astley Castle in September 2007. Note the brick skin of the vice tower still partially standing in the centre below, and the northern portions of the castle that could not be saved and had to be taken down.

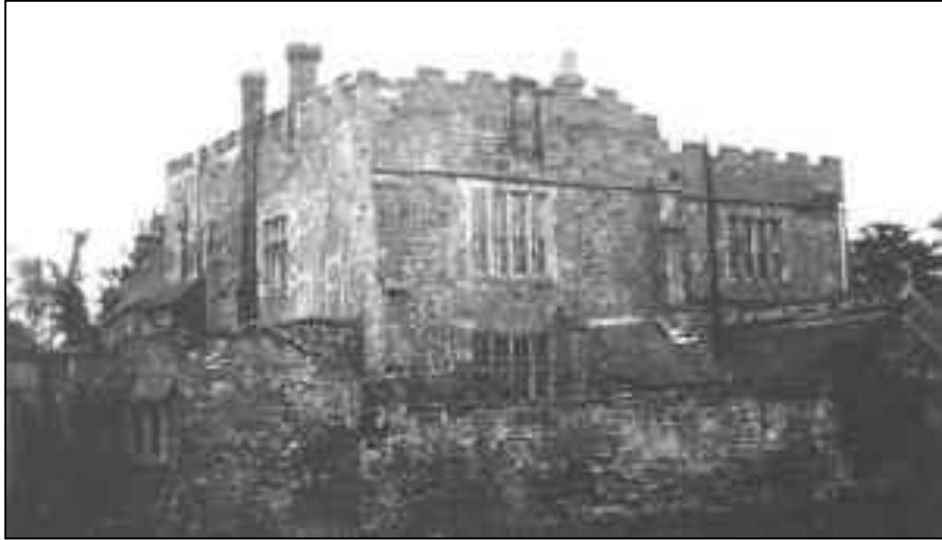
Astley Castle from the south west long before the fire in 1978

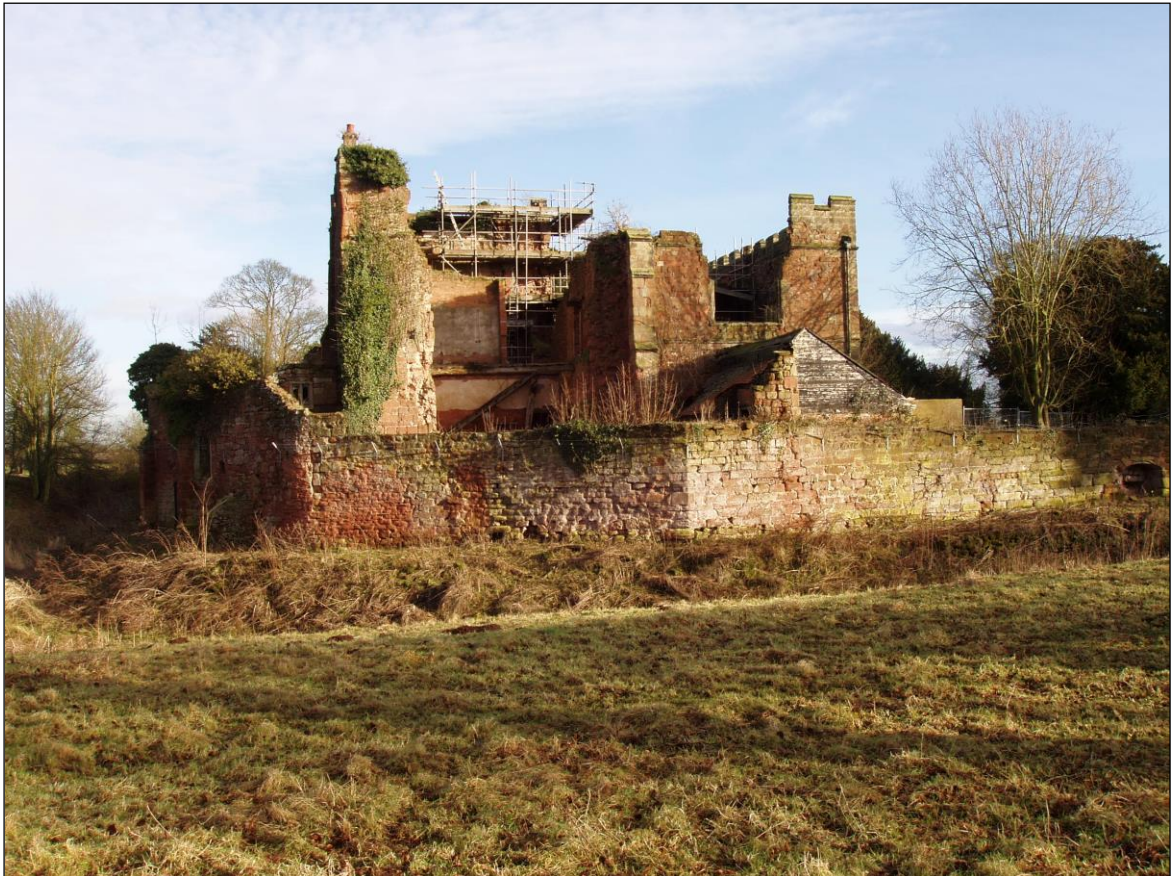
The same view in 2005 with much of the south elevation now collapsed

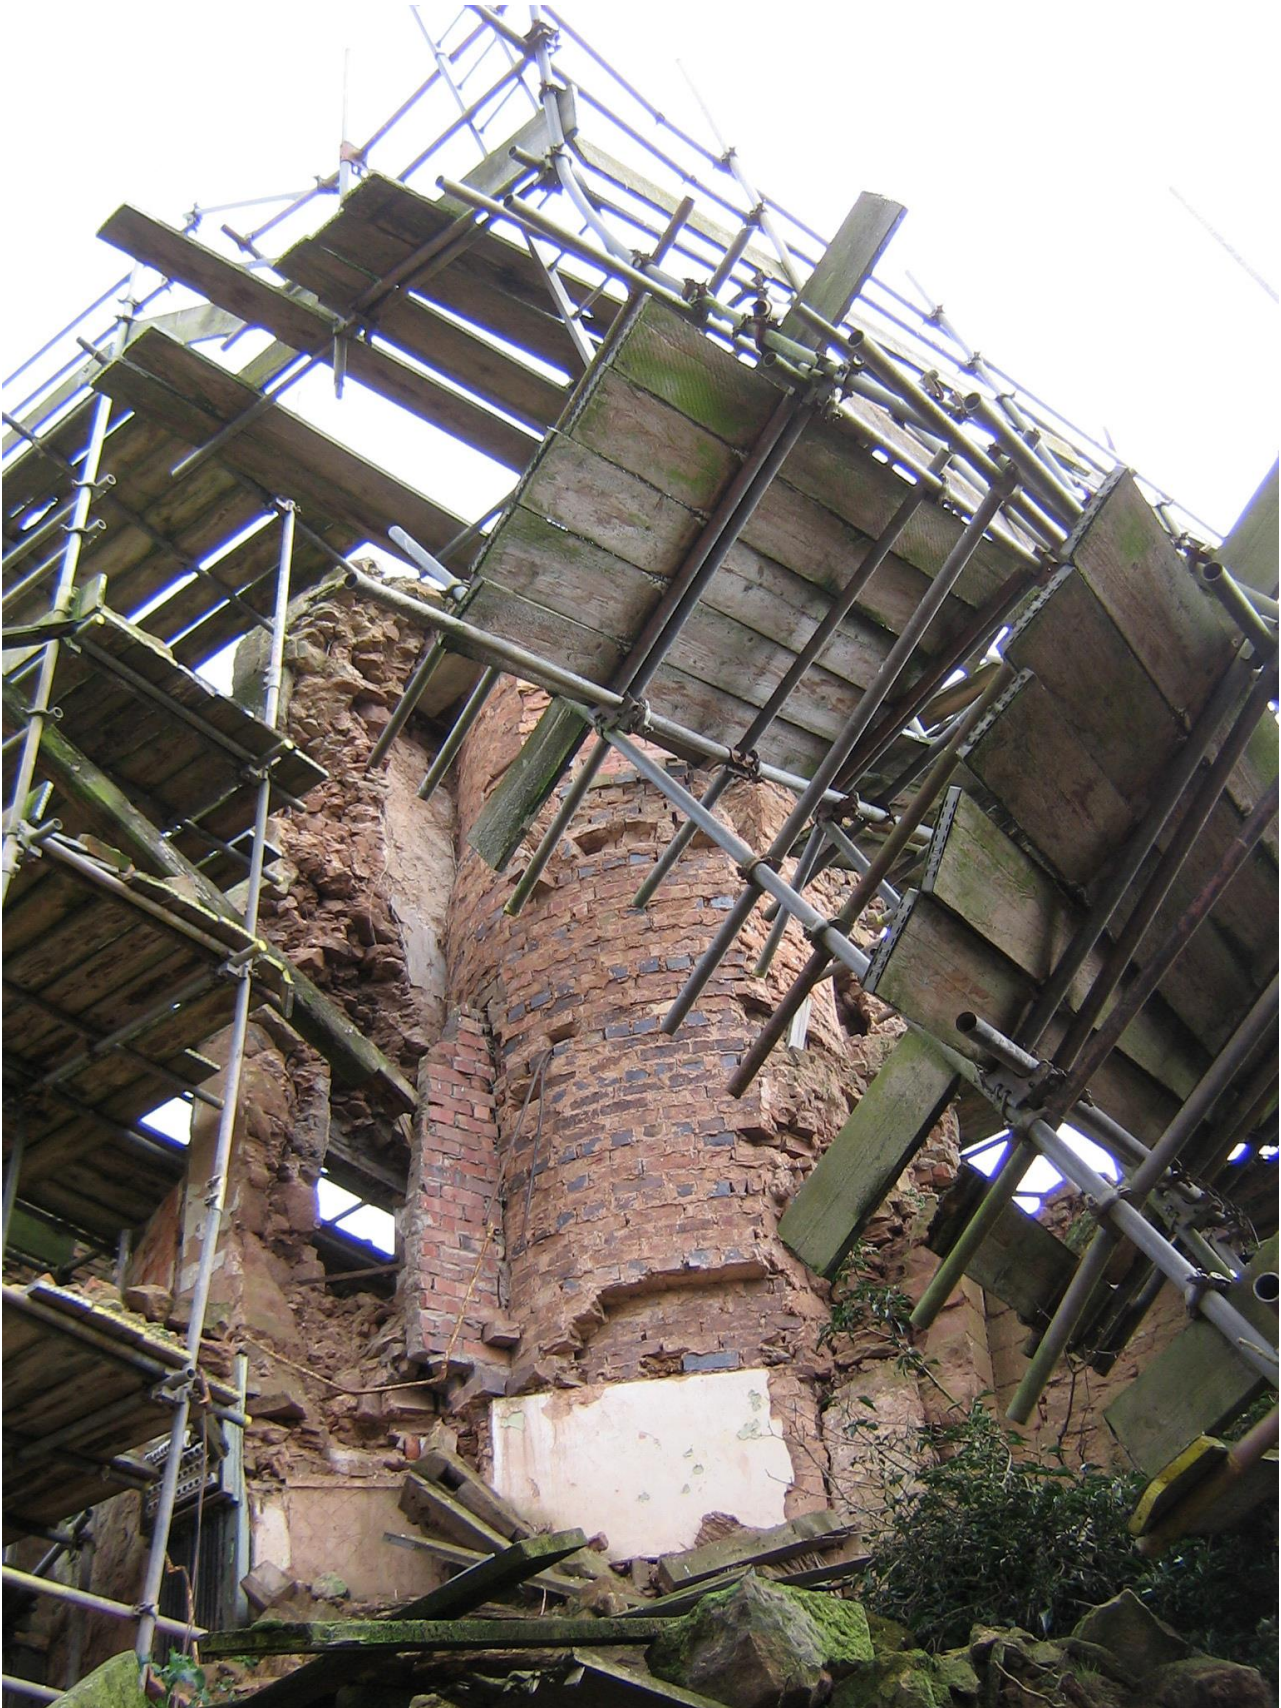
Most of the vice had collapsed by 2007 leaving only a thin brick inner lining. Its remnants now hold the lift.

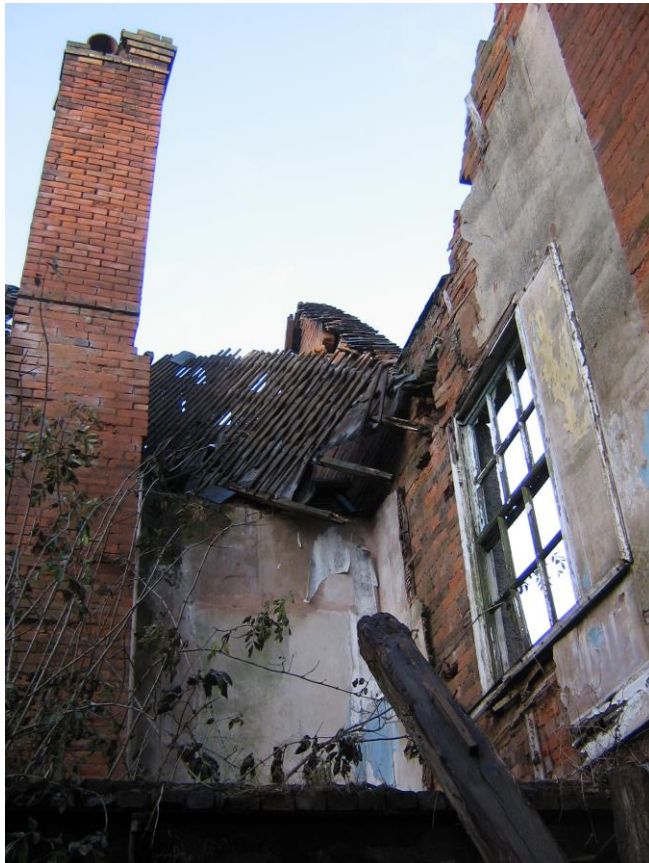
Areas of collapsed roof at the north end of the castle. Much of this area could not be saved

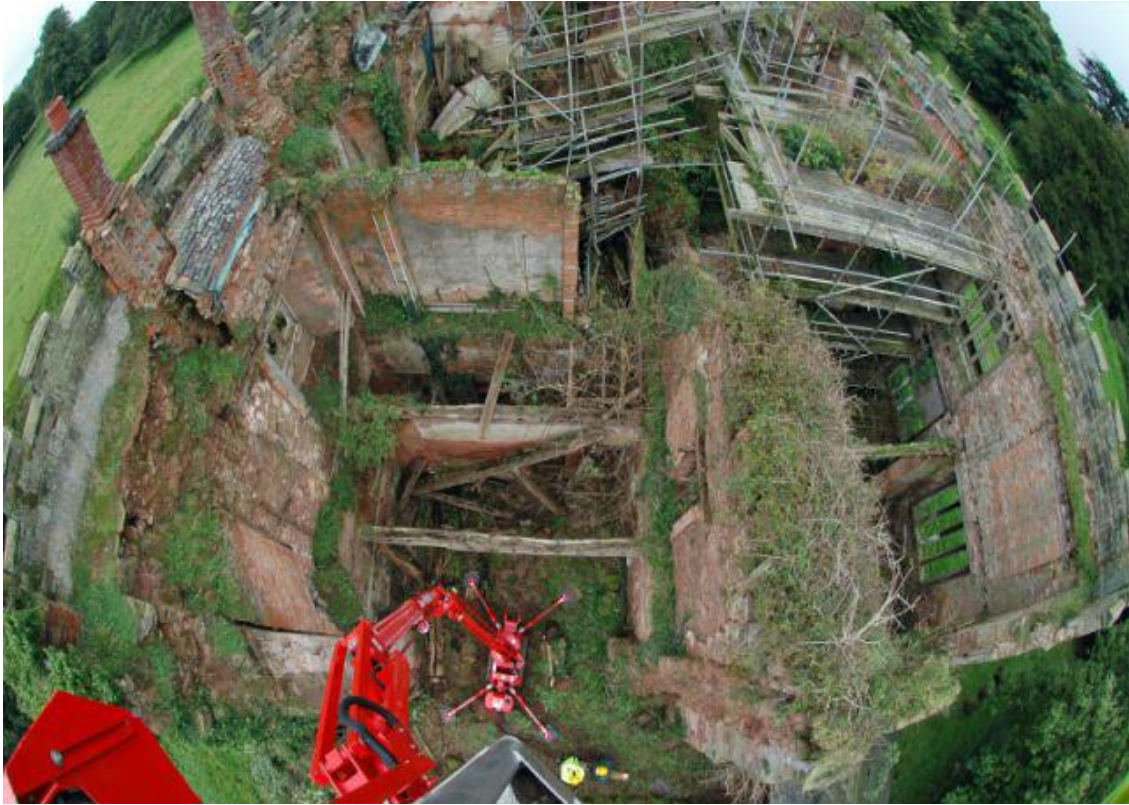
Above: looking down into the south west corner of the castle, site of today's living room, from a cherry picker before work began.

Below: the unstable 19th-century north gable was considered impracticable to repair and had to be taken down.

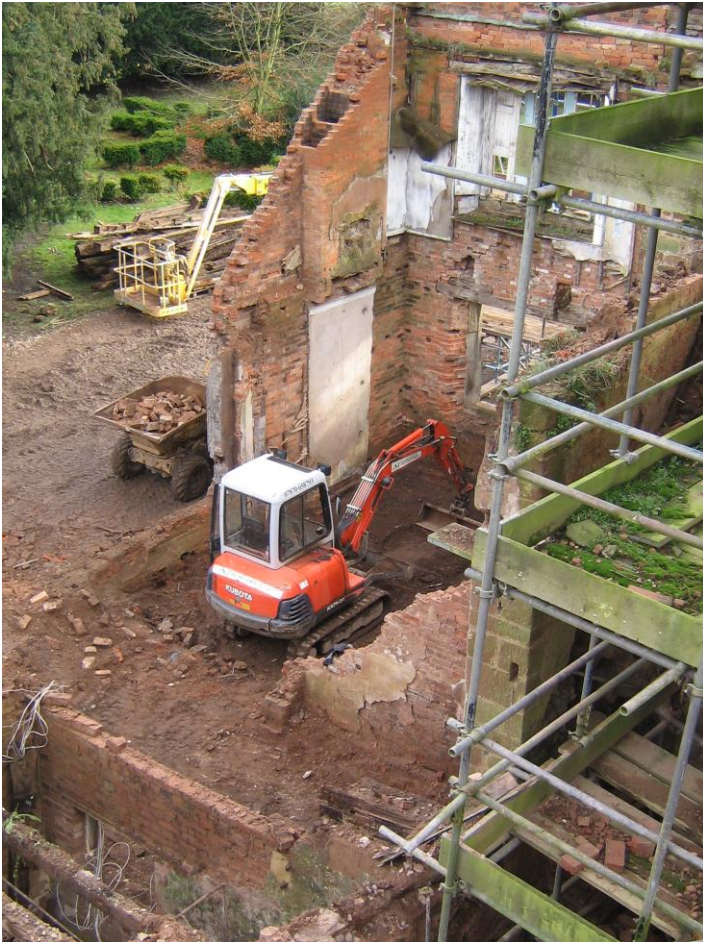
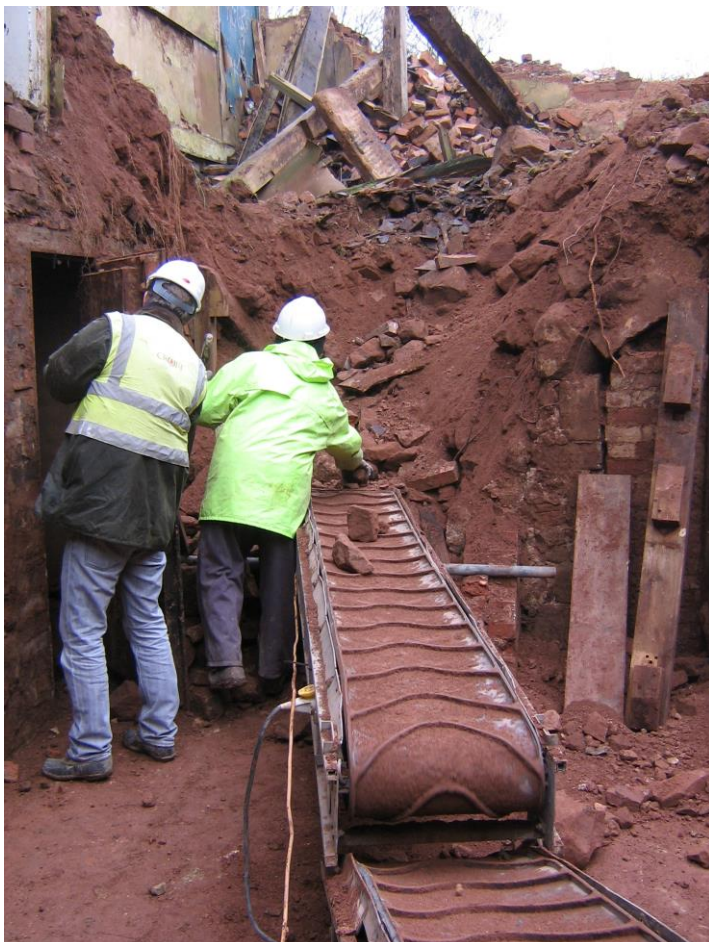
Top: Clearing out the N end with a small digger and dumper truck after the taking down of the N gable.

Below: Clearing out the collapsed debris using a chain on conveyors

Once the key areas of demolition had been cleared, mostly using a small digger and dumper truck, the main internal clearance could begin. Because the biggest area of debris was where the north wall had collapsed, it wasn’t possible to get vehicles in here, and so Croft rigged

up a series of quarry-type conveyor belt to get all this material out – which had to be loaded onto the conveyors by hand. As the photos show, the rubble was at least 10' high in places. Buried in the rubble was the old medieval doorway in the north wall, which Richard Morriss insisted should be retained. More of this later, but the arch survives, in the bathroom. The old bent and damaged scaffolding was removed (the boards were long rotten) and a new scaffold went up to enable the consolidation to start.

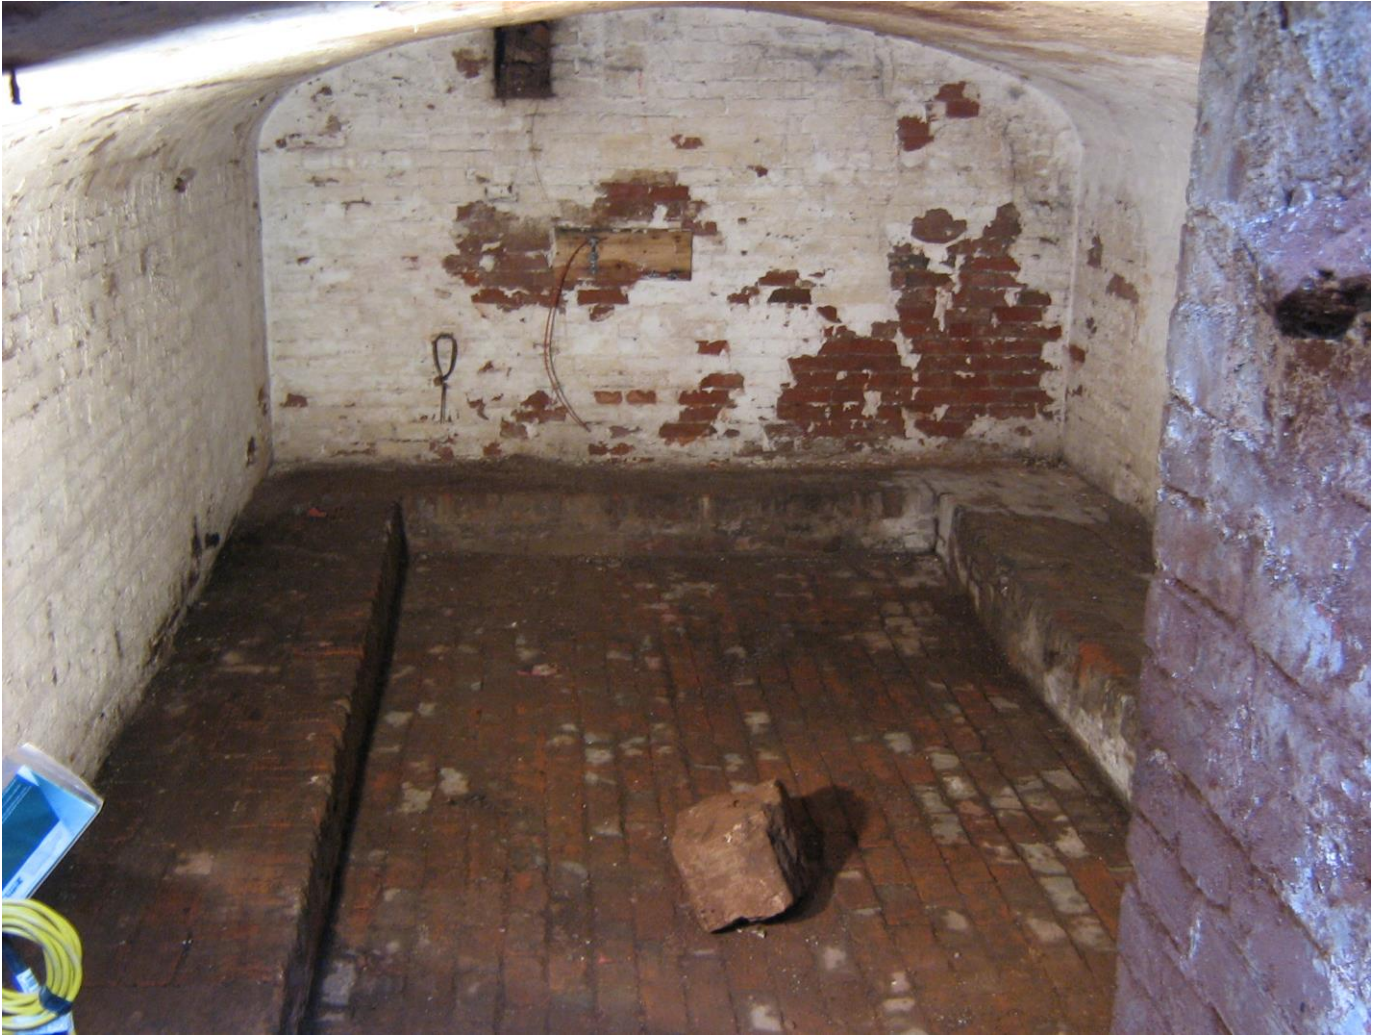
The Victorian cellar underneath the hall. The shelf is for barrels of beer

The cellar (under the bathrooms and hallway) appears to have been a bold Victorian intervention in that it was dug out within the walls of the old medieval part of the castle. It had a relatively thin and shallow arched roof, which was showing some cracking, no doubt because of the collapsing stair turret landing on it. So the new structural engineers, Price & Myers, designed a reinforced mesh that was fixed to the brick arch to reinforce this area. The ground floor concrete floor slabs were then poured to provide a firm base off which to erect subsequent scaffolding.

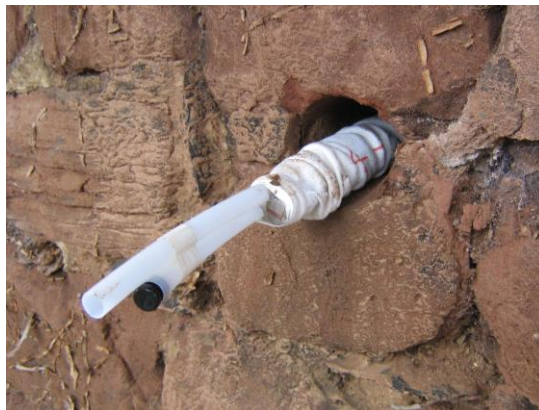
A Cintec anchor in its drilled hole before it has been pumped full of grout

Extensive use was made of Cintec anchors to tie the very vulnerable rubble walls together. These are stainless steel rods enclosed within a fabric 'sock'. A hole is drilled through the wall using a diamond-tipped drill, the anchor is inserted, and then a grout is pumped into the far end of the sock which swells and so fits into any holes and voids within the wall. Once set, the hole is simple plugged with a closely matching piece of stone, leaving an almost invisible repair.

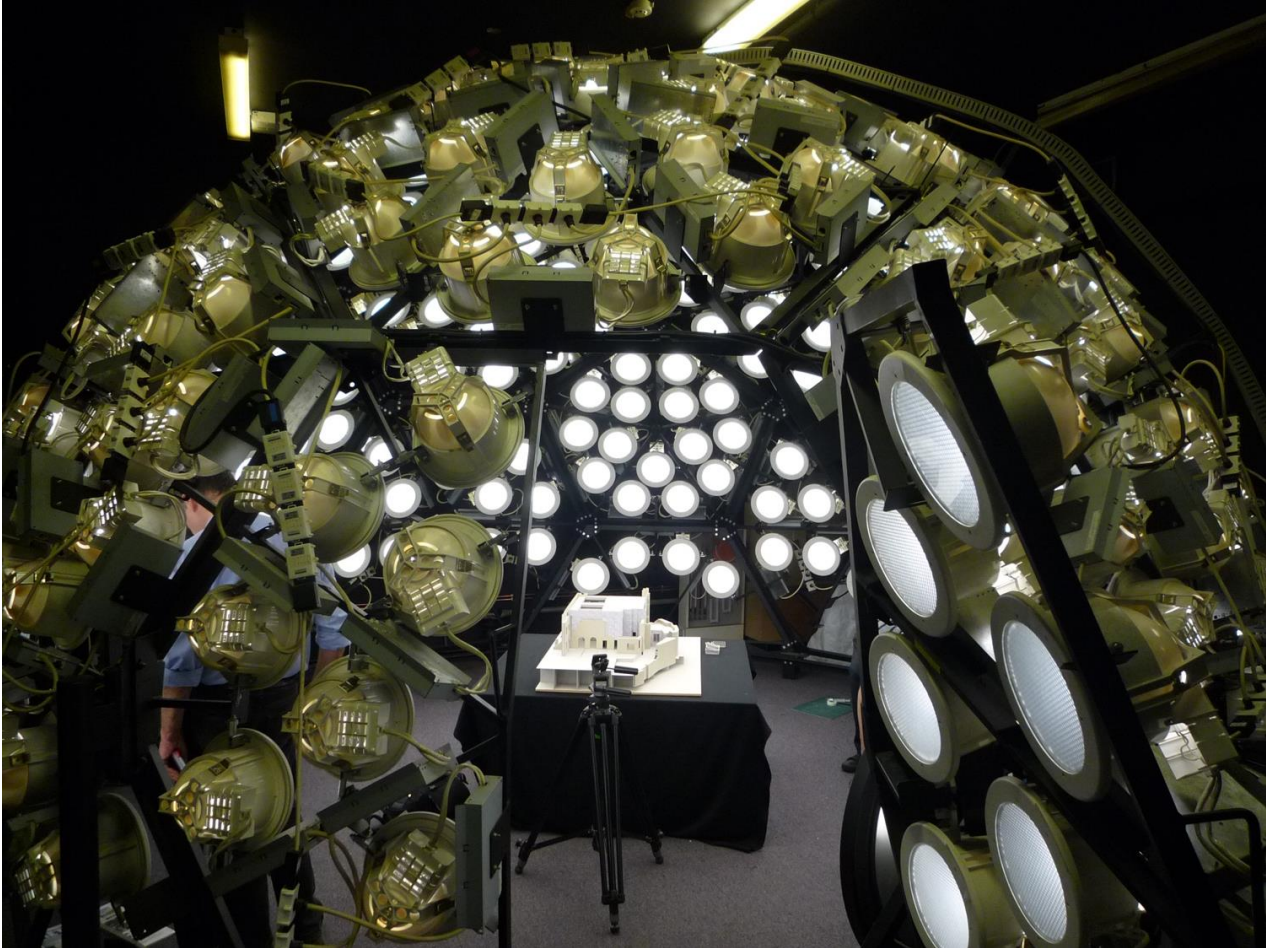
The latest technology was used to help develop the scheme. An 'artificial sky' at the Bartlett School of Architecture, University College London, here dwarfs the model of the castle. The computerised lamps enable the light to be simulated for any time of year or day, in all weather conditions, to help finetune the placing of windows and openings. As seen in the two examples below, the simulations proved remarkably accurate of the end results (left: first floor, kitchen area; right: the garden court).

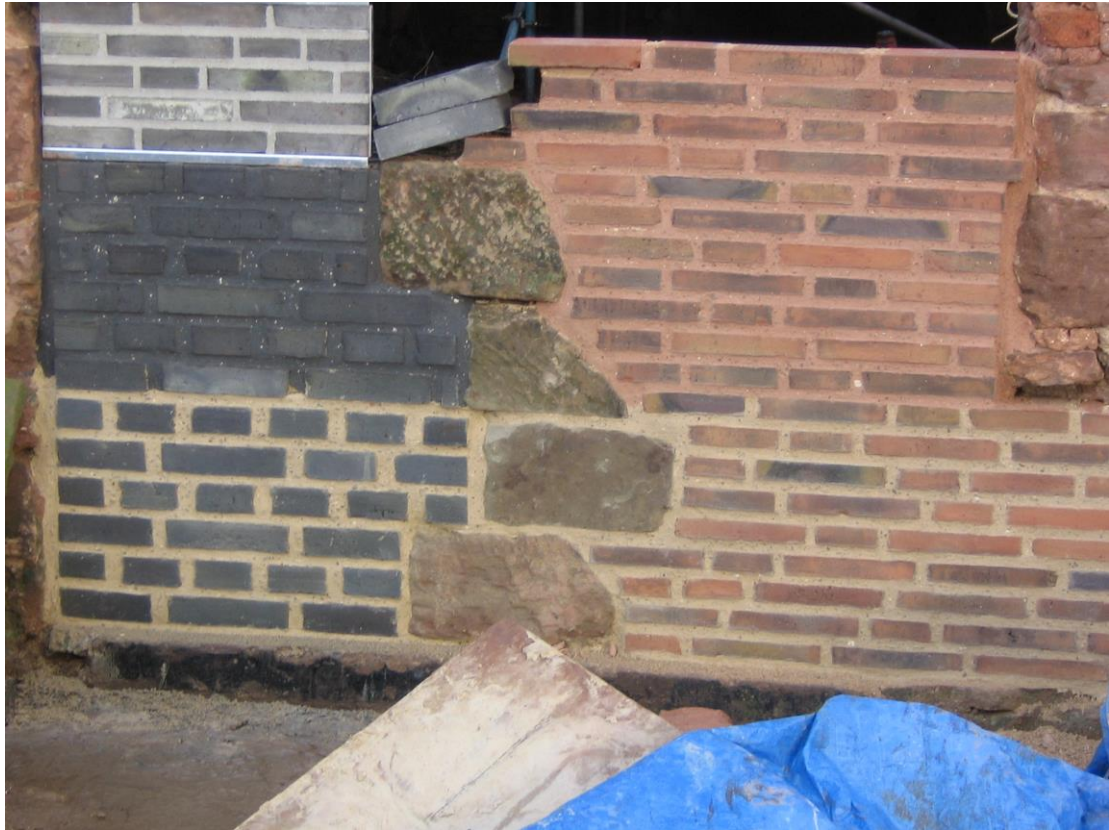
A sample panel of different Petersen bricks

Quite rightly, the decision process was led by the architects, who assessed samples from various suppliers from the UK and beyond before they finally recommended Petersen bricks from Denmark. The Petersen bricks are manufactured in a different way to most UK-made bricks, being charcoal-fired and water-struck (de-moulded using water), and such care manifests itself in the fine texture presented by the end result. One UK supplier was keen to replicate the brick eventually selected, but while they achieved a good result in terms of dimensions, the colour match with the Astley sandstone was less good.

Trial panels of different types of bond and joint width were built in the archway in the south elevation. There was much discussion over whether to use greyer or pinker coloured bricks. Finally, the architects' recommendations of Petersen's 'D36' range was chosen as offering a particularly good colour match to the range of colours in the sandstone walls. The long, thin shape of the bricks were also especially desirable so that the neatest possible junctions could be obtained where the new brickwork has to tie-in up against the old ruinous wall edges. The architects were very keen to avoid visual disjuncture with the inevitably

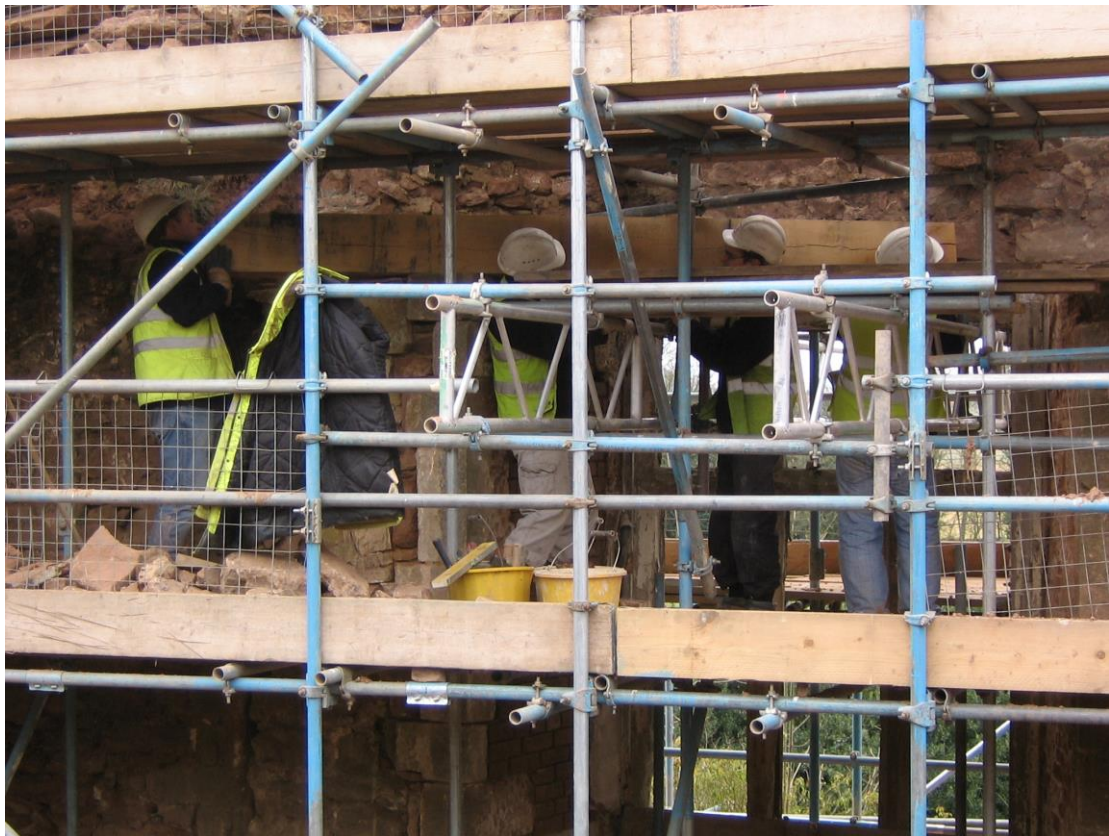
Manhandling one of the new oak lintels into position on the west wall

In February 2009, the very plain modern caps of the chimneystacks in the west wall were taken down. The wall below this west elevation turned out to be in a very poor condition, and a substantial area between the two stacks had to be taken down and rebuilt. New oak lintels (very long and very heavy) had to be carefully man-handled onto and along the scaffold to get them into position over the west wall windows. Work was not helped by the first falls of snow!

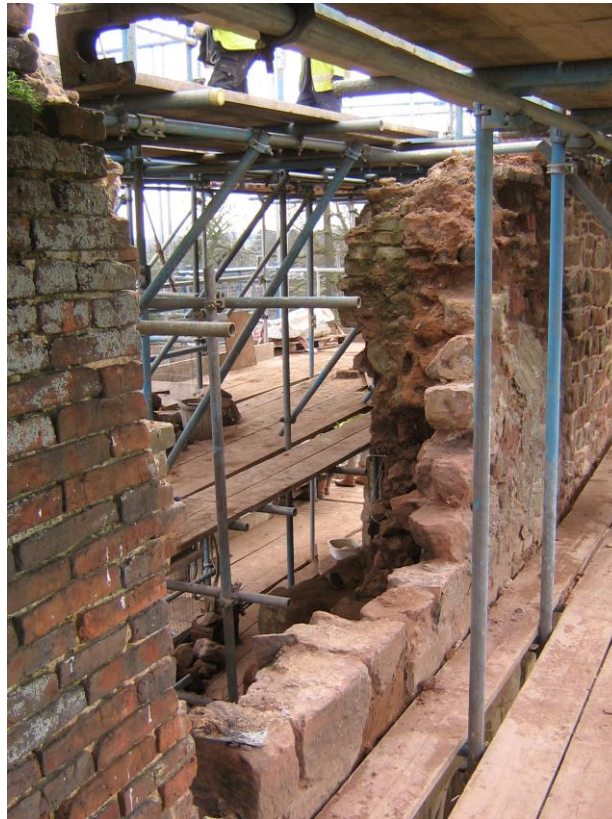
A significant area of the west wall had to be taken down and rebuilt

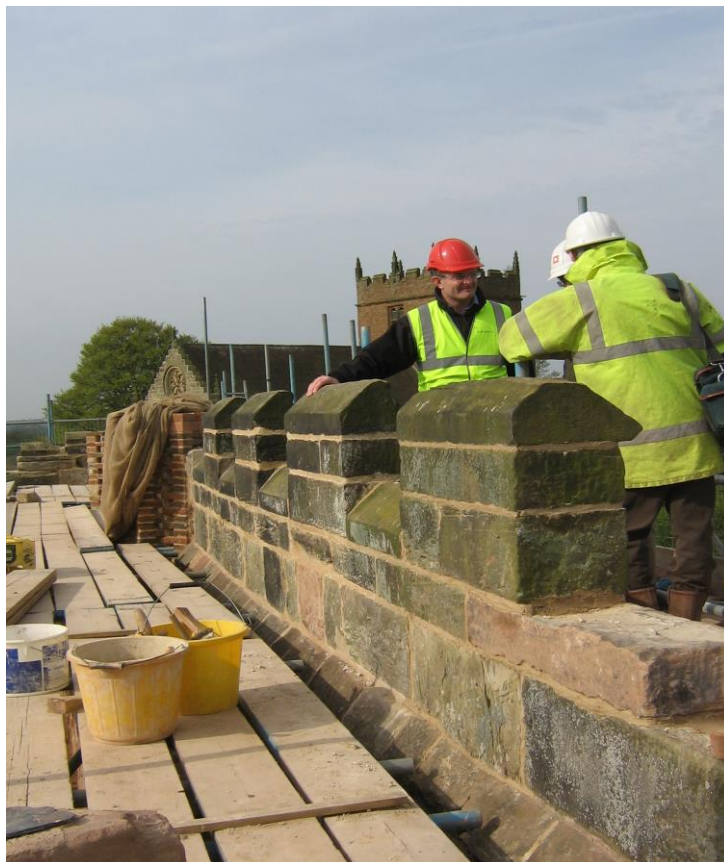
The rebuilt merlons and chimneystack bases on the west wall

By the end of April 2009, much, but by no means all of the consolidation had been done. The west wall was rebuilt and repointed, and the brick Tudor stacks rebuilt to the height they had existed as first built– but we chose not to extend them to the taller height shown in old photos. This was consistent with the philosophy of repair adopted by WWM, which was to 'freeze' the historic fabric as it was in 2008, and thus not to rebuild any missing areas or features in old materials, even if the evidence to do so existed.

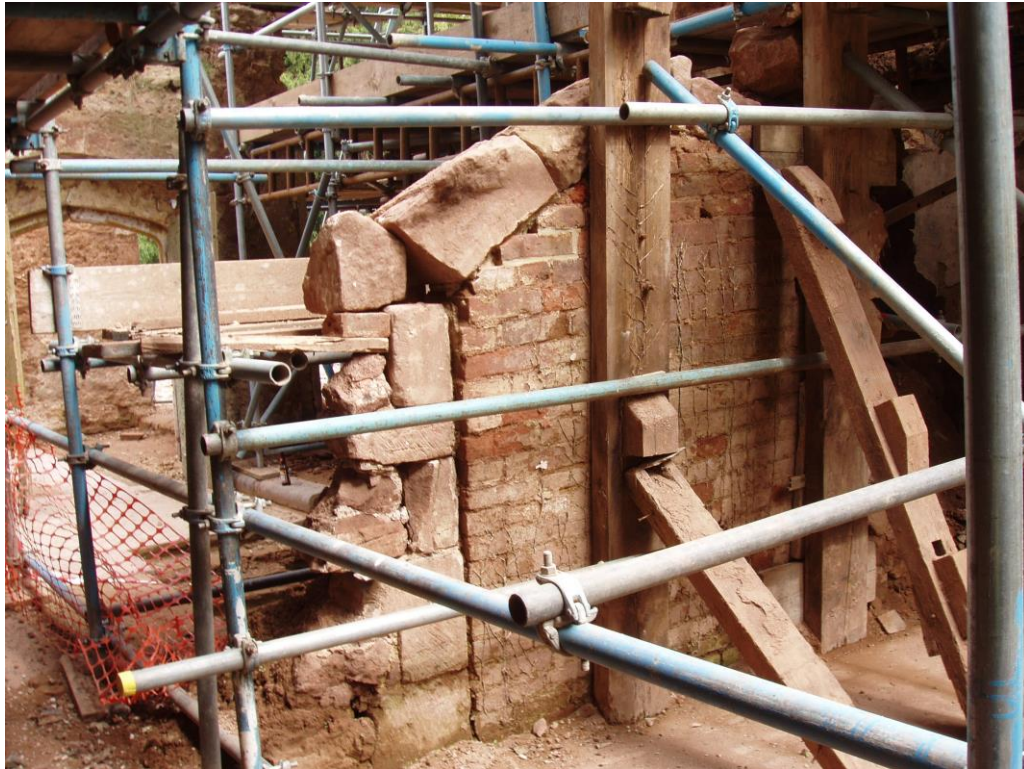
The surviving arch in the original medieval north, now in the bathroom

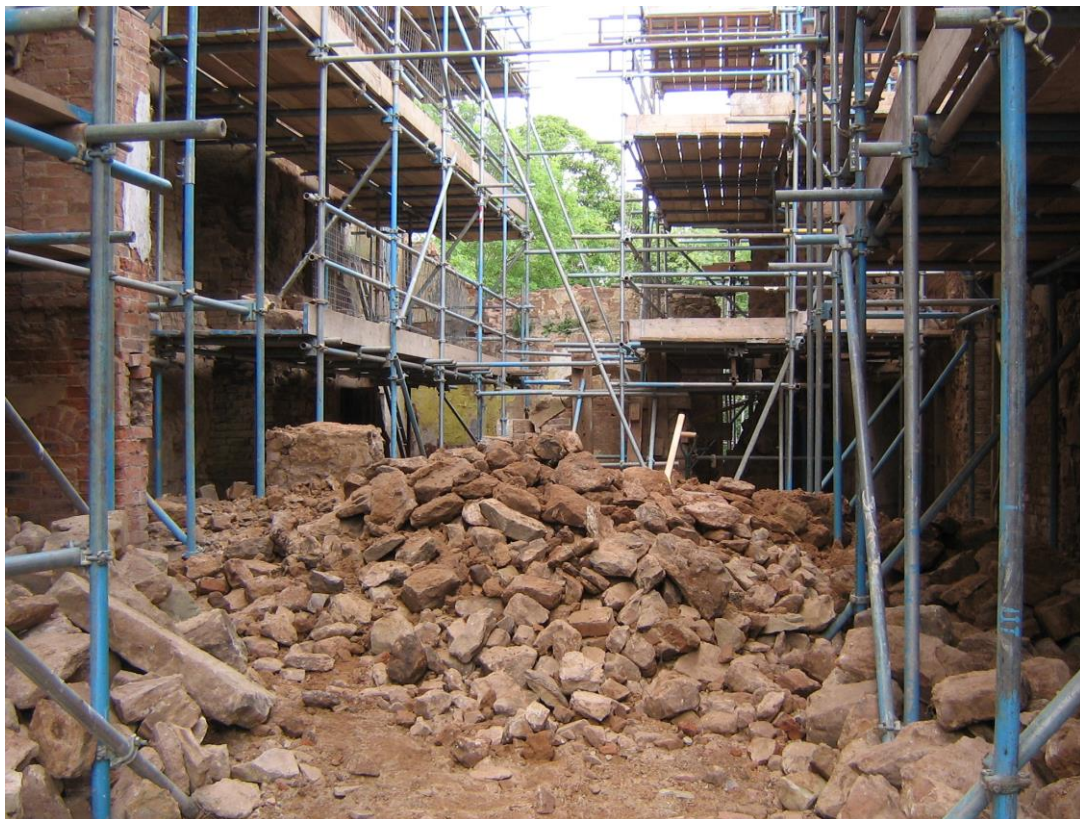
The cross wall on the ground floor being demolished

Later that summer, with some reluctance, we agreed that the ground floor cross wall in the main area had to come down. Although it was well-built and of stone, Richard Morriss confirmed that it was a much later addition and so not primary fabric. The brick entrance lobby in the spine wall, which we had at one time thought might make a good location for the lift, was removed, and in the process, the rather fine remnants of the double moulding on the ground floor entrance court (i.e. north) chimneystack was revealed. Most of it had been cruelly hacked off when such features were unfashionable. A similar detail can be seen on the south side of the same stack.

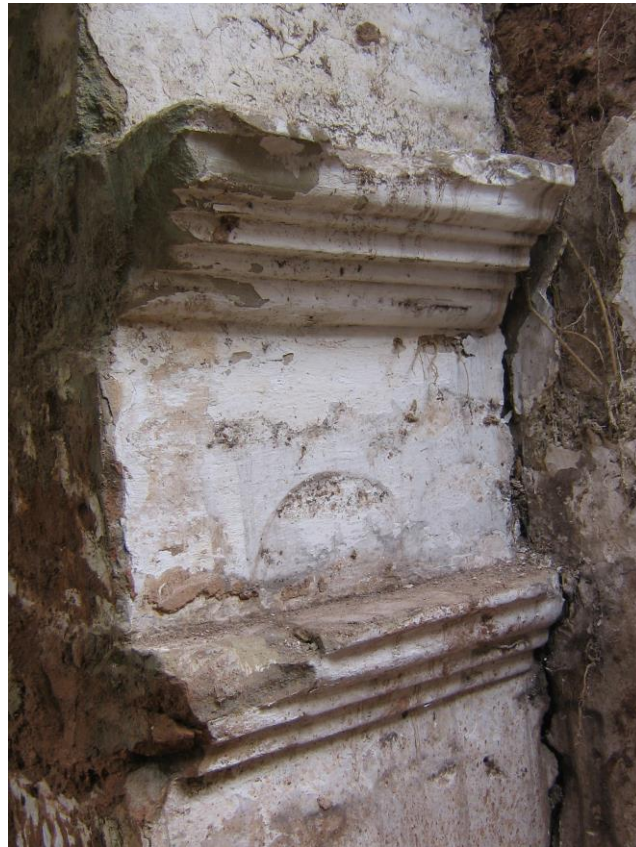
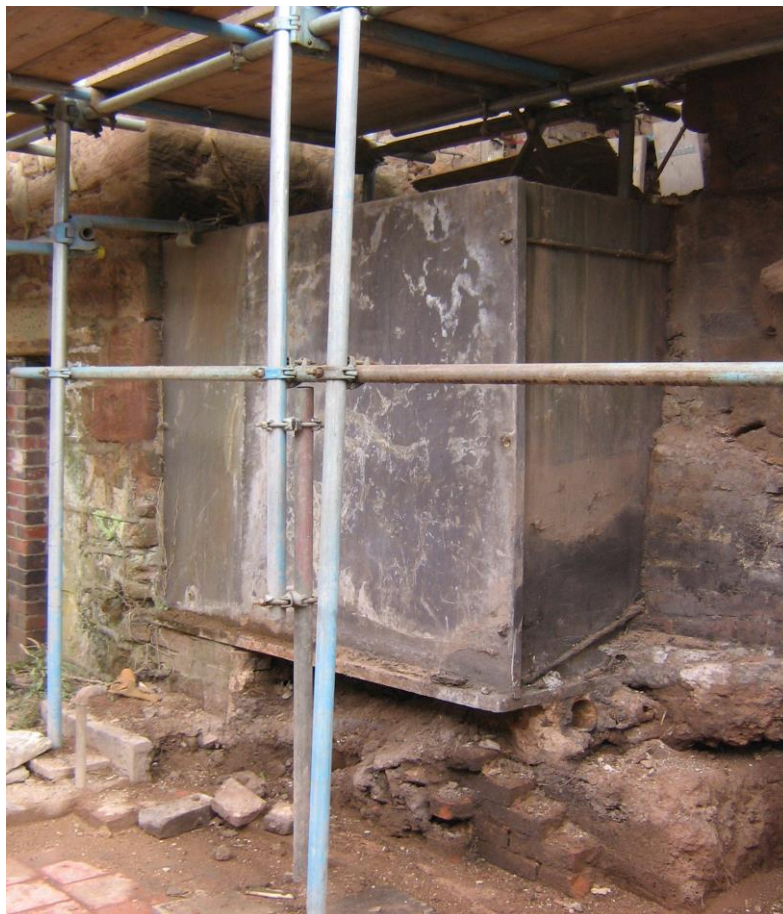
**Above: The double band of decorative moulding discovered on the garden court fireplace
Below: The slate water tank still intact in the old service area, its sides now the table top
in the garden court.**

At the base of the west wall, where the doorway into the more accessible bedroom now is, we unearthed a large, and rather fine, slate Victorian water tank. This had been beautifully made with rebated grooves cut into the base and sides so that it all locked together. Amazingly, it was still completely intact. We very carefully took it apart, and it has been reused as the table top in the garden court.

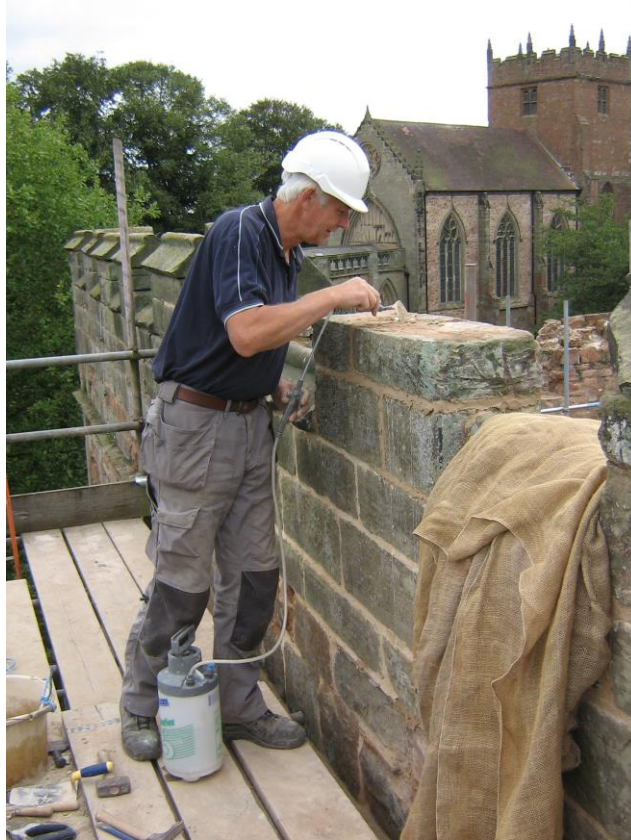
Len Hardy rebuilding the merlons on the east elevation

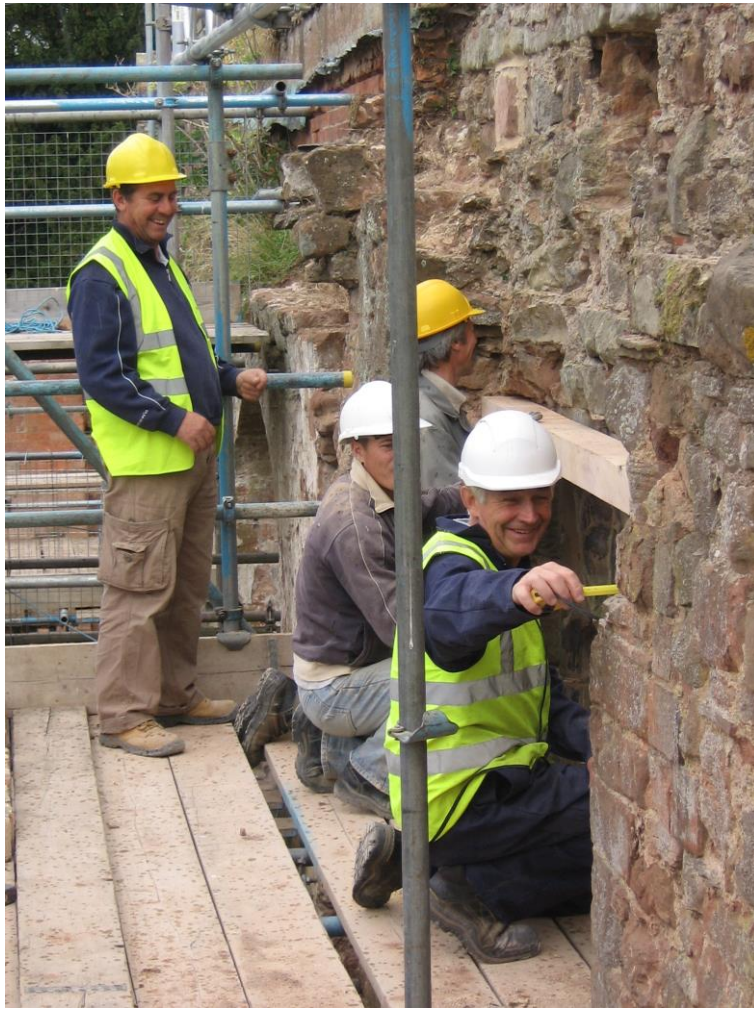
Putting in new oak lintels to the garden court windows

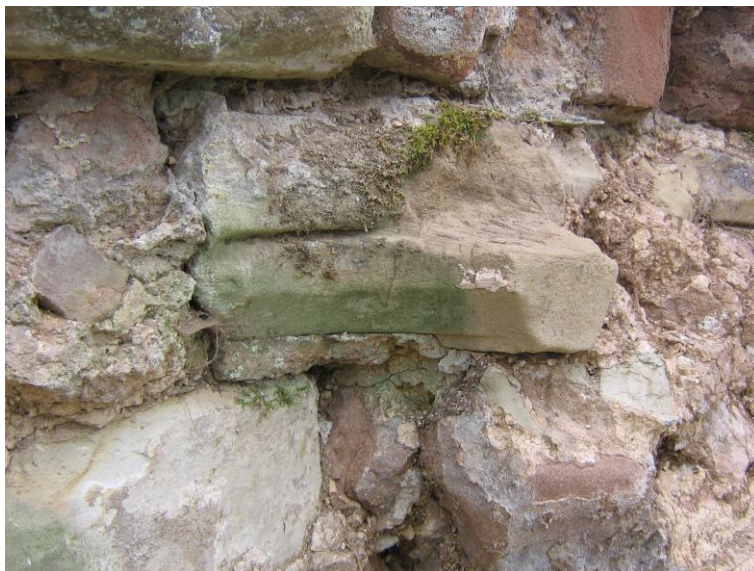
Moulded window tracery stones found built into the east elevation and probably from the dismantled nave of St Mary's Church

Much work was done to the parapets above these windows along the east elevation. In the core of this wall we found plenty of moulded window-tracery type stones, possibly from the demolished nave of the

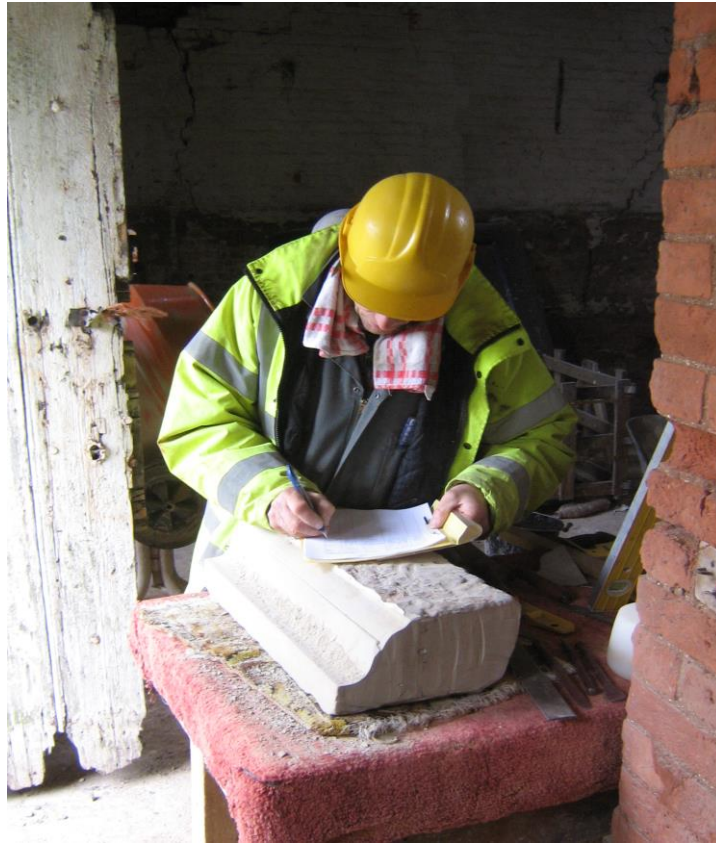
John Brown carving a replacement drip mould stone for the front elevation

church. Some of the moulded drip course stones on the east elevation turned out to be just a mess of chicken wire and cement. So these areas were carefully cut out and either old replacement stones fitted, or when none were left, new ones were carved from old blocks. No new stone has been used in Astley's repair at all (except for a few plinth blocks on the west wall chimneystack). Much time was spent in repairing and repointing the spine wall, which enabled us to keep more than was first supposed and indeed allowed for under the Listed Building Consent.

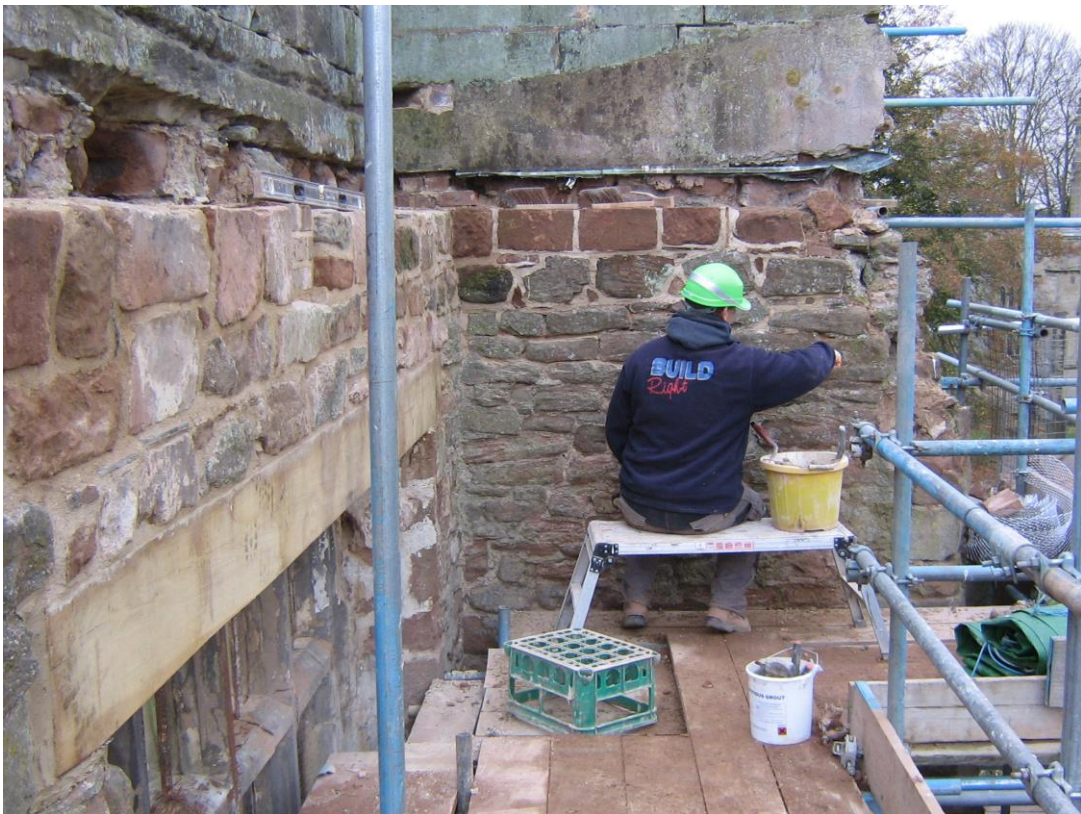
Ian McGregor of Buildright repointing the garden court walls
