ASTLEY CASTLE History Album

Volume II: Conservation & Conversion

Written by Alastair Dick-Cleland & Caroline Stanford
June 2012

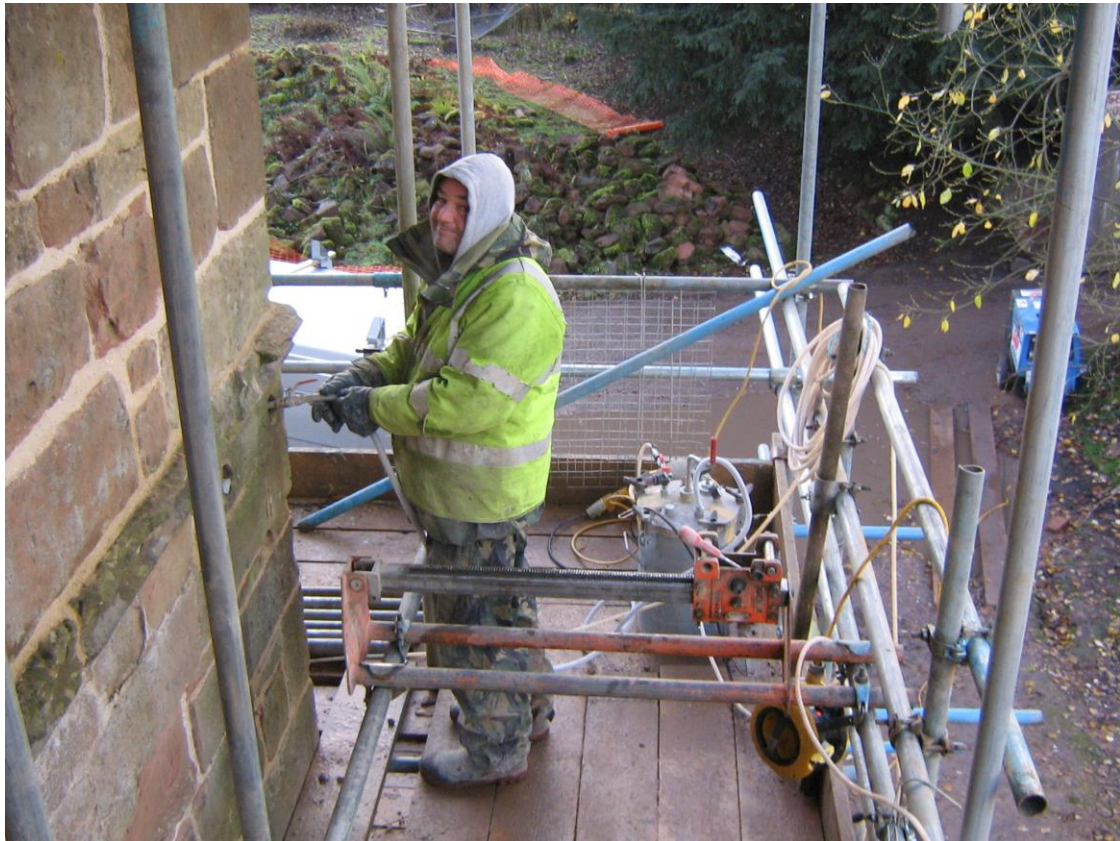
Pumping grout into the two 11m long anchors inserted into the SE corner

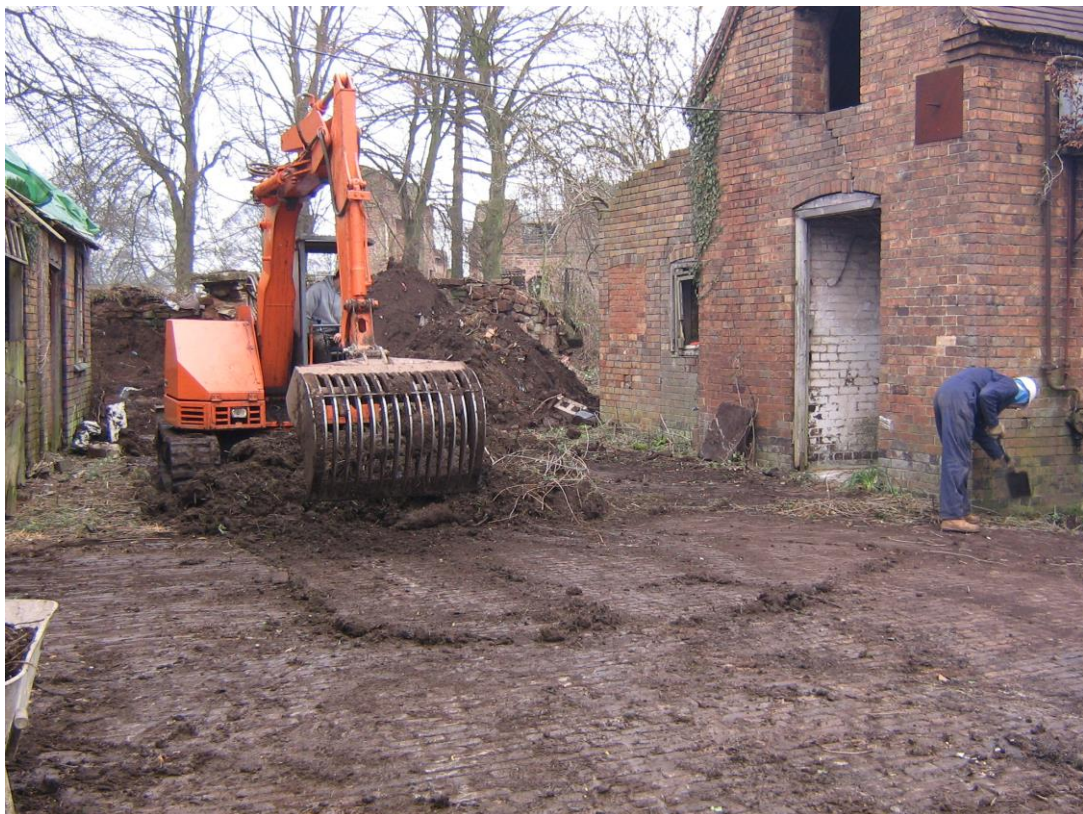
Clearing the Coach House yard and finding the brick paving

The Coach House has been something of a Cinderella to the castle, with the latter necessarily taking priority for funding. It could only be our intention to make the Coach House weathertight and sound, which we have achieved, but for now it awaits an internal fit-out and a new use. Early in 2010, and with fundraising still continuing, attention turned to the row of sheds behind the Coach House. Like the castle, these were in very poor condition too, and almost buried under ivy and brambles. A digger was brought in to clear the yard, revealing a rather good brick paved surface that covers about half of the yard. The roof was stripped of its tiles.

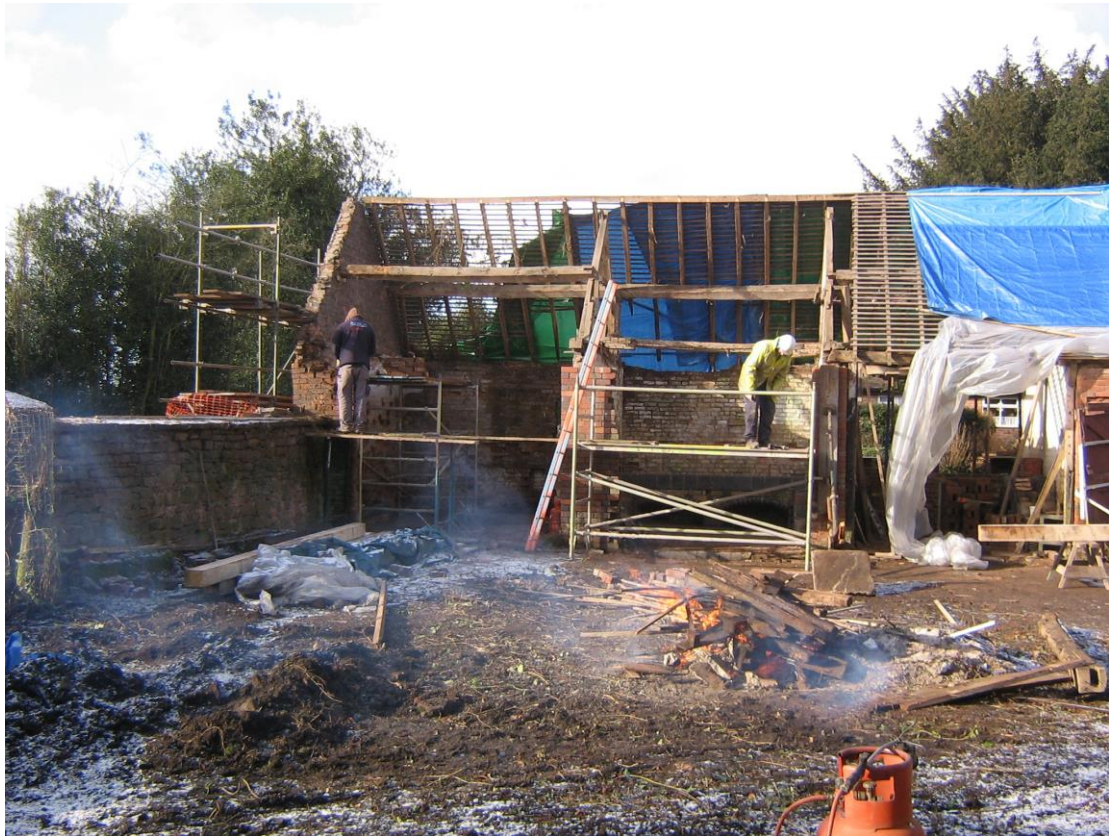
The sheds being re-roofed and the end gable rebuilt.

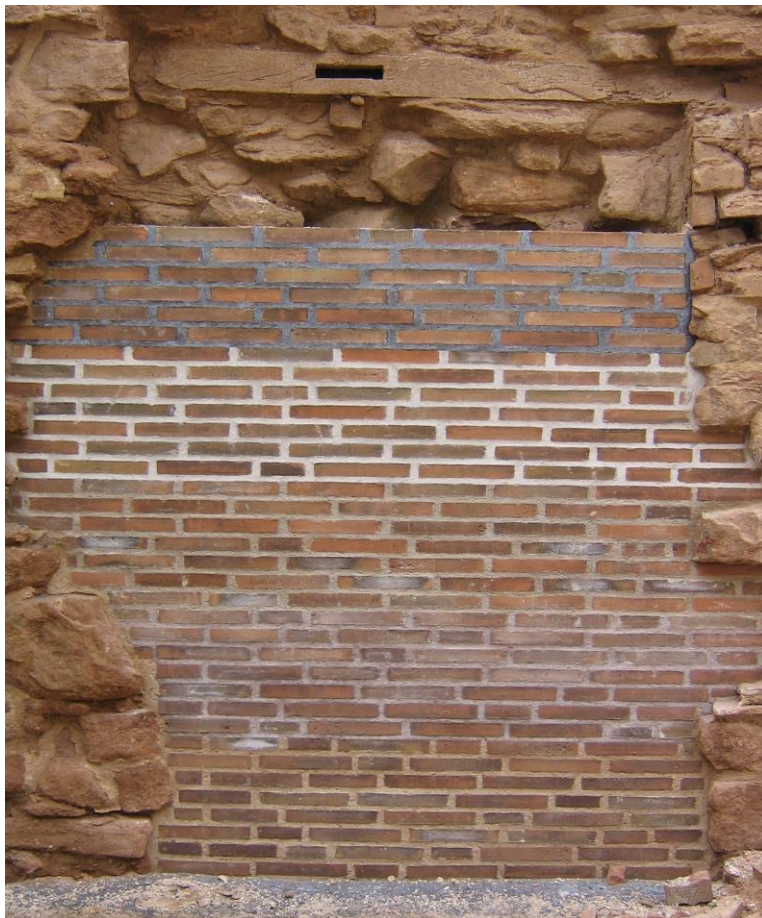
A trial panel to test different mortar colours with the new brickwork

Although a decision on the Danish brick by Petersen had been taken a while back, we still had to decide on what mortar to be used. WWM had devised a 'quarter lap' bond for the new brick walls to the castle, and they wanted the perpends (the vertical joints between adjacent bricks) to be wider than is conventional. A trial panel was done with some widely differing mortar colours and a selection made. All the large glazed screens in these brick walls were to have precast concrete lintels, and so a colour also had to be chosen for the concrete. Inspired by the greyer stone used for many of the historic windows in the castle, a special blend of white and grey cements was chosen with a mild acid-etched finish to the surface to improve the texture.

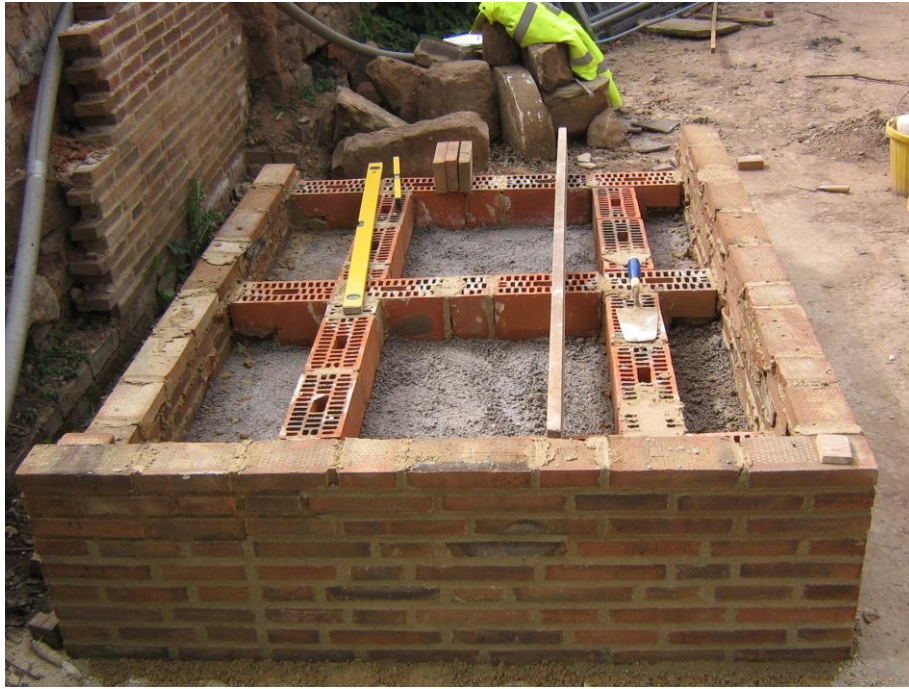
A sample section of the proposed diaphragm wall showing the use of clay blocks

The intention was that new brick walls, to be rebuilt on the line of historic walls, should be nearly the original thickness – i.e. up to 2 metres thick in some places, and so a diaphragm construction was devised using extruded clay blocks and LECA (Lightweight Expanded Clay Aggregate) infill to provide insulation. Again a sample section of such a wall was

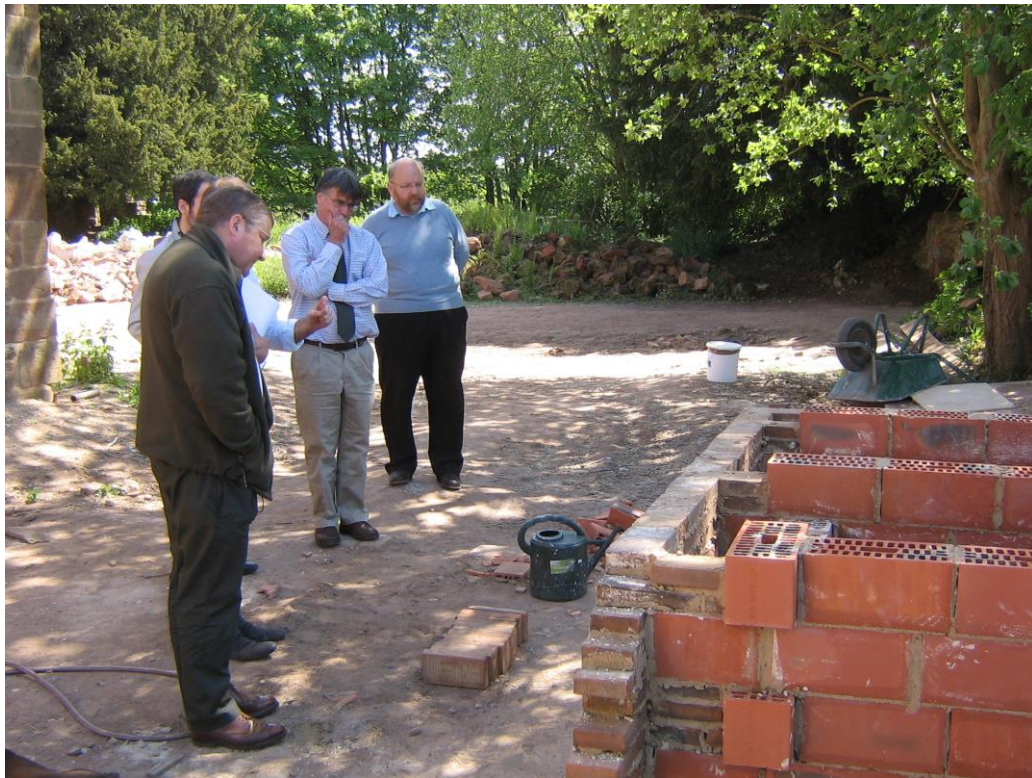
The conservation officer and English Heritage staff inspecting the sample wall

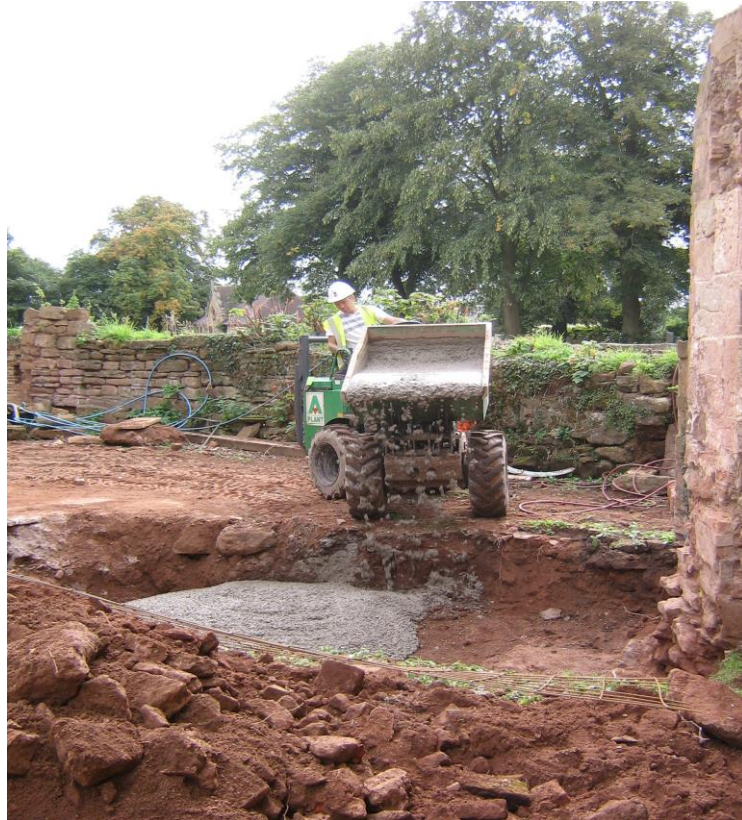
Concrete footings going in for the new diaphragm walls

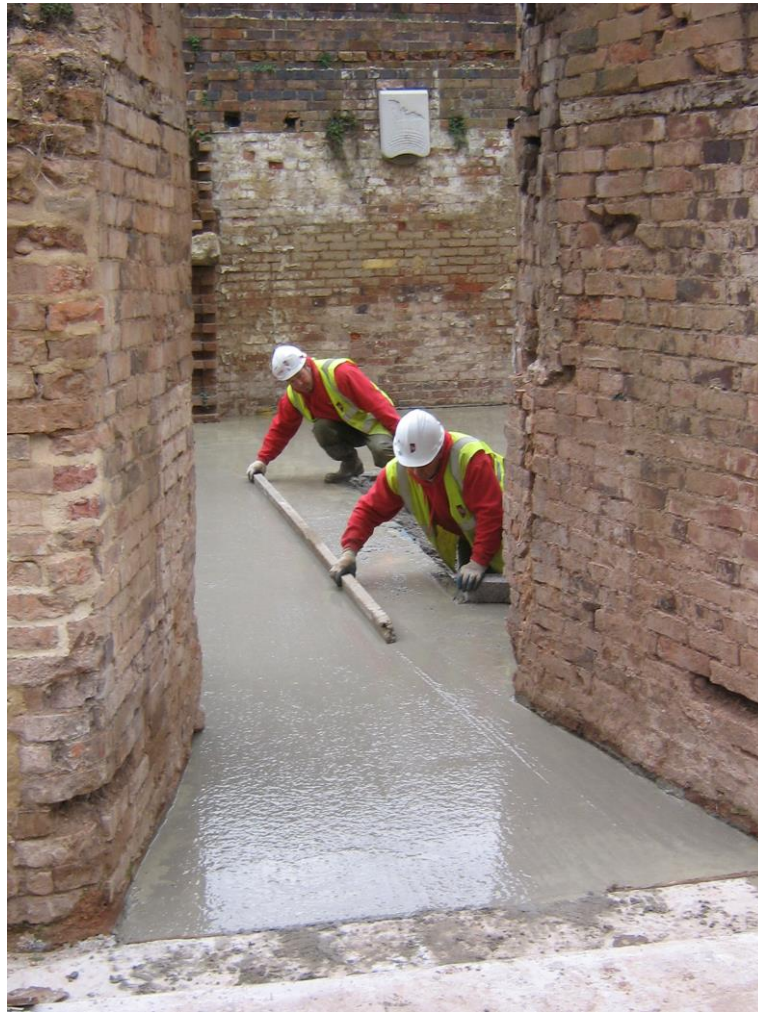
A new floor slab being laid. A 'bat box' is on the rear wall

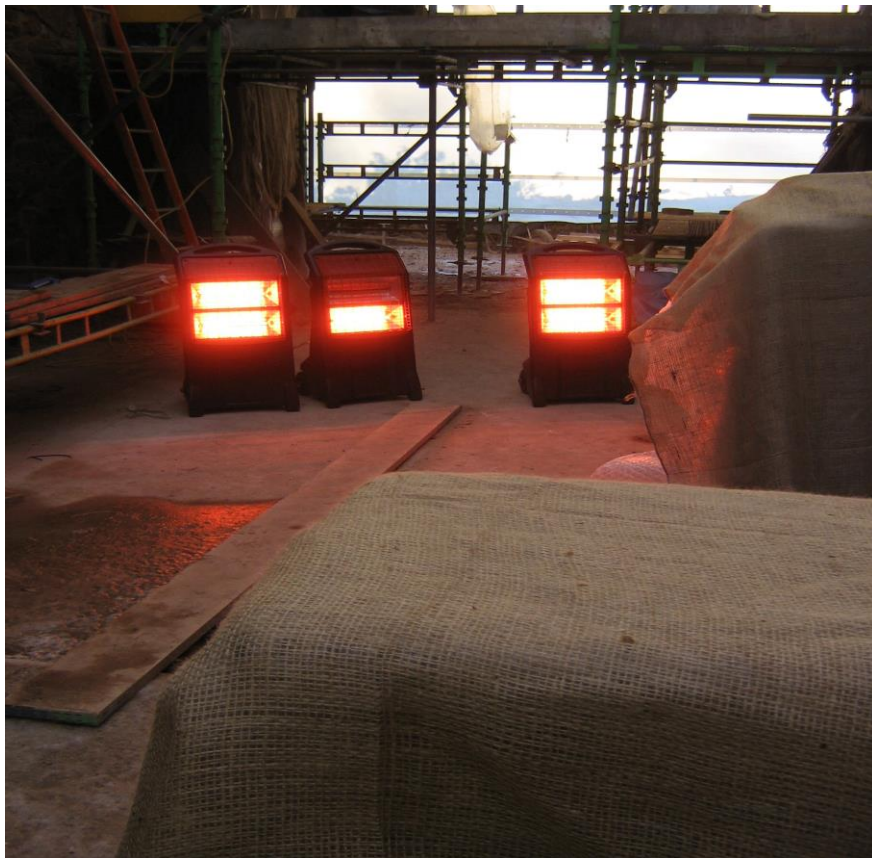
Heaters were needed to keep frosts at bay and thaw out pallets of bricks

In December the cold weather returned once again, the winter of 2010/11 being a particularly bitter one. The new brickwork is laid in lime mortar which should not be used below 5°C, and so temperatures had to be very carefully monitored. Numerous heaters were required to keep even a modicum of heat within the building. Even the packs of damp bricks had to be thawed out. Inevitably progress slowed.

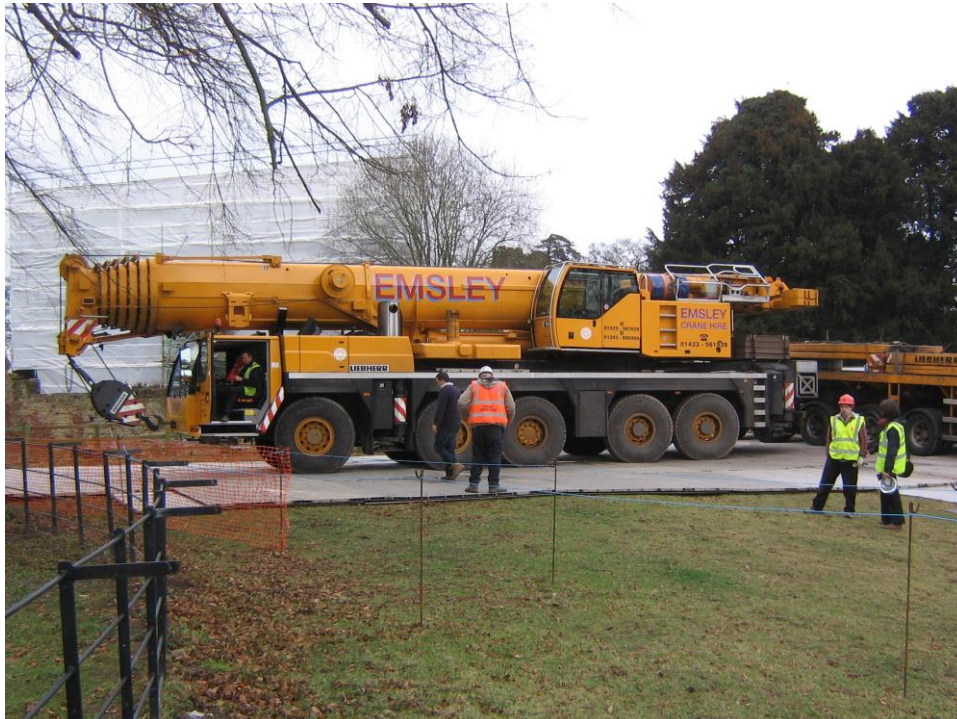
The crane for lifting the pre-cast lintels into place

sufficient size to lift them into position could pass under the moat archway. Instead, these lintels had to be lifted from the *outer* bank of the moat – greatly increasing the leverage and thus the size of crane needed. To help reduce their weight, the lintels were designed as ‘top hat’ lintels - i.e. the top section was left hollow to be filled-in with concrete onsite once they were in position. So much of the lintels you see today are in fact hidden by the brickwork sitting on the rim of the ‘top hat’.

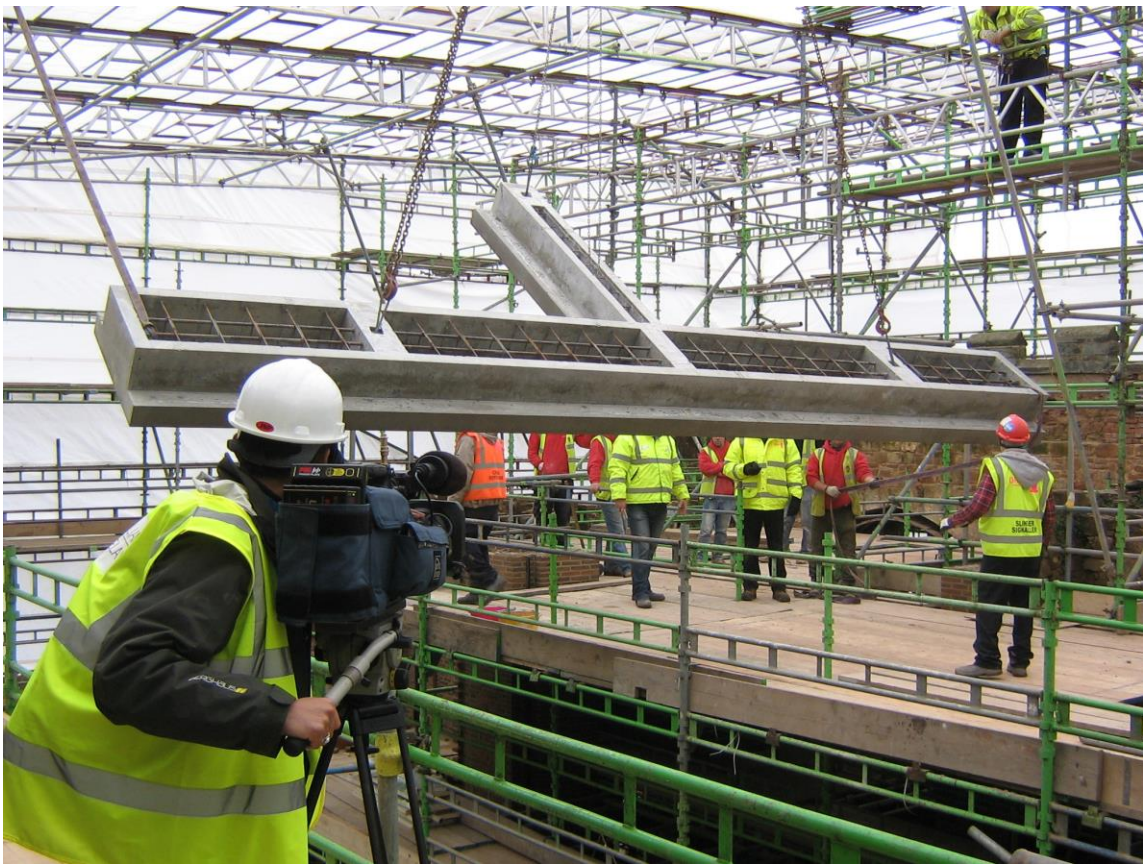
The heaviest T-shaped lintel being lowered through the roof

In February, the first of the new concrete lintels arrived on site manufactured by Cambridge Architectural Precast. It was an exciting day to see these members in reality, after poring over them for so long on WWM's model. To span the width of the new glazed openings, the lintels were long and thus very heavy. The main issue was that no crane of

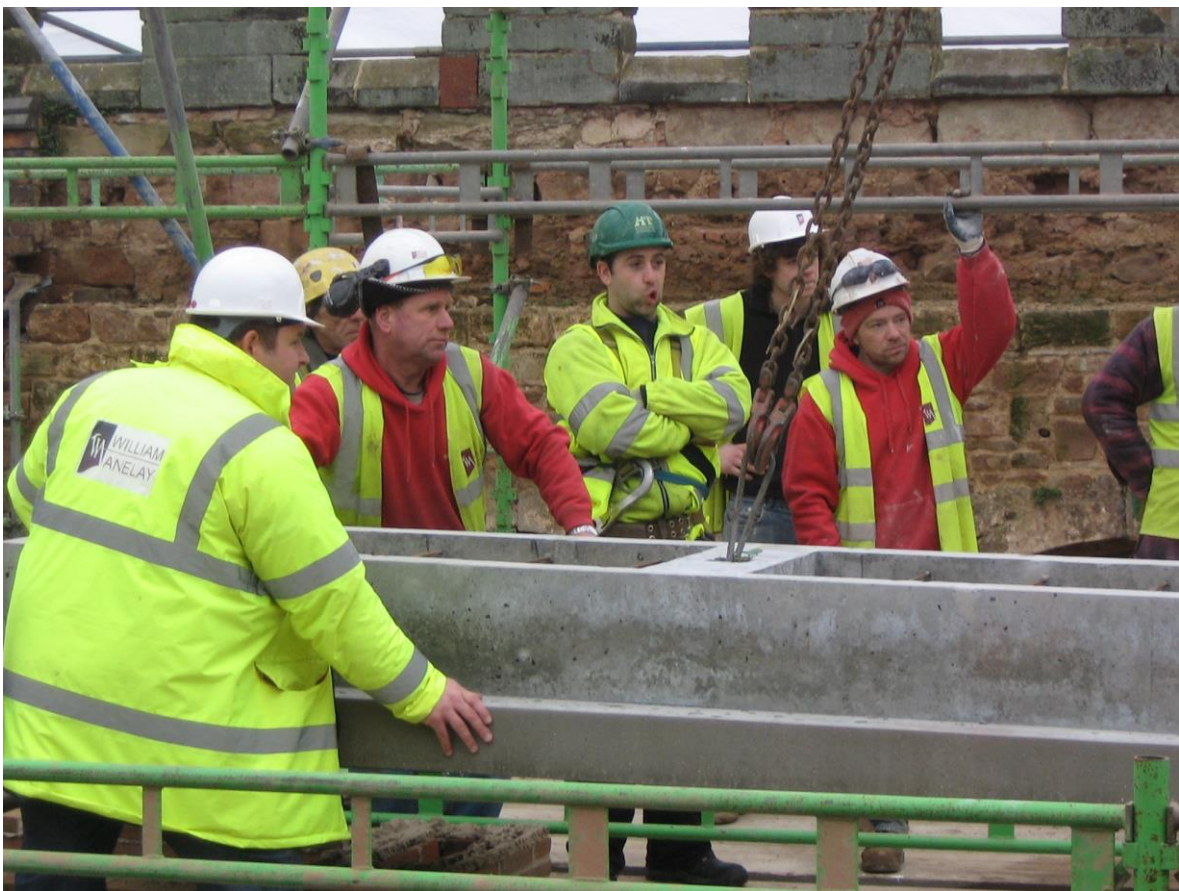
The lintel was lowered into position with millimetre precision

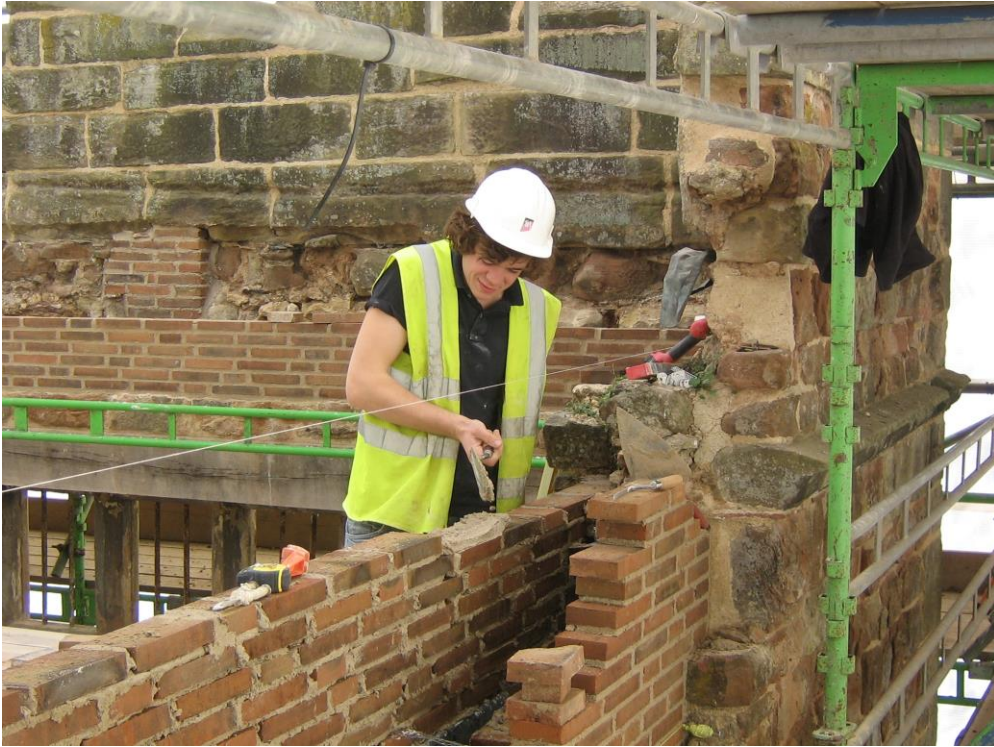
Nathan Grassby lays new brickwork at the south end of the garden court

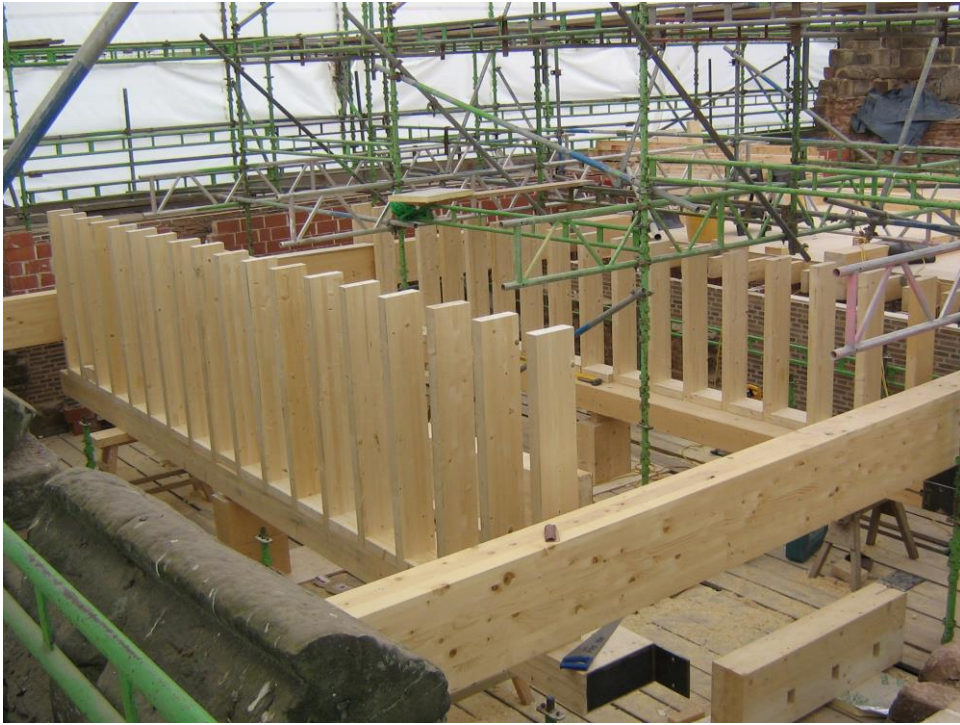
The principal glulam beams and joists to the courts start to take shape

With the castle brickwork now largely complete, in May 2011 the first of the glulam beams (laminated beams constructed by gluing smaller sections of timber together to form a larger section) arrived. These had to be carefully raised up to ceiling height and then Anelays' joiners had to painstakingly cut out sections for the large metal 'saddle' brackets that tie the principal beams together, as well as cutting out all the numerous mortices to take the smaller joists beams. As everything remains on display, all these joists had to be very accurately cut. Visitors may also notice that the roof is 'upside-down' in the sense that the joists are tenoned into the *bottom* edge of the principal beams rather than the top

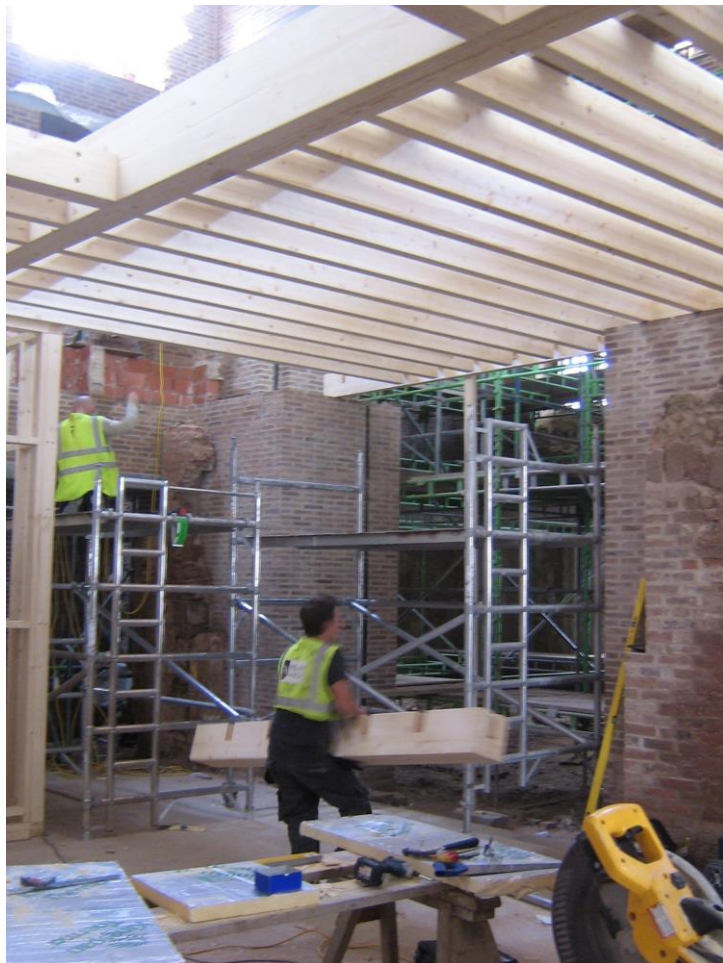
The ground floor ceiling going up

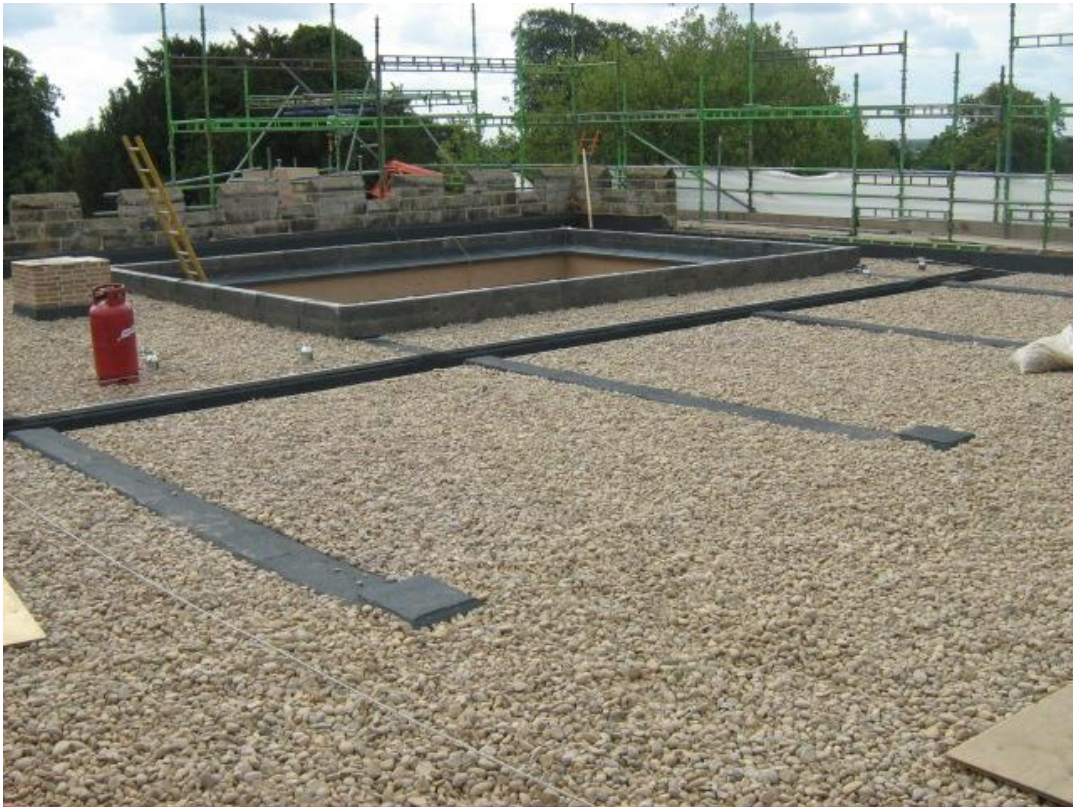
Gravel ballast to the upper roof laid over an insulated membrane system

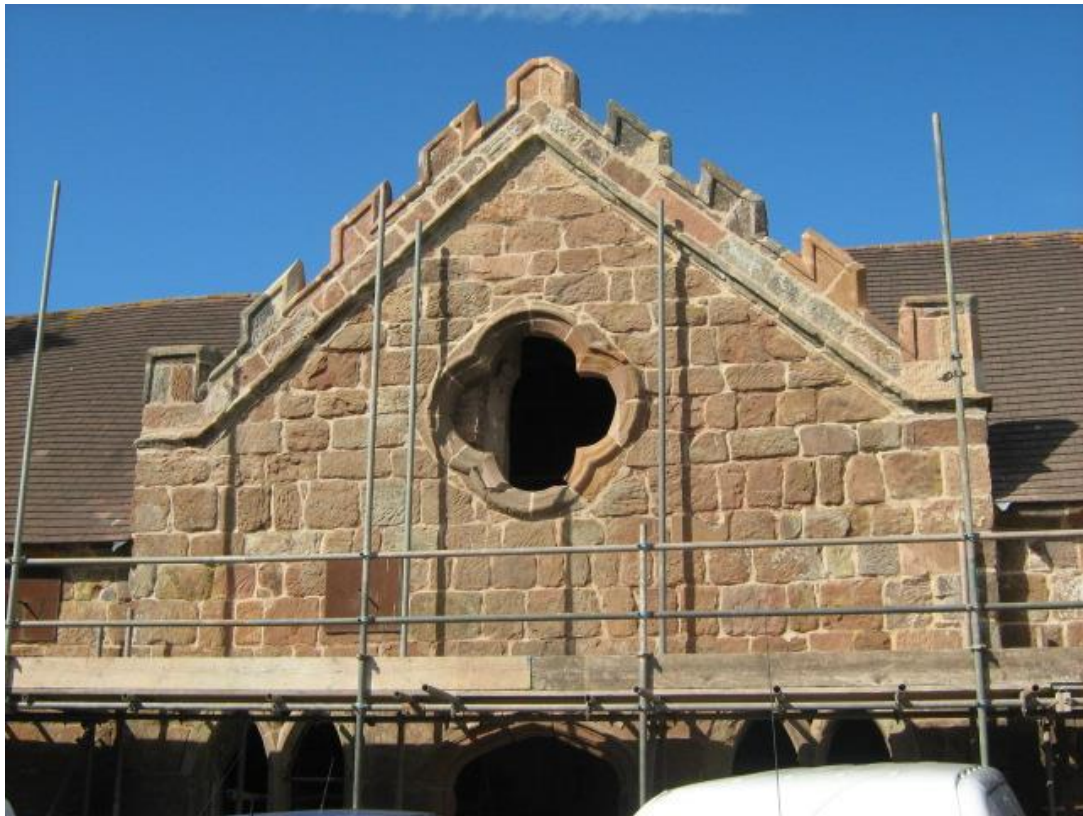
Len Hardy's rebuilding of the front of the Coach House nearing completion

Len continued his painstaking work on the Coach House. As the metal plates on the exterior still show, the Coach House is suffering from significant structural problems, because the tie beam of one of the principle trusses had been removed causing the walls to spread. Fire damage had also played its part. There was also a degree of cracking in the cross walls, which had to be remedied, which may have been in part caused by coal-mining subsidence, a problem throughout the area (the church was so badly affected that it had to be completely underpinned in the 1960s). The Gothick pediment to the Coach House also turned out to be in very poor condition and much of it had to be taken down and rebuilt. Where they were missing, Len carved replacement coping stones.

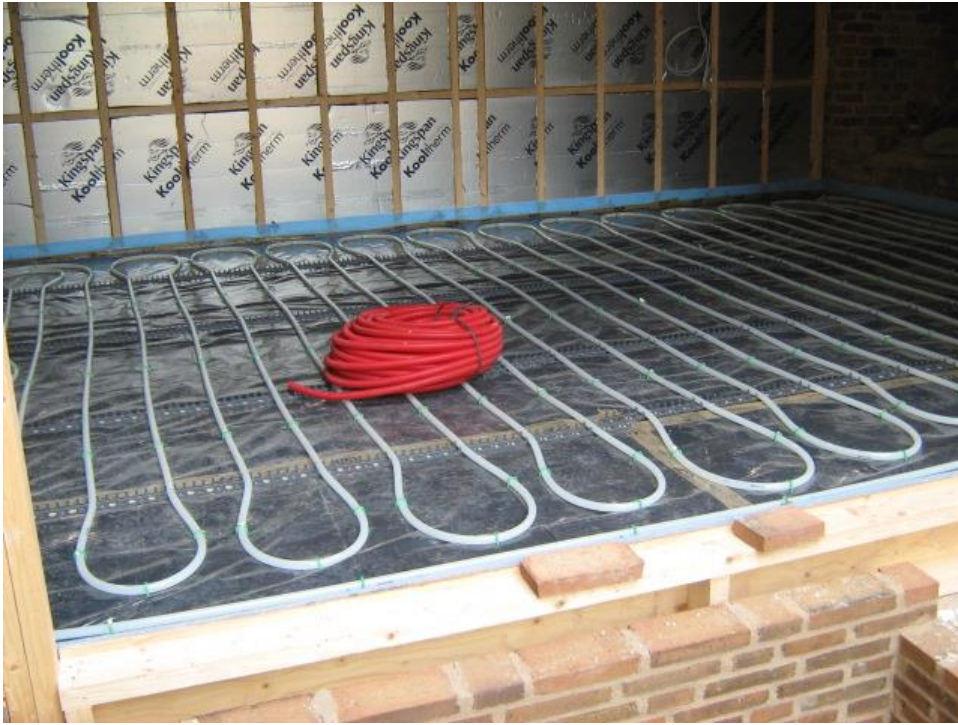
Underfloor heating pipes going in

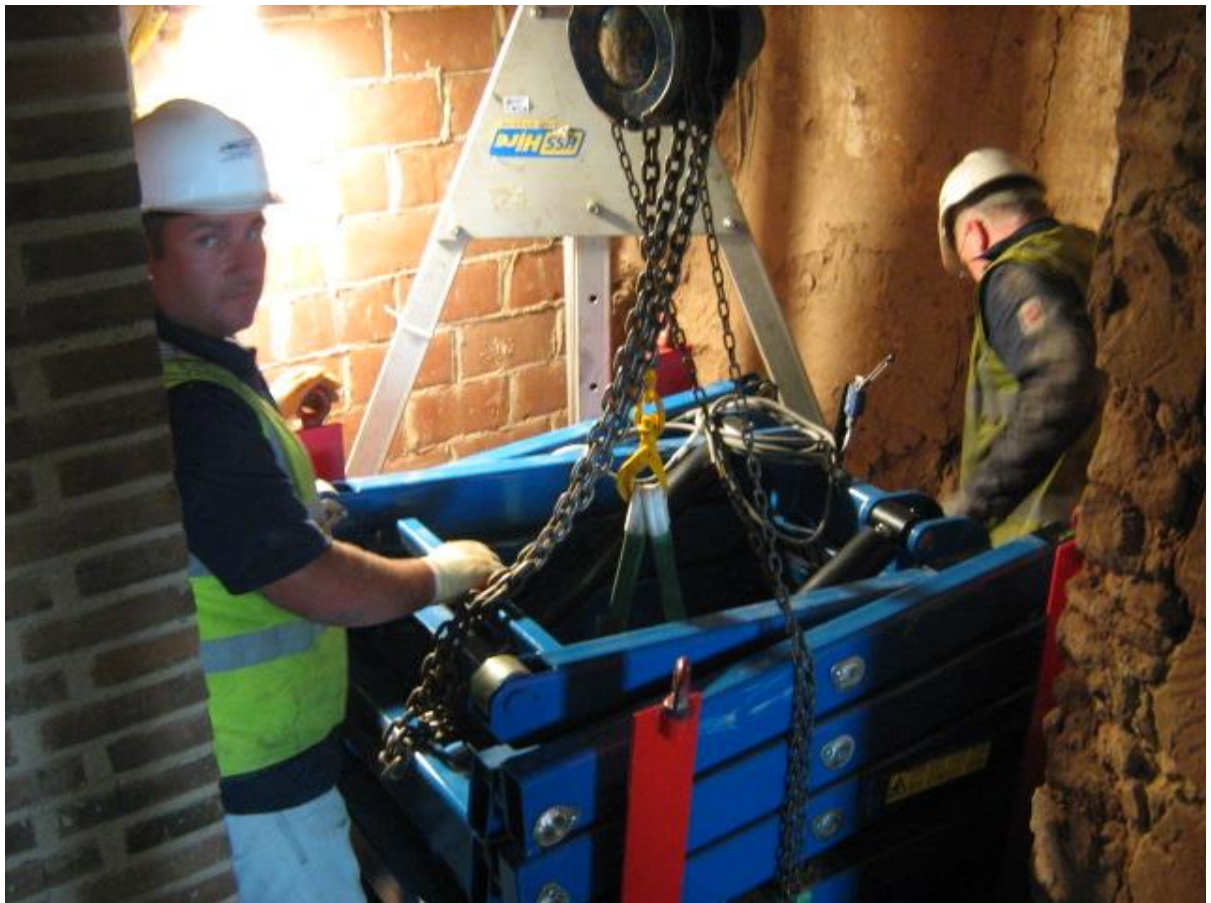
The scissor mechanism for the lift being lowered into its pit

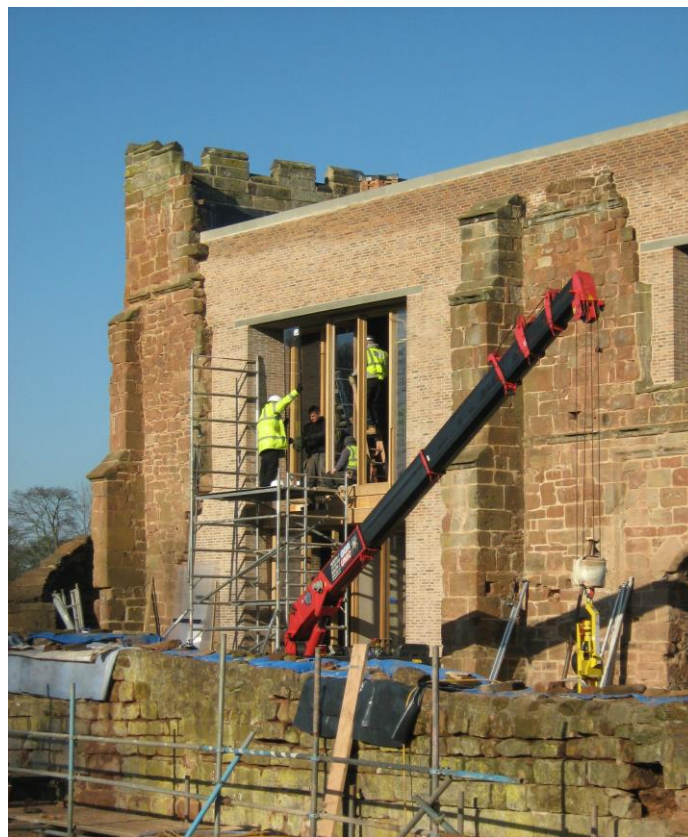
Fitting the double-glazed units using a crane with suckers

In March, the correct glazing finally arrived and could be fitted, replacing temporary sheets of polycarbonate. The cellar doors were fitted and the oak boarding done to the curtain wall bedrooms. The remaining area of the coach house yard was cleared of the multiple pallets of salvaged bricks and stone (now in the sheds) and dug out to receive its stone fill.

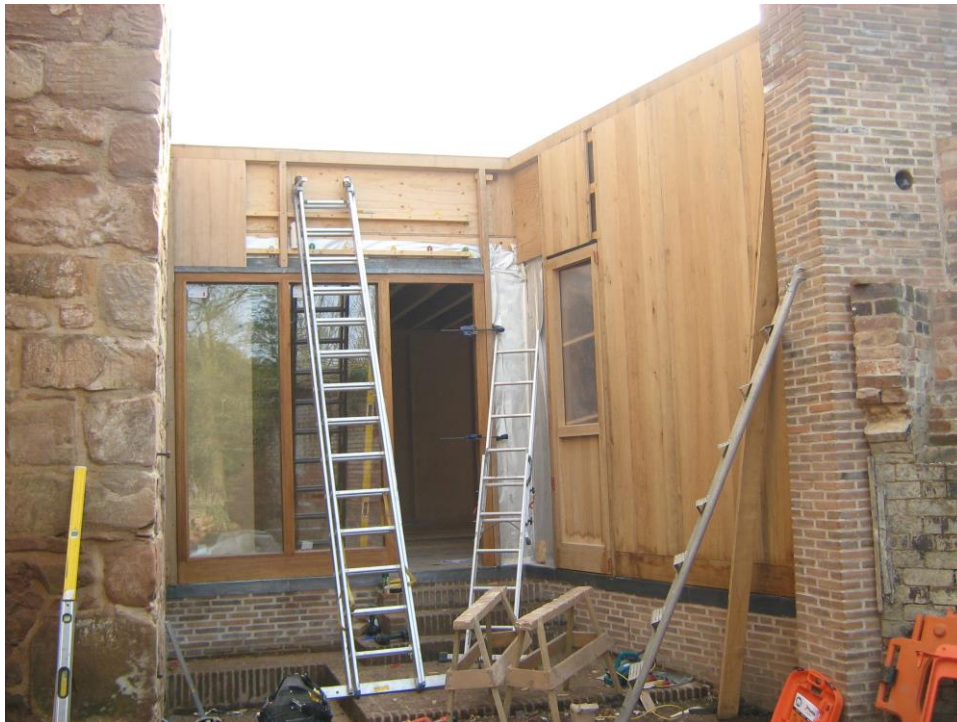
Fixing the last of the oak cladding to the bedroom and bathroom walls

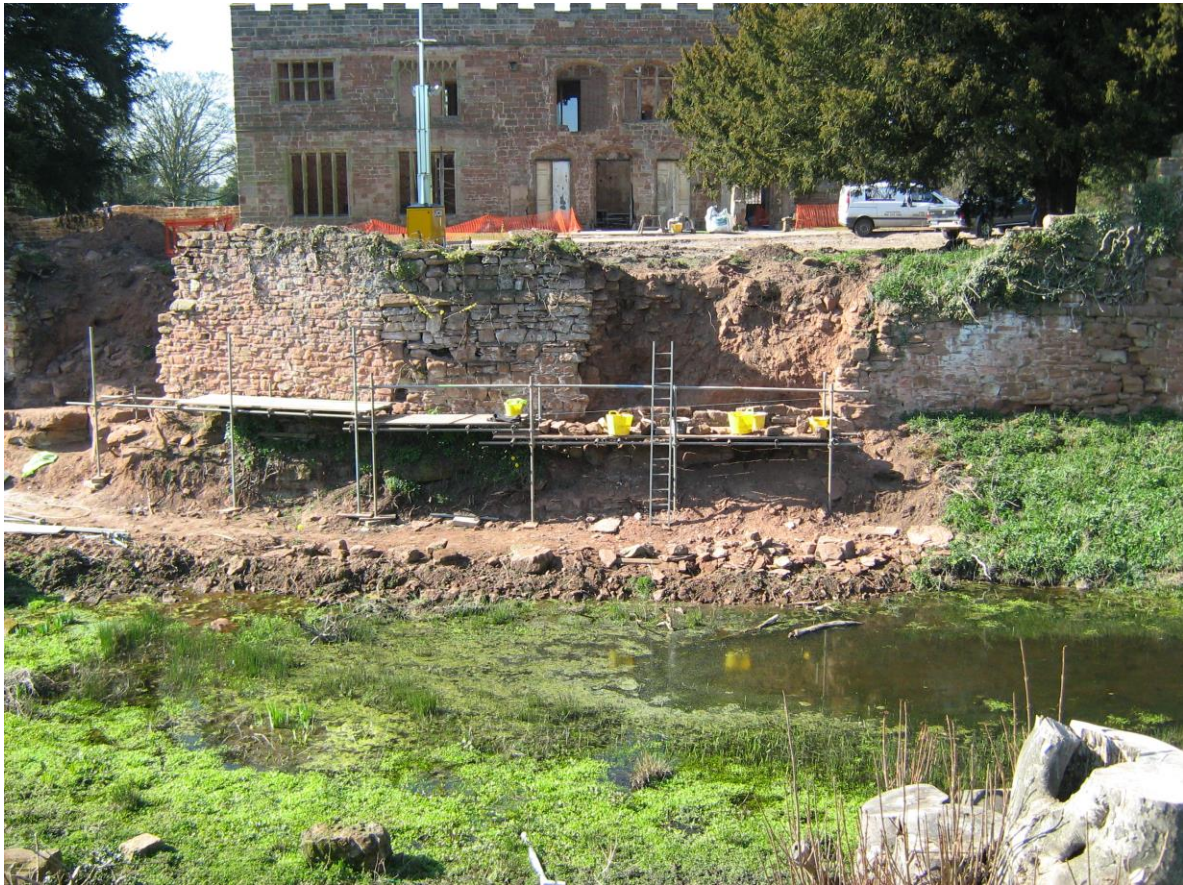
Two areas of the curtain wall on the east side had completely collapsed

Many areas of the curtain wall were in a very poor condition, and two areas in the south-east zone had completely collapsed down into the moat. The team from Midland Conservation have carefully rebuilt these areas matching as best they can with the salvaged stone available, the style of the adjacent stonework. Searching through the nettles on the outer bank to find that right-sized piece of stone, and then have to manhandle it up and into position, was rarely easy. The tops of the walls have been finished off with a 'soft' capping using a specially chosen turf that is relatively drought resistant and should look attractive.

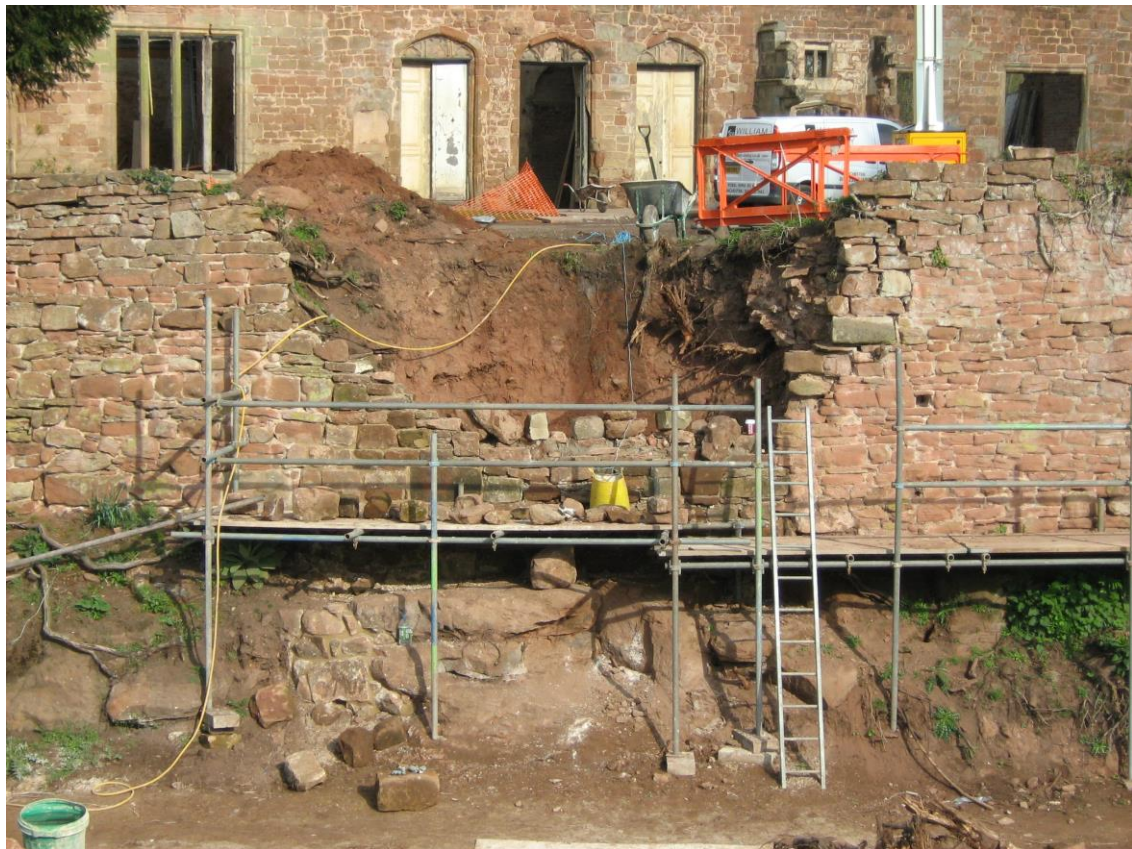
Stone salvaged from the collapse is used to rebuild the missing sections

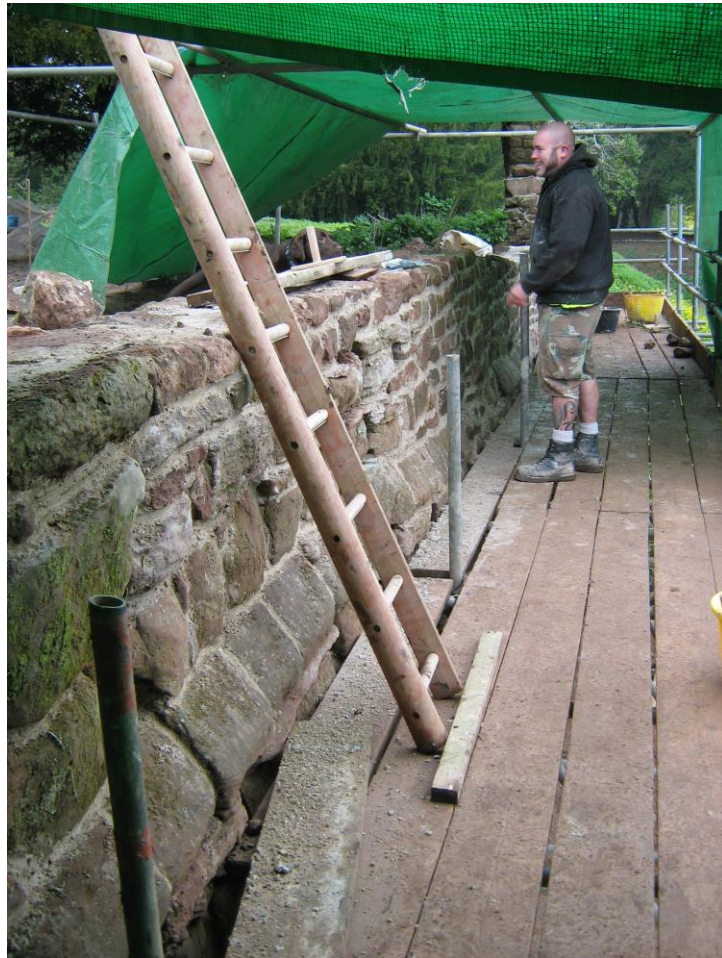
The rebuilt curtain wall close to its finished height

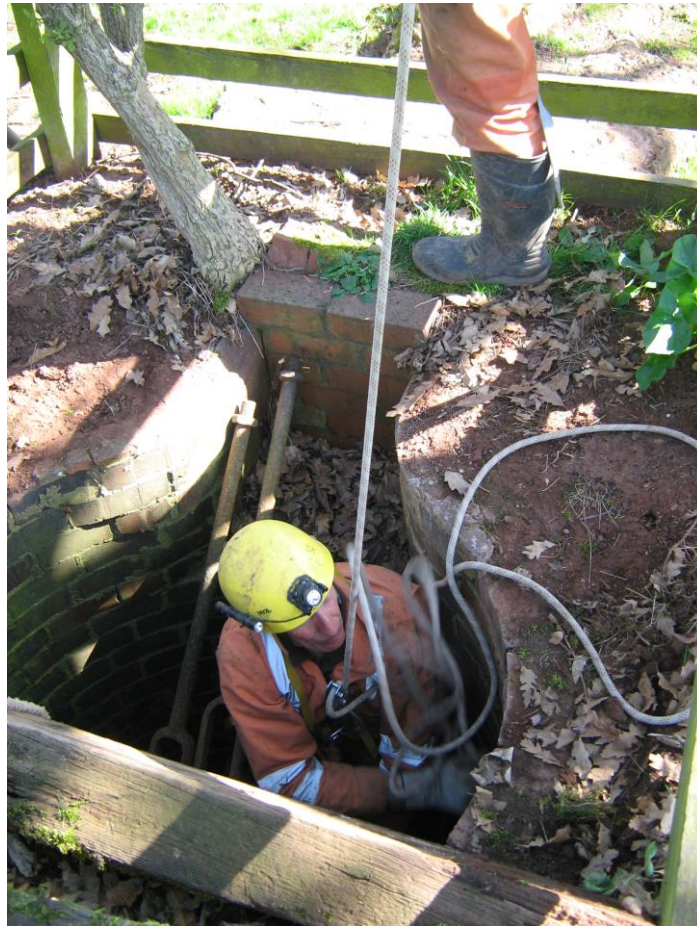
**Mark Noble of Geotechnical prepares to go down the well
15 metres down there was a blockage but water was discovered below this.
The old pump mechanism is visible**

The other problem is, assuming that ground water alone is insufficient, where a water supply to fill up the moat might come from. We have put considerable effort, listening too to local anecdote, to try to trace the ancient water systems on the estate – there are various brick built culverts and shafts apparent in the landscape around the moated site. Understandably, the Arbury Estate is not keen for us to take water out of Astley Pool, as the fishing syndicate that lease it already have concerns about water levels there. There is a deep brick shaft near the outer bank of the moat that has now been investigated, and does contain at least some water. Whether there is sufficient to put in the moat is not yet known. It would need a relatively powerful pump and an electricity supply to this point to make it possible.
