ASTLEY CASTLE History Album

Volume II: Conservation & Conversion

Written by Alastair Dick-Cleland & Caroline Stanford
June 2012

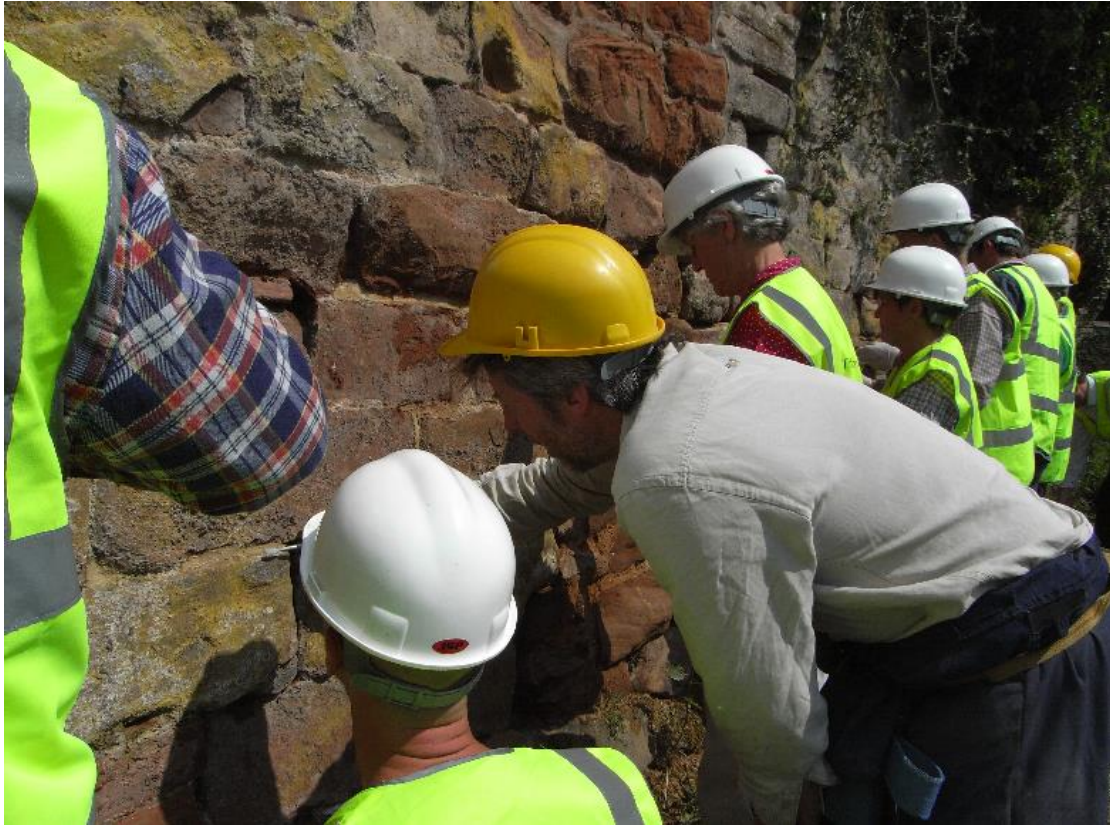
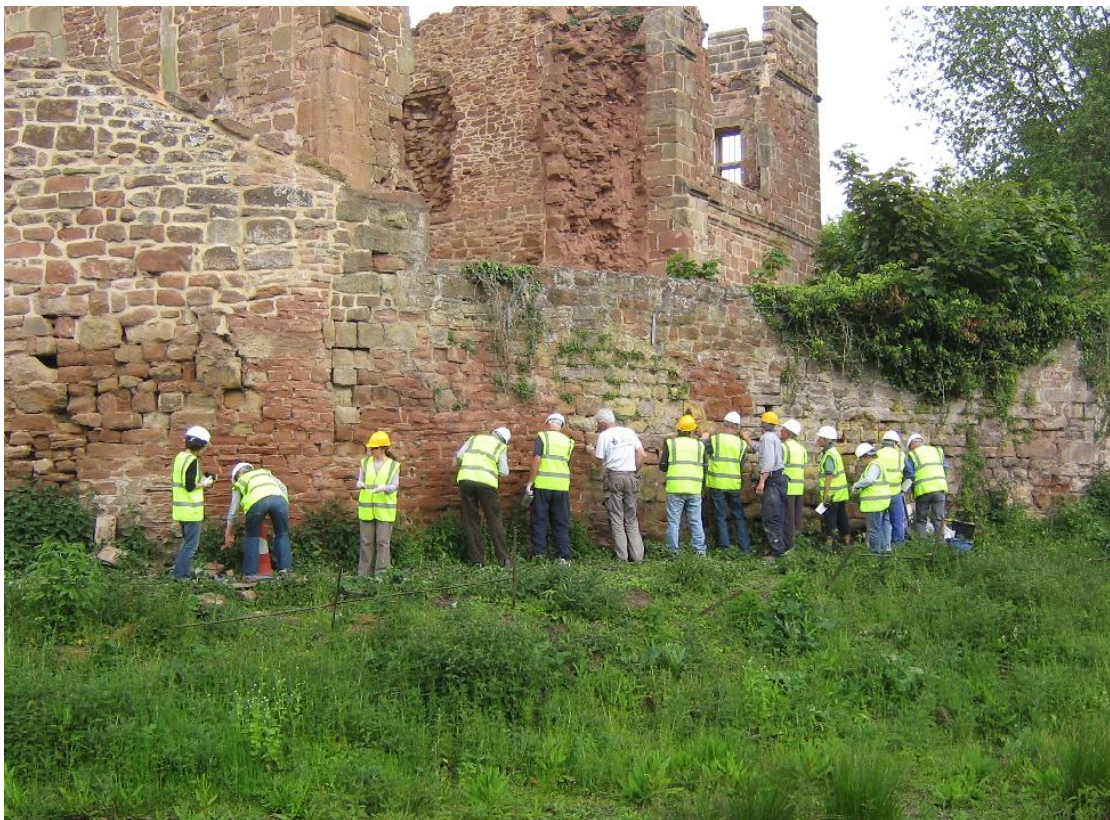
John Brown runs a day on lime repointing for volunteers and Landmark Friends, making a real contribution to the repointing of the curtain wall.
