CALVERLEY OLD HALL

History Album

Volume II:

Repair & Conversion

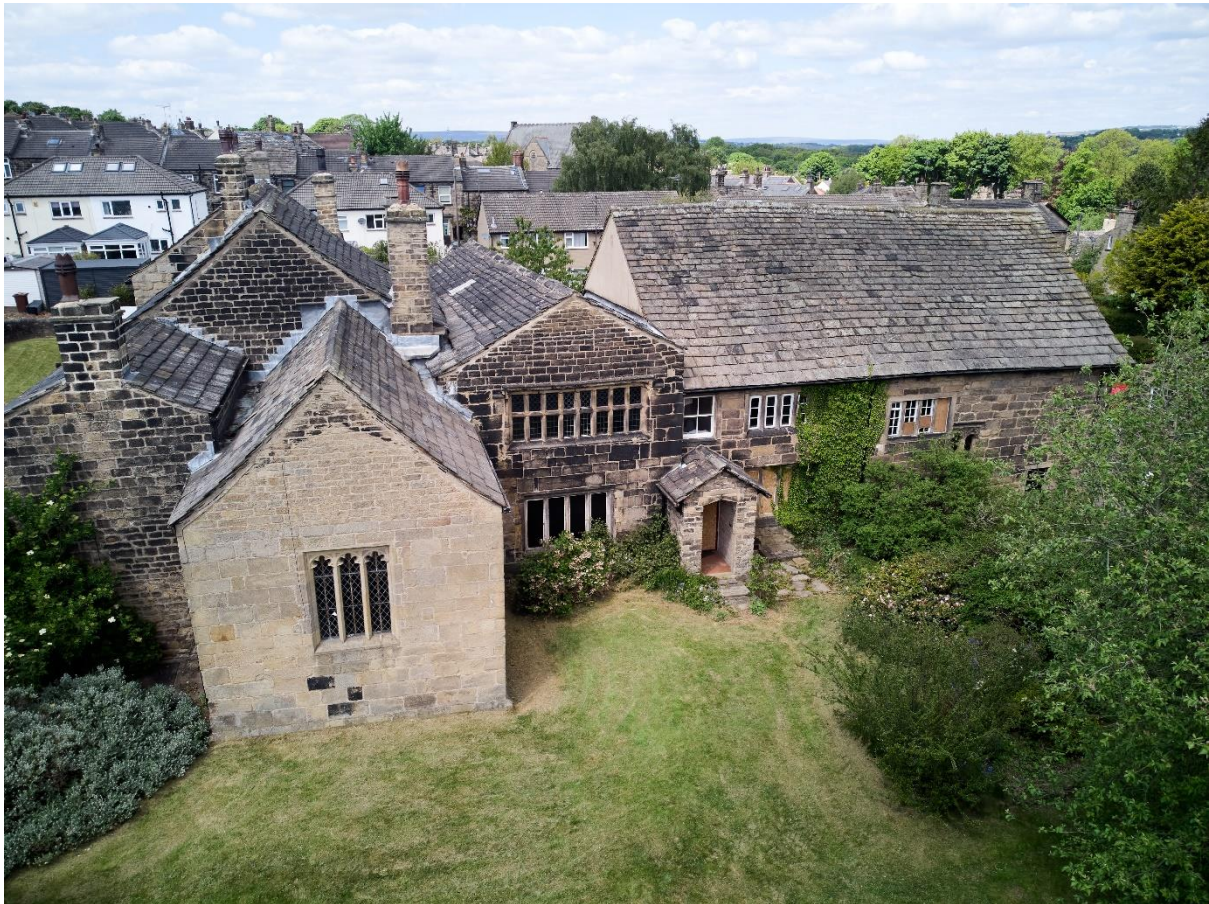
The exterior of Calverley Old Hall in 2020. Much work has been done since to conserve and repair the entire shell, but the intention was that its external appearance should change as little as possible. The little front porch, a late addition, has since been removed.

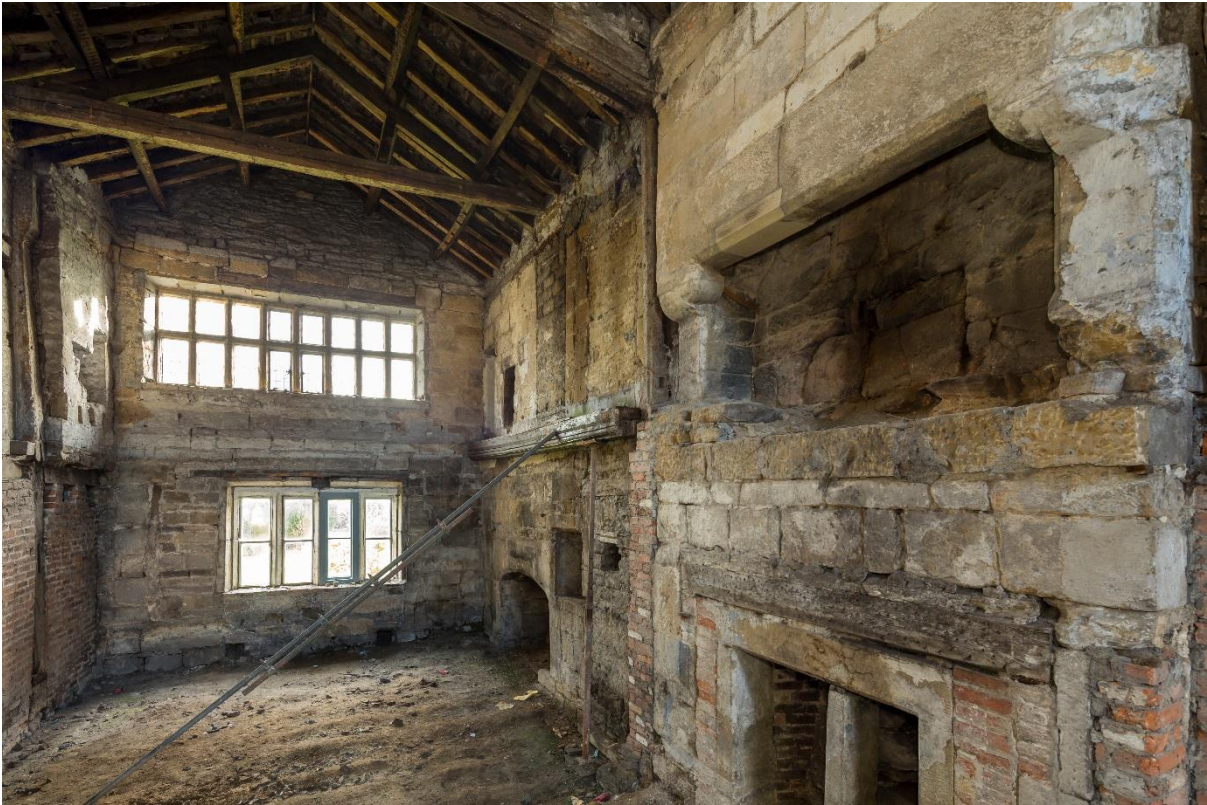
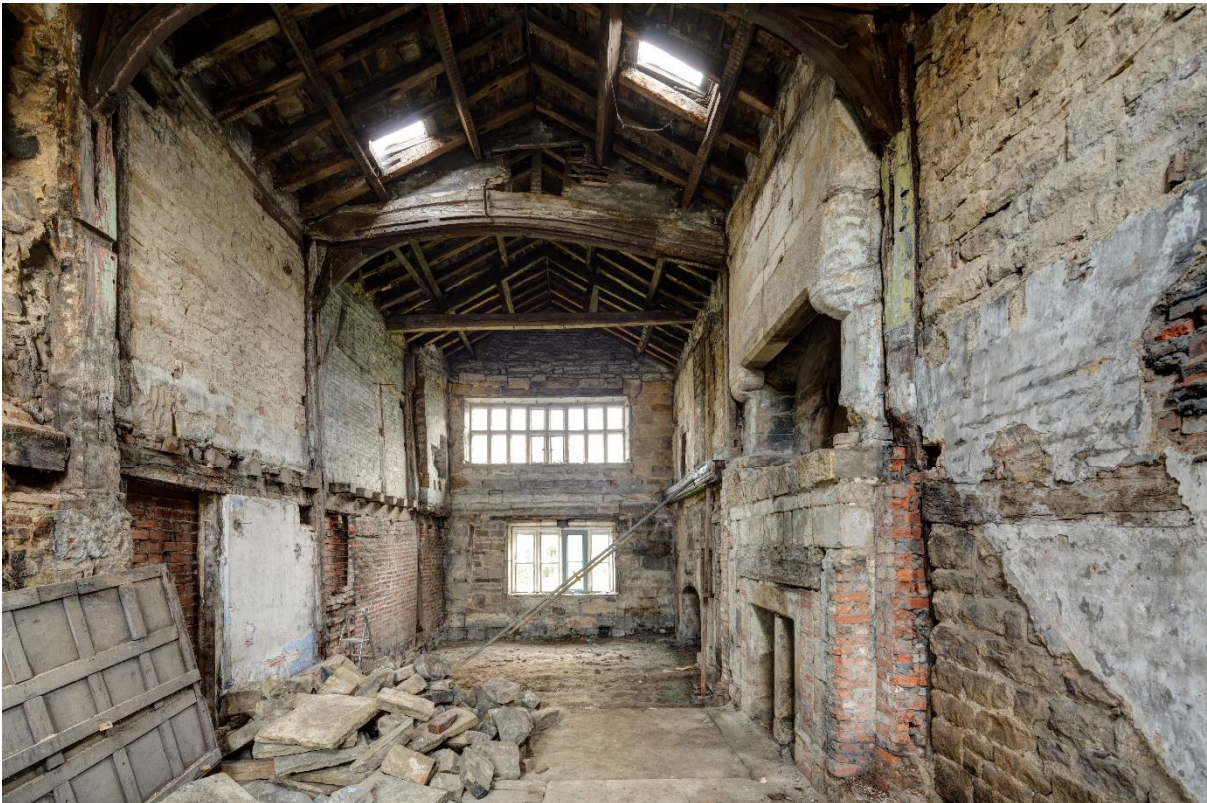
The Solar Block in 2020.

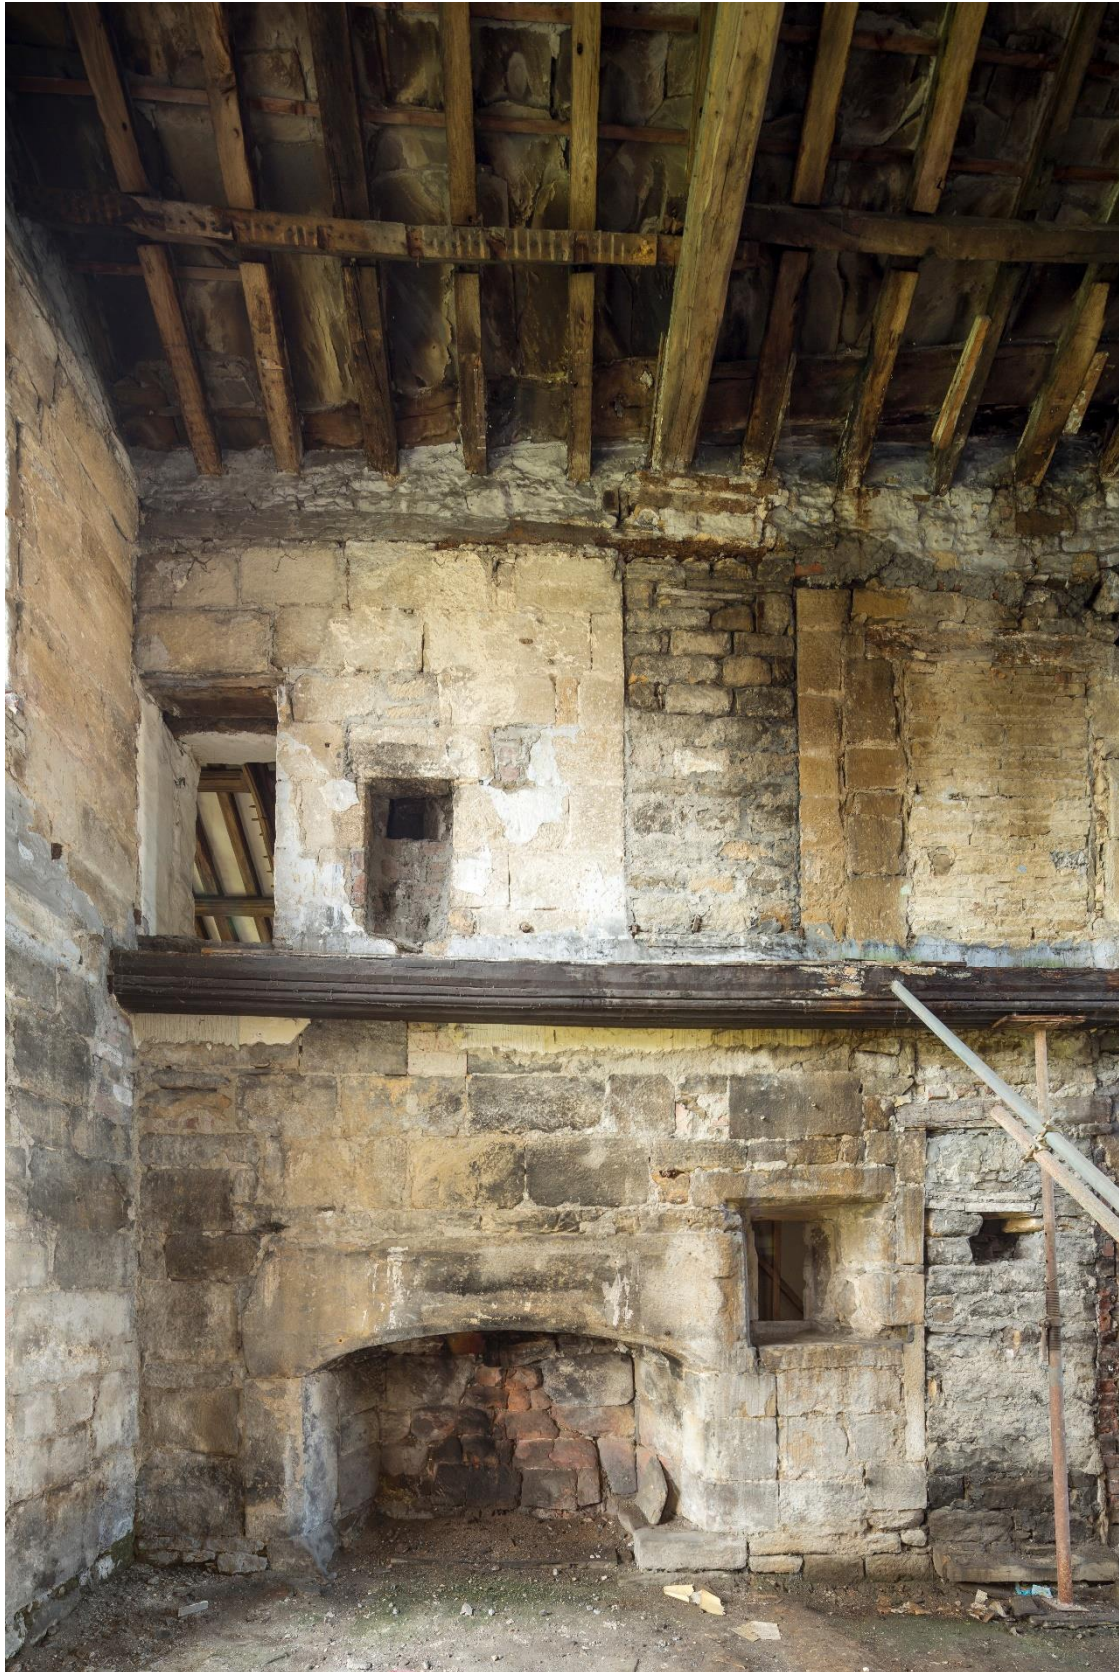
The much-altered southwest end of the Solar Block in 2020, extended in the 16th century and with a glimpse of the Chapel gallery roof through the doorway

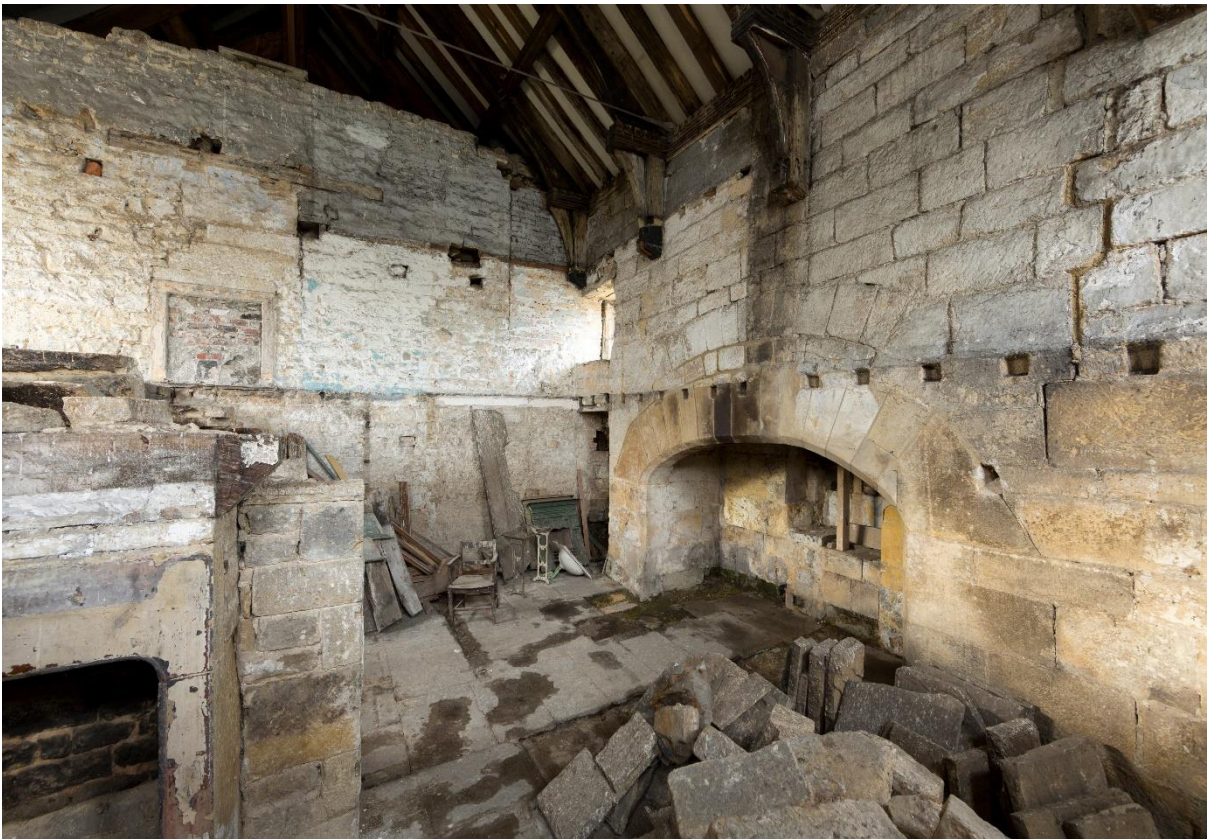
The Great Hall in 2020. The remains of cottage chimney breasts have yet to be cleared. While they remained in situ, it was impossible to find a viable alternative use for the Great Hall. Heaps of carefully salvaged stone and other materials lie on the original flagstone floor.

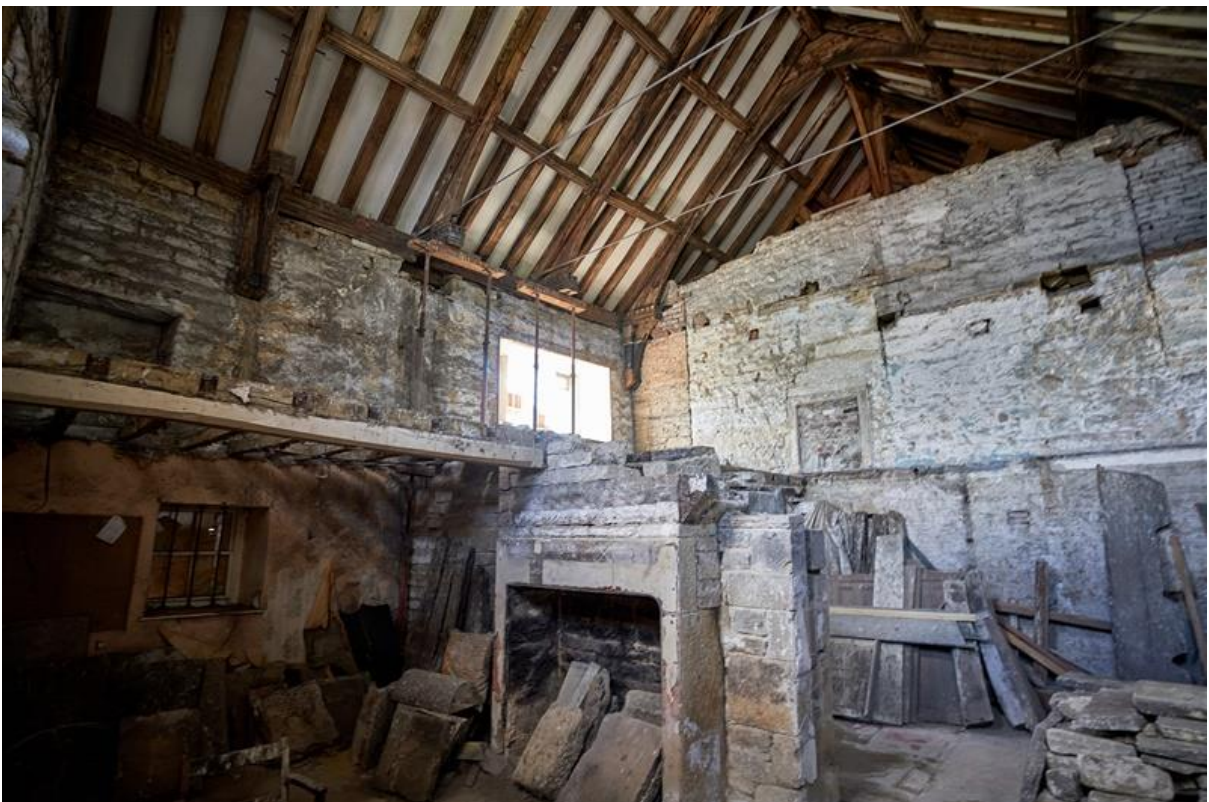
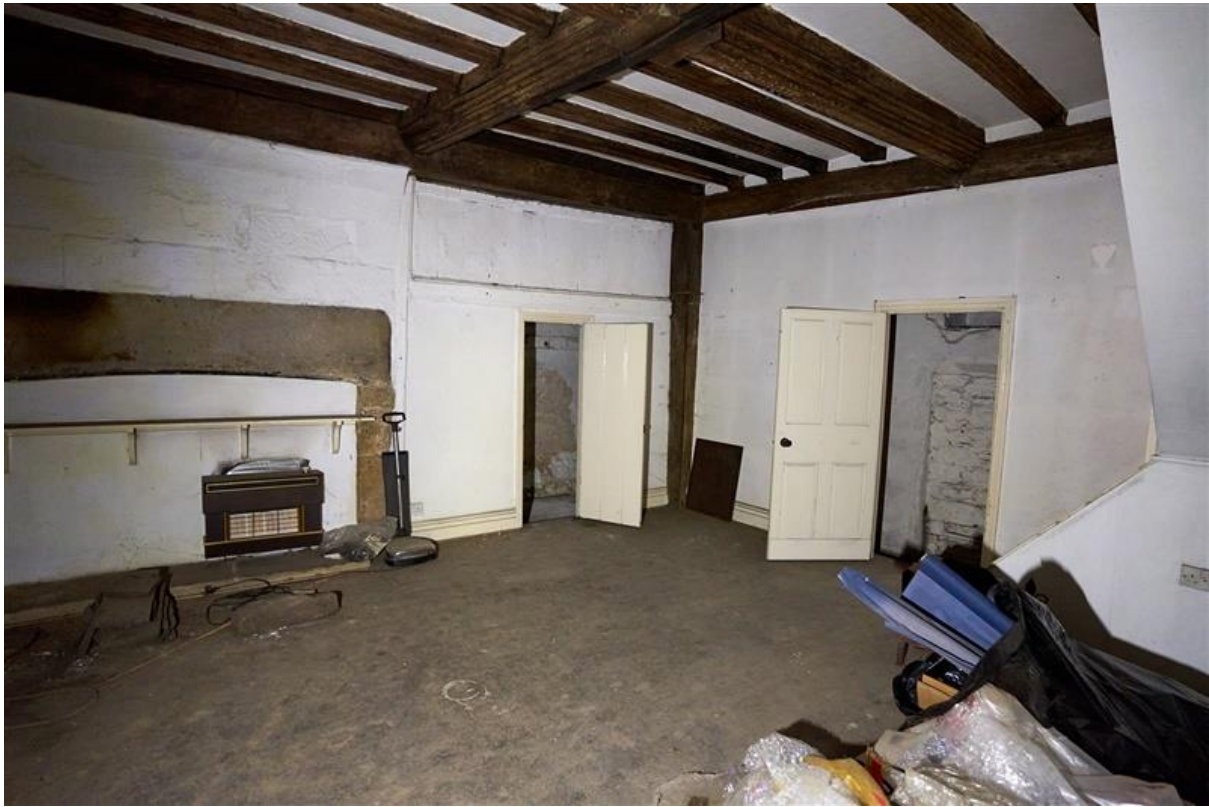
Top: the ground floor of the Parlour Block in 2020. The slope of an inserted cottage staircase is in the foreground. The blocked doorway to the Solar Block was a cupboard.

Below: the medieval spere truss protruding through a cottage bedroom.

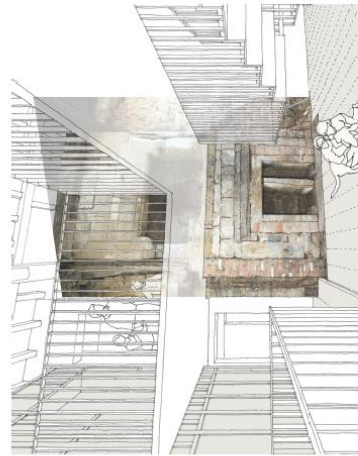
Sketch view of the new stair hall rising through the Solar.

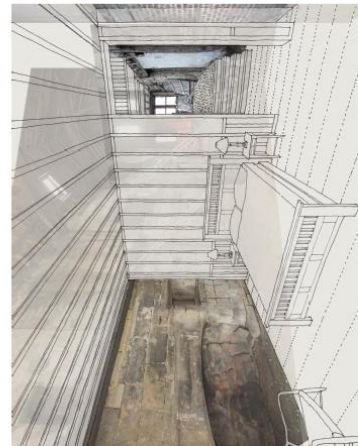
Sketch view of ground floor accessible bedroom 'pod' within the Solar.

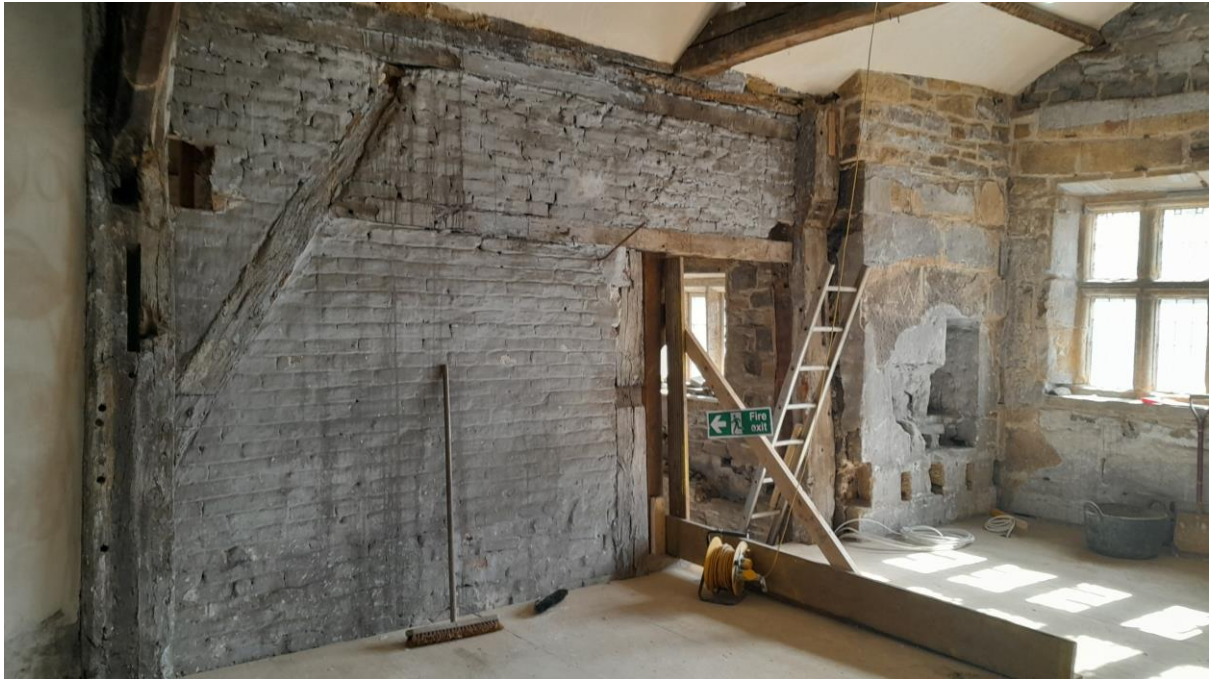
Residual framing from the 1320s hall block, and the original doorway into the first-floor hall, now in use once more, after raising the lintel to take account of modern statures.

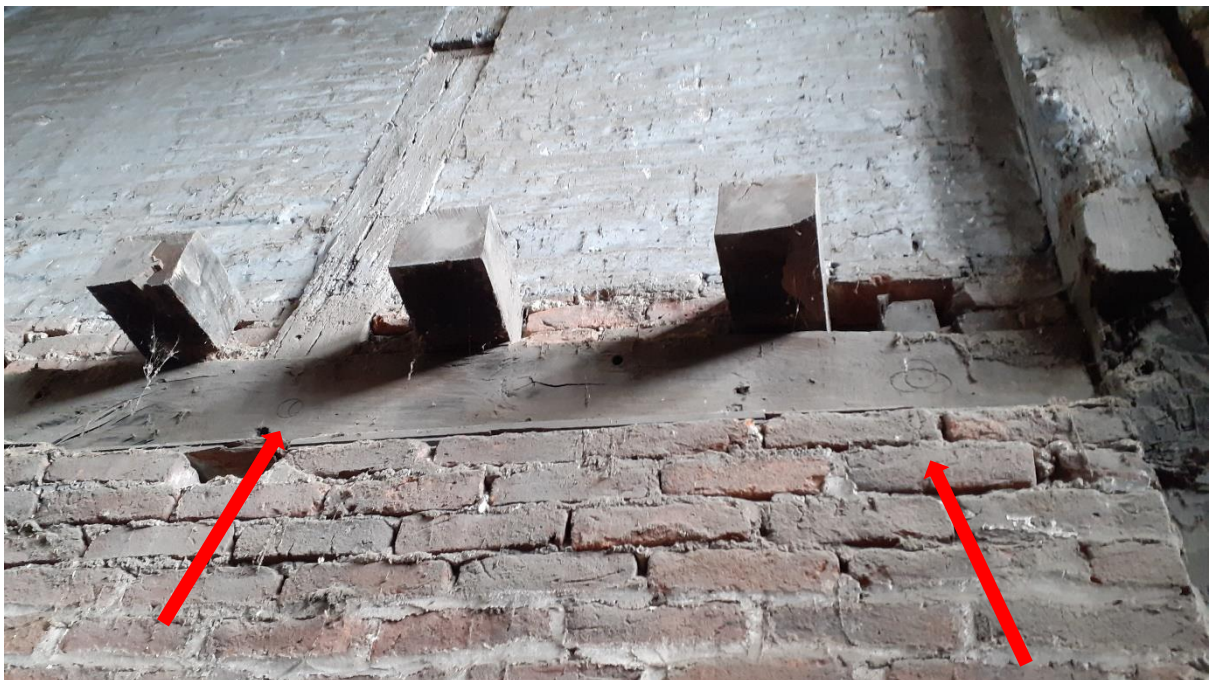
Examples carpenter's scribed setting out marks for the 1320's hall block (now called the Solar Block).

The southwest wall section has very little framing suggesting it was not built as an external wall - so therefore must have had an abutting range originally. On the Lodging Block framing on the other side, a doorway on the first floor is clearly visible in the framing (although this is now hidden in a housekeeper's cupboard). This doorway, it was realised, led into a 14th-century solar range. In addition, what had been thought to be deliberately shortened posts at first-floor level turned out instead to be a timber-framed first-floor storey resting on ground floor masonry walls. The theory therefore emerged that the Solar Block had not been built as such, but rather as a hall house in its own right whose timber-framed upper storey rested on stone walls below, and which had a solar housed in a wing at right angles at the northwest end, extending across, and eventually subsumed into, the later Lodging Block. It then became clear that the primary timber for a first-floor hall was all present and clearly marked with carpenter's marks, all in order. The huge stone fireplace is biased to the high end, with the solar range leading off it. Peg holes suggest that the ground floor would have been partitioned as service rooms.

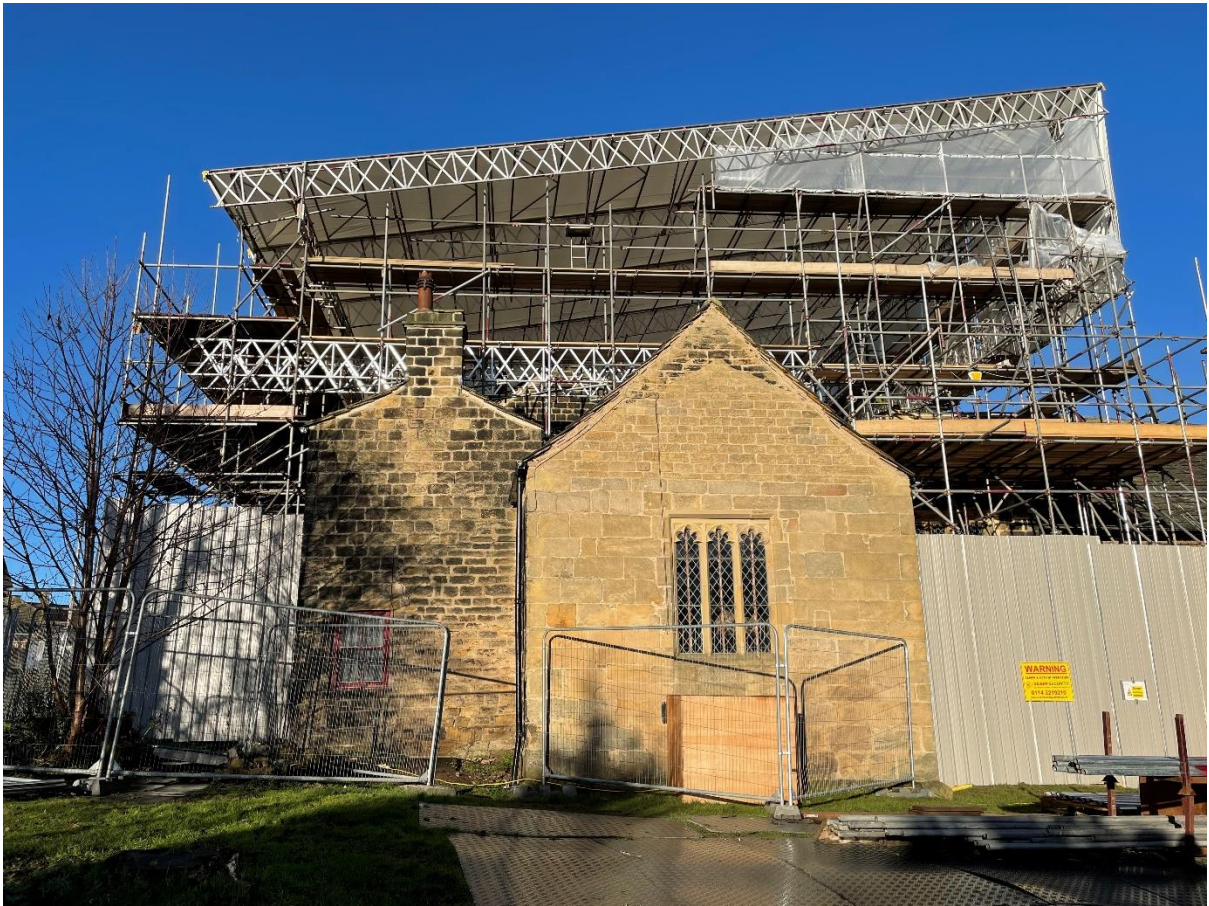
Scaffolding going up for the re-roofing works in January 2022.

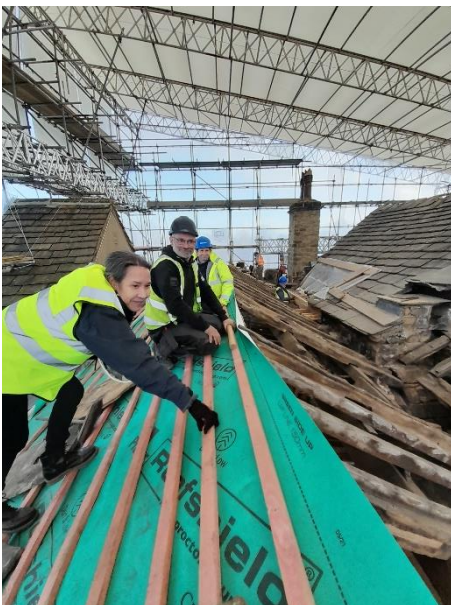
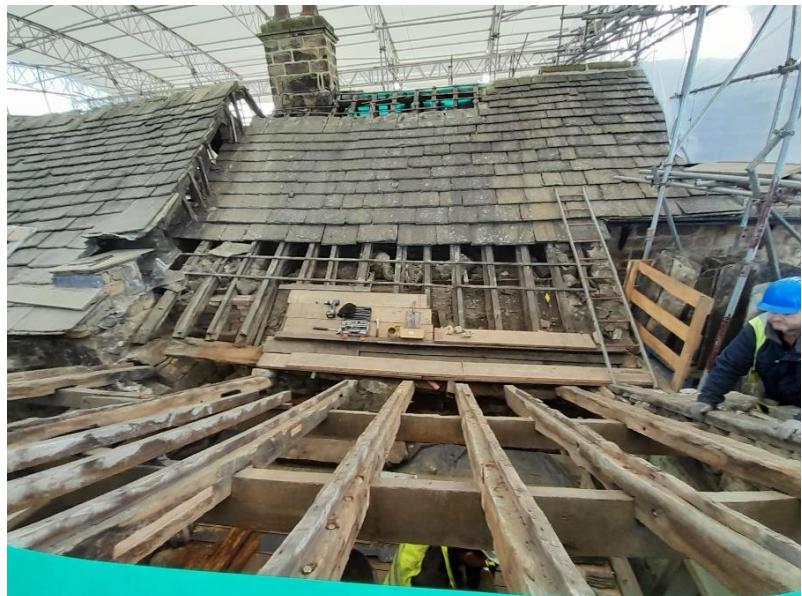
Architect Karen Lim under the shelter roof on the Solar Block roof; looking down the southwest slope of the Solar Block roof towards the Parlour Block and Chapel.

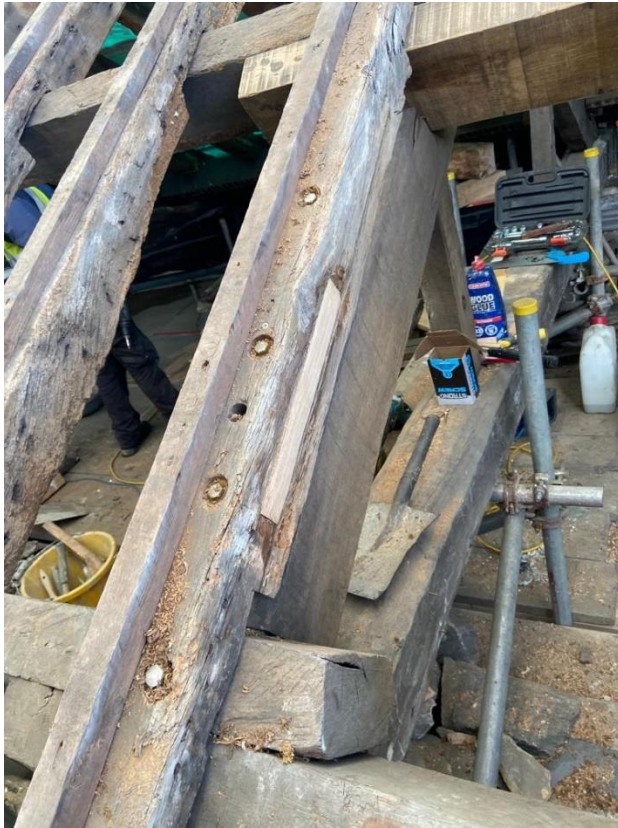
Examples of timber repairs, each carefully specified.

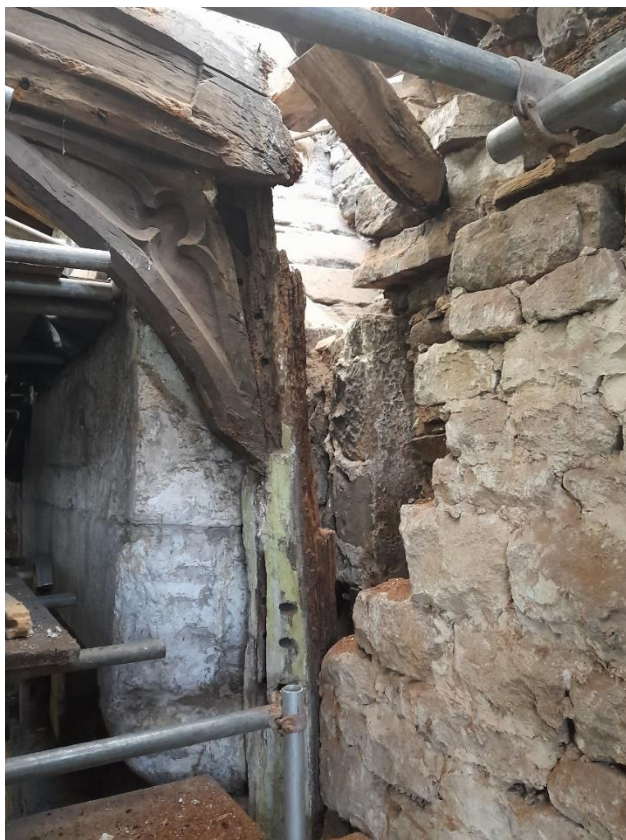
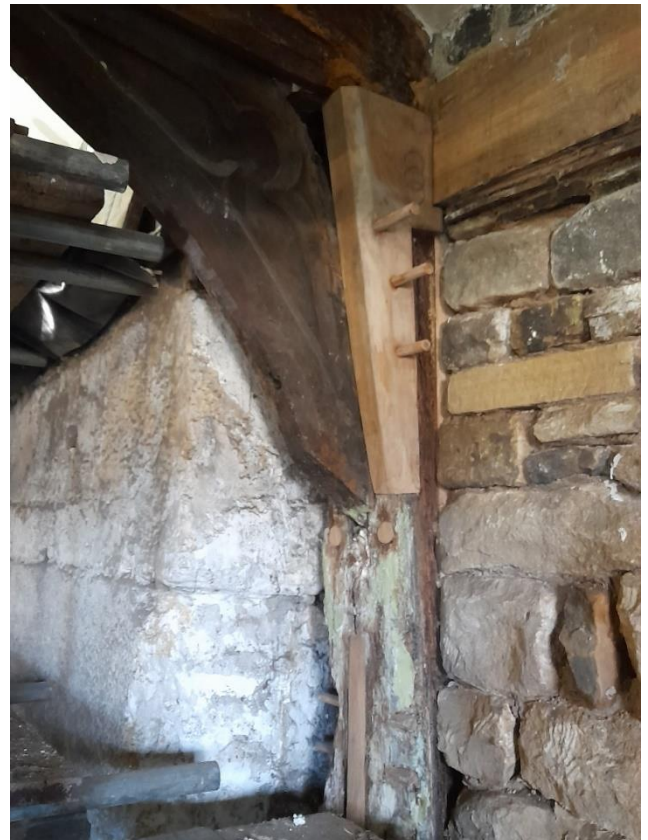
Below: this junction point had fared especially badly, with considerable decay in a post holding one of the ornamental trusses in the Solar Block above the huge hearth. The wall plate had also rotted. With advice from the structural engineer, we were able to repair it in situ. The void behind the post was one of the locations where a cache of concealed finds was discovered, a typical location for such finds beside an opening (the chimney flue).

The roof timbers were found to be in mostly sound condition except for rotten feet of many of the rafters in the valleys between the Solar Block and the other blocks. The wall plate was also rotten in places. We took a very conservative approach to the timber repairs, scarfing in new wood, inserting stainless steel bolts and fitches where necessary, in order to retain as much of the original fabric as possible.

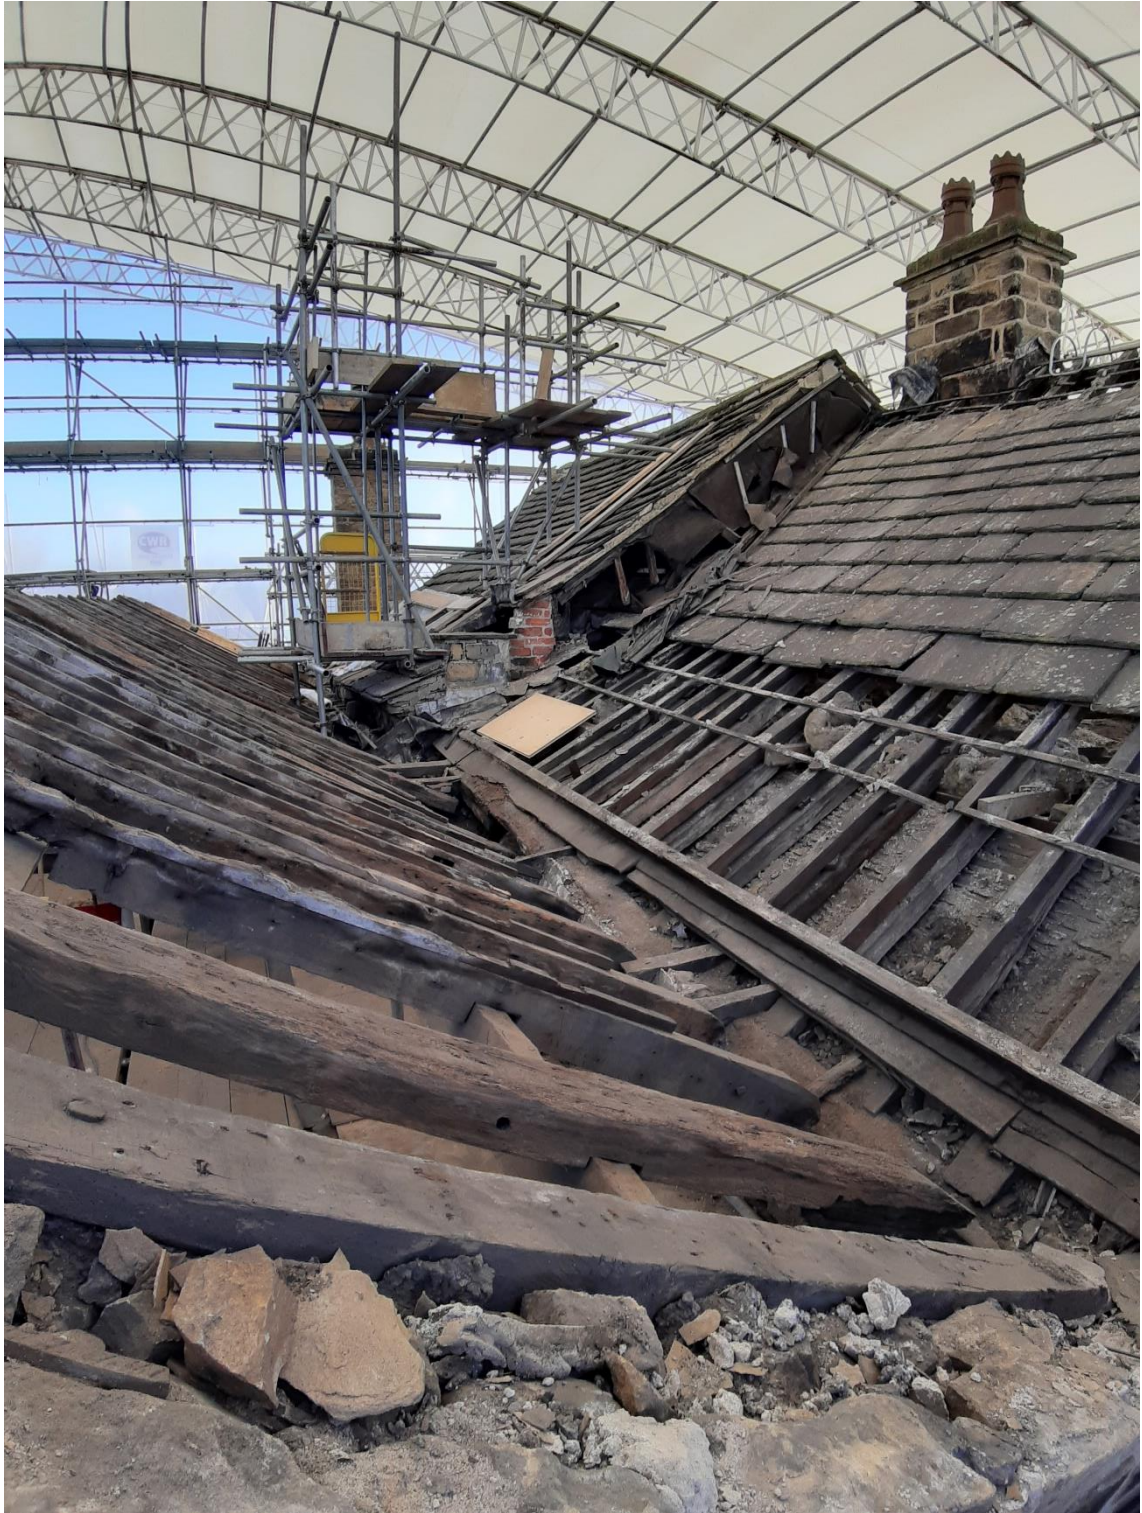
View southwest along the length of the Solar and Parlour Blocks during re-roofing, with the Chapel at the far end. While some rafter ends had rotted, the roof was not in as bad a condition as feared.

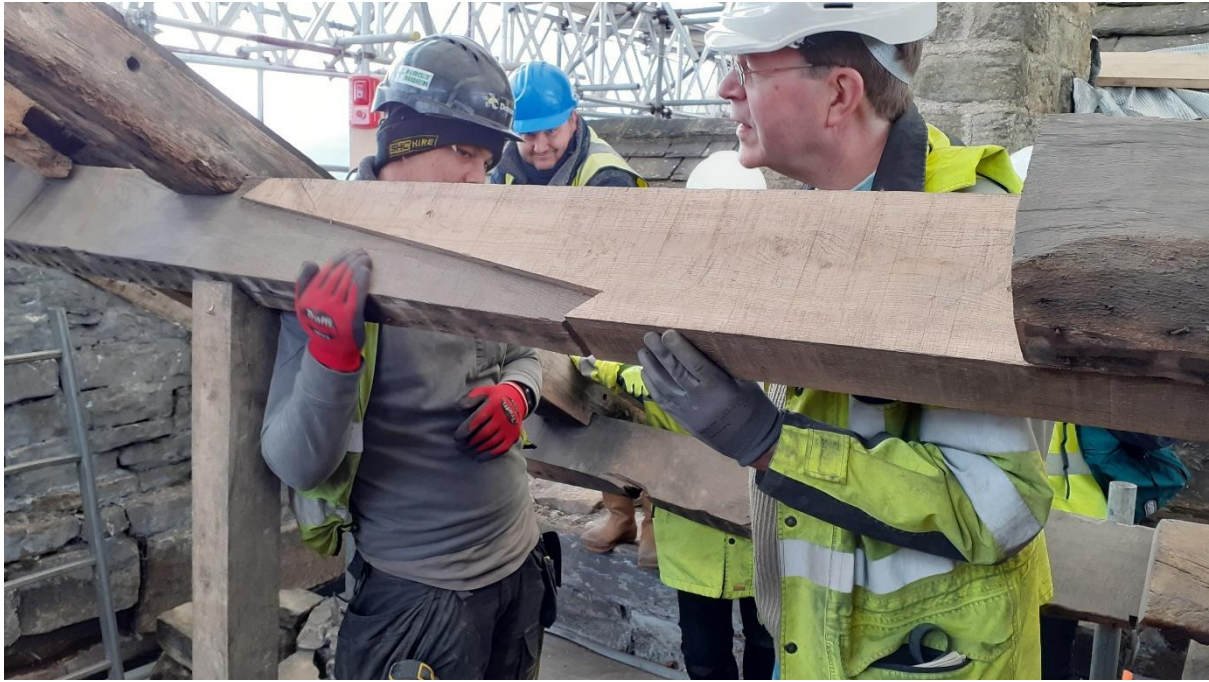
Archaeologist Jonathan Clark inspects a scarf joint repair to a decayed purlin.

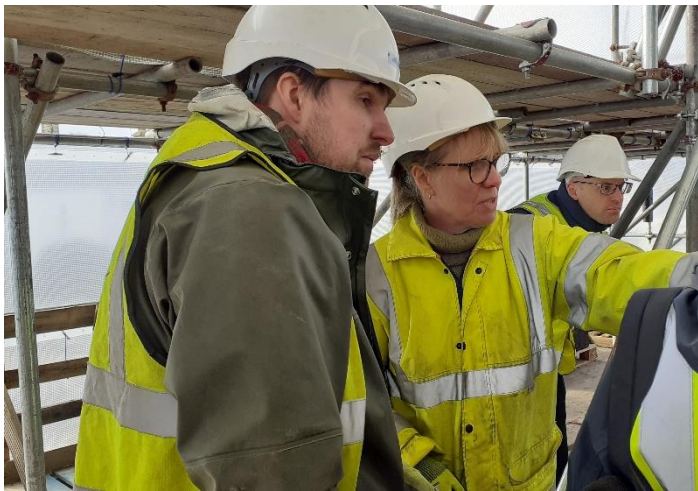
Landmark's senior surveyor, Linda Lockett, discusses a structural point with structural engineer Robert Ratcliffe.

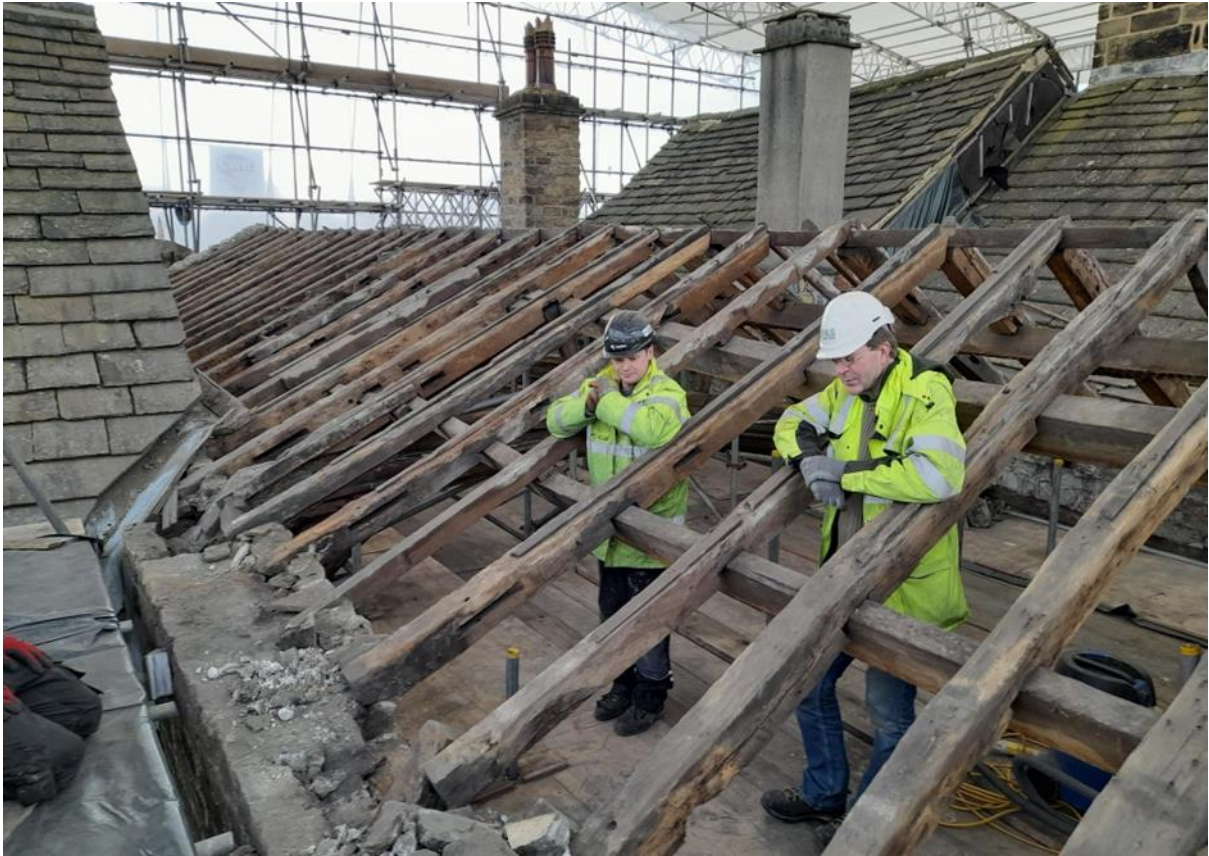
Pondering the evidence in the roof of the Solar Block. The rafters mostly belong to a re-roofing campaign in the late 19th century, but include many 17th-century timbers re-used from the roof from a barn or similar structure, perhaps one of the outbuildings known to have stood on the site previously.

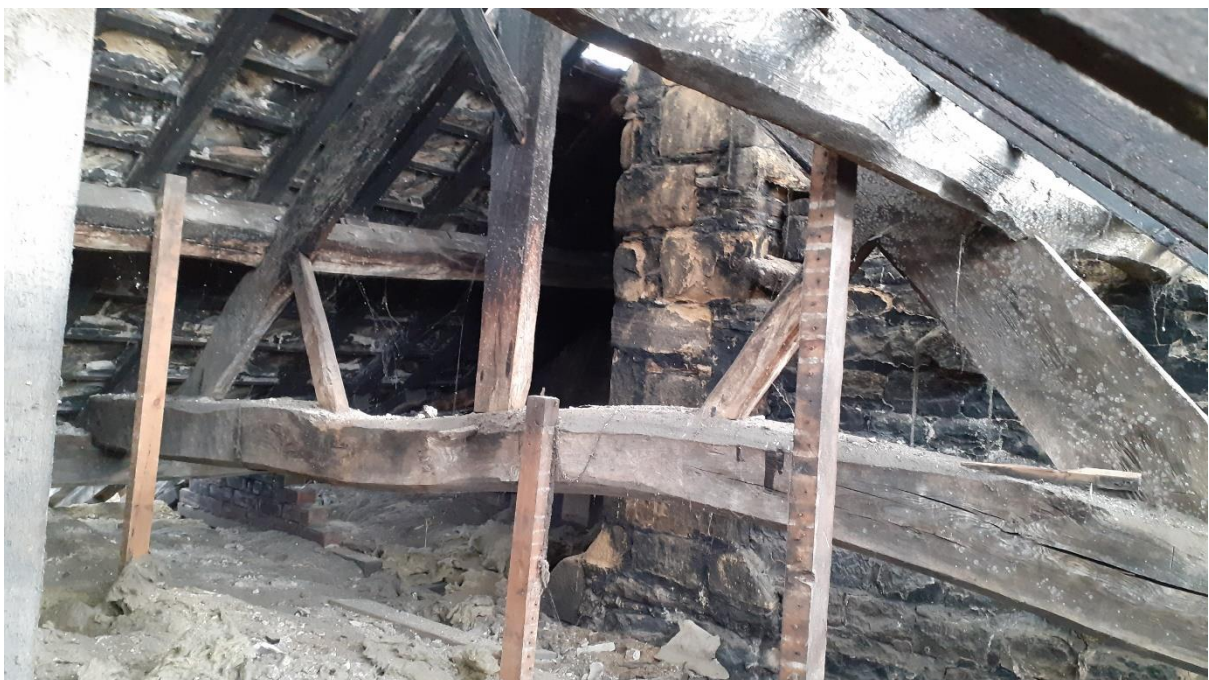
Below: timbers in the original early-14th century roof truss of the early solar range, now embedded in the roof space of the Lodging Block and smoke blackened, probably by the 1977 fire.

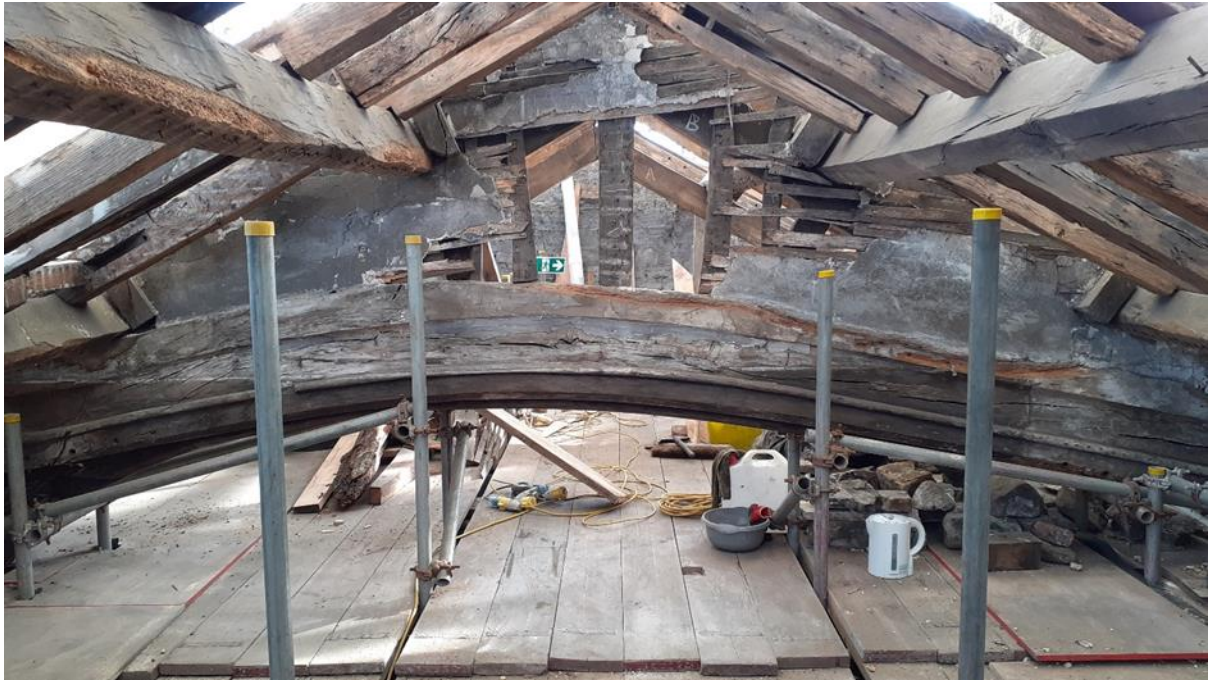
Remnants of lath and plaster above a roof truss in the Solar Block, dating from the 19th century when three storeys were created in the block. The fabric has been incorporated into the repaired apex.

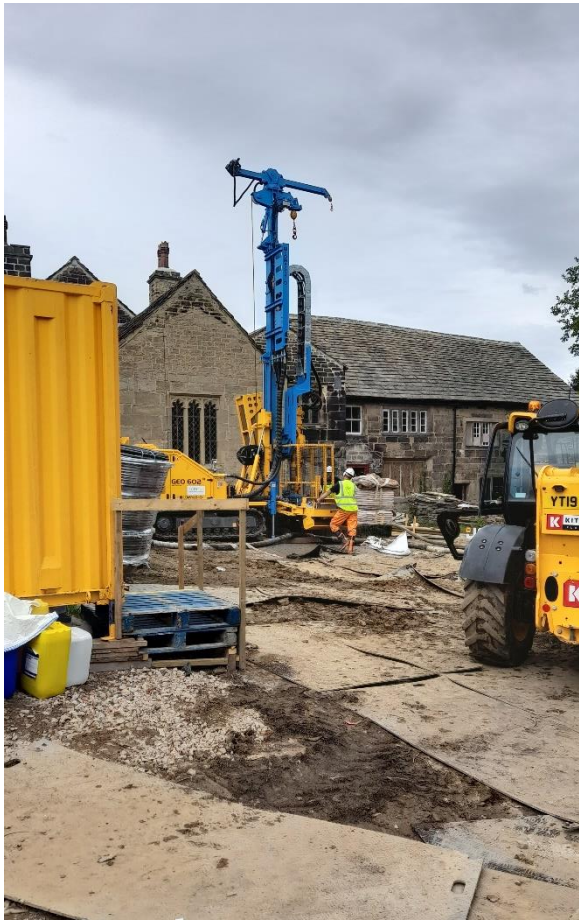
Drilling the bore holes for ground source heating. Six bore holes were drilled to a depth of 143 metres. The process proved easier than anticipated, to everyone's relief.

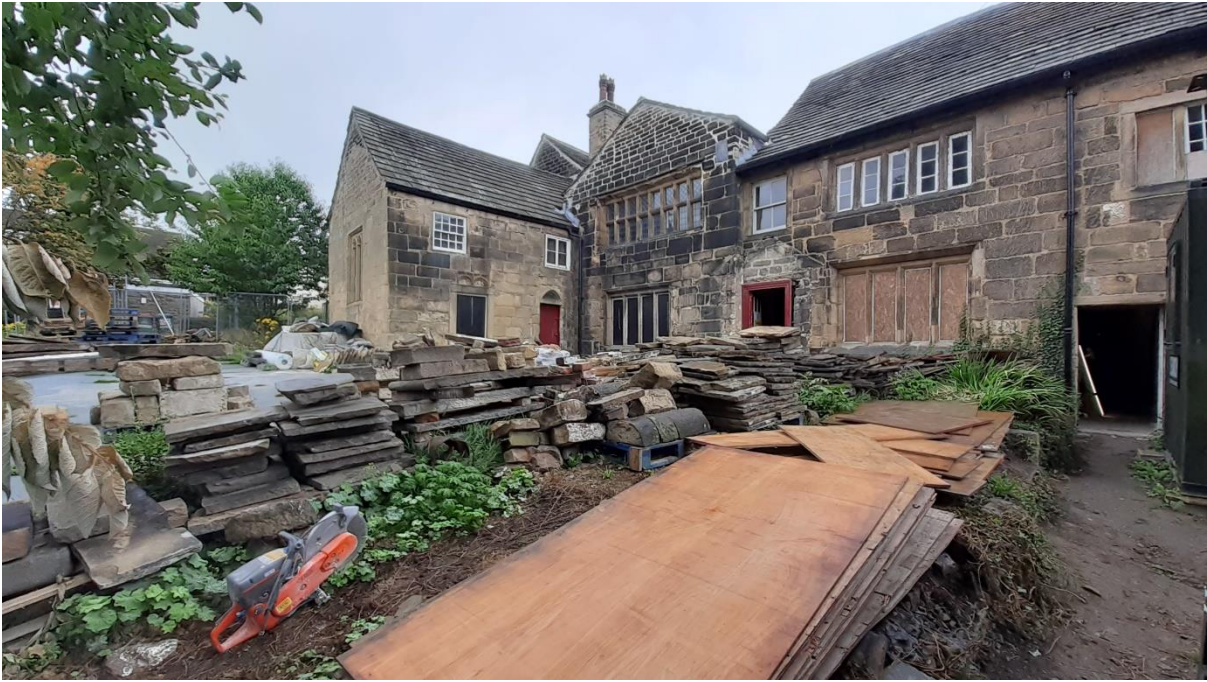
By summer 2022, the scaffolding was down and site set-up complete. The flagstones from the Great Hall had been recorded and were now carefully stacked while underfloor heating was installed.

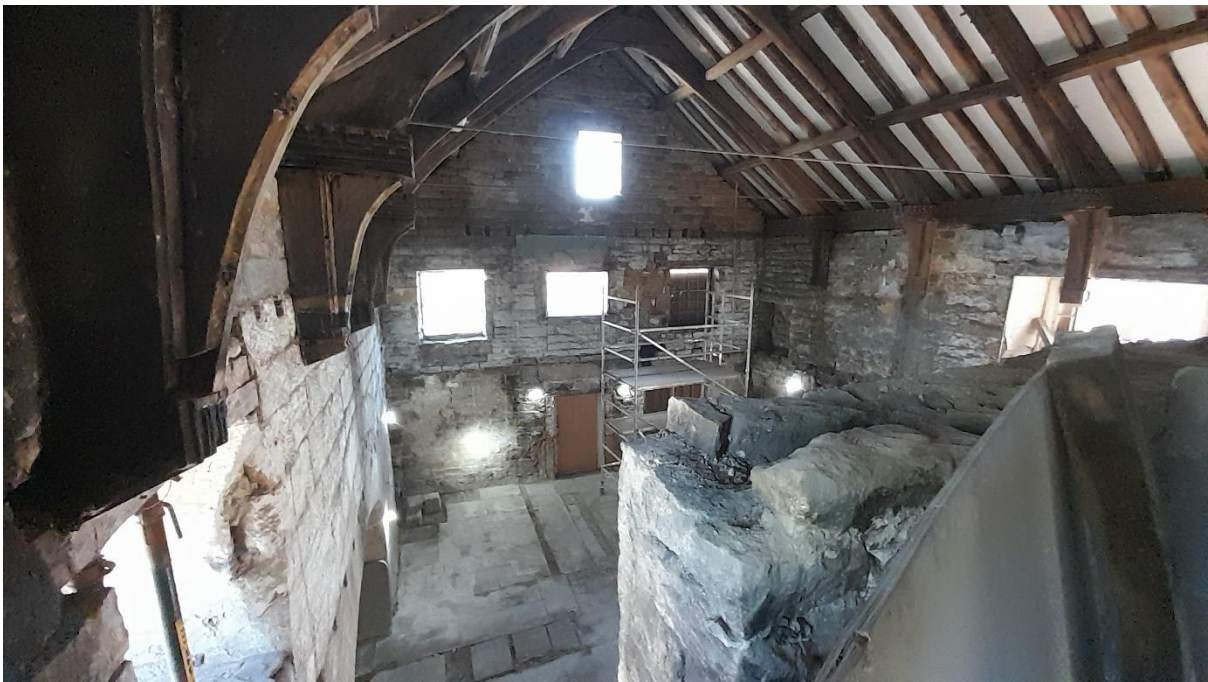
The removal of the cottage in the southeast end of the Great Hall allowed a first glimpse into the Great Hall from high level, a view that is now familiar as a key element in the conversion scheme.
