CALVERLEY OLD HALL

History Album

Volume II:

Repair & Conversion

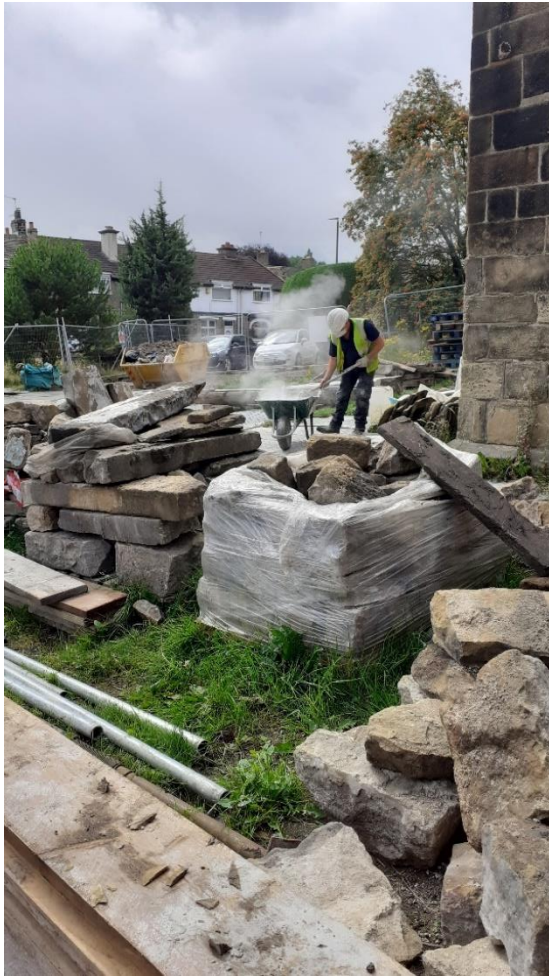
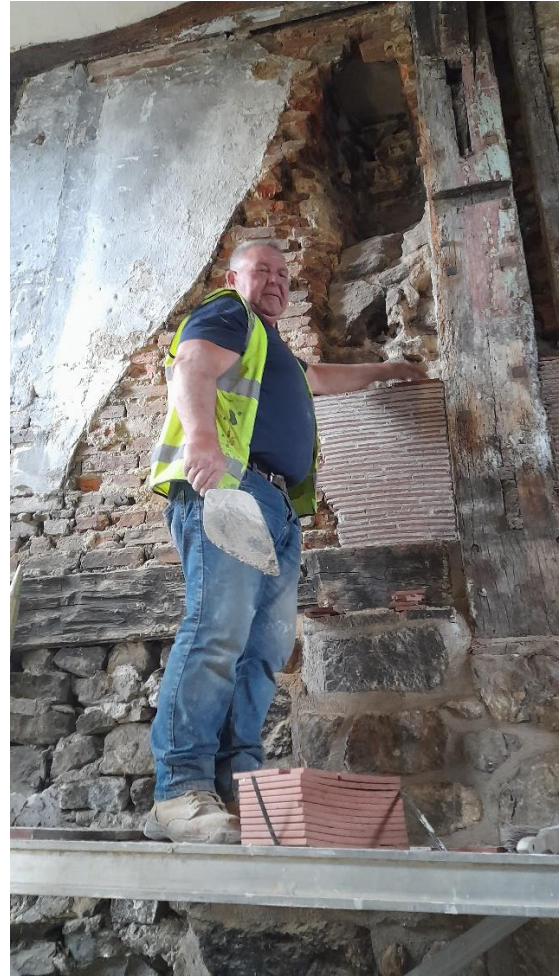
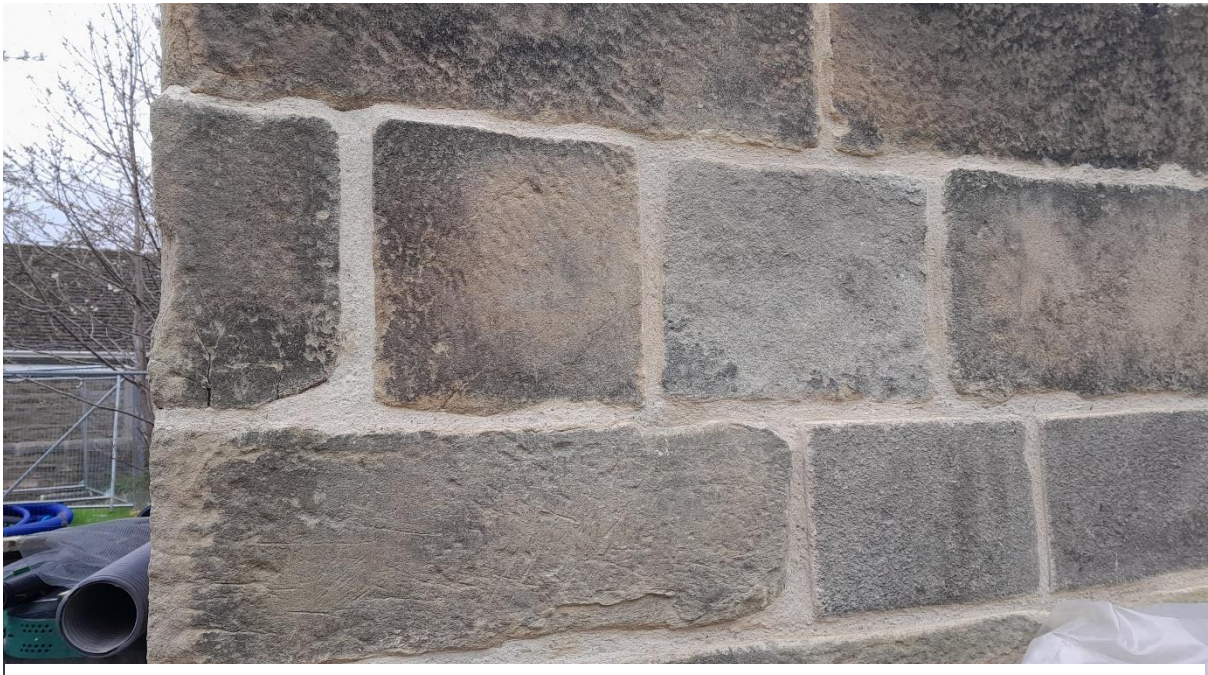
From top left: slaking lime on site; tile repairs in one of the many wall cavities, here in the partition wall of the Great Hall; a sample of external pointing, the mortar mix and style refined with great care by stone mason Kevin Woods and his team.

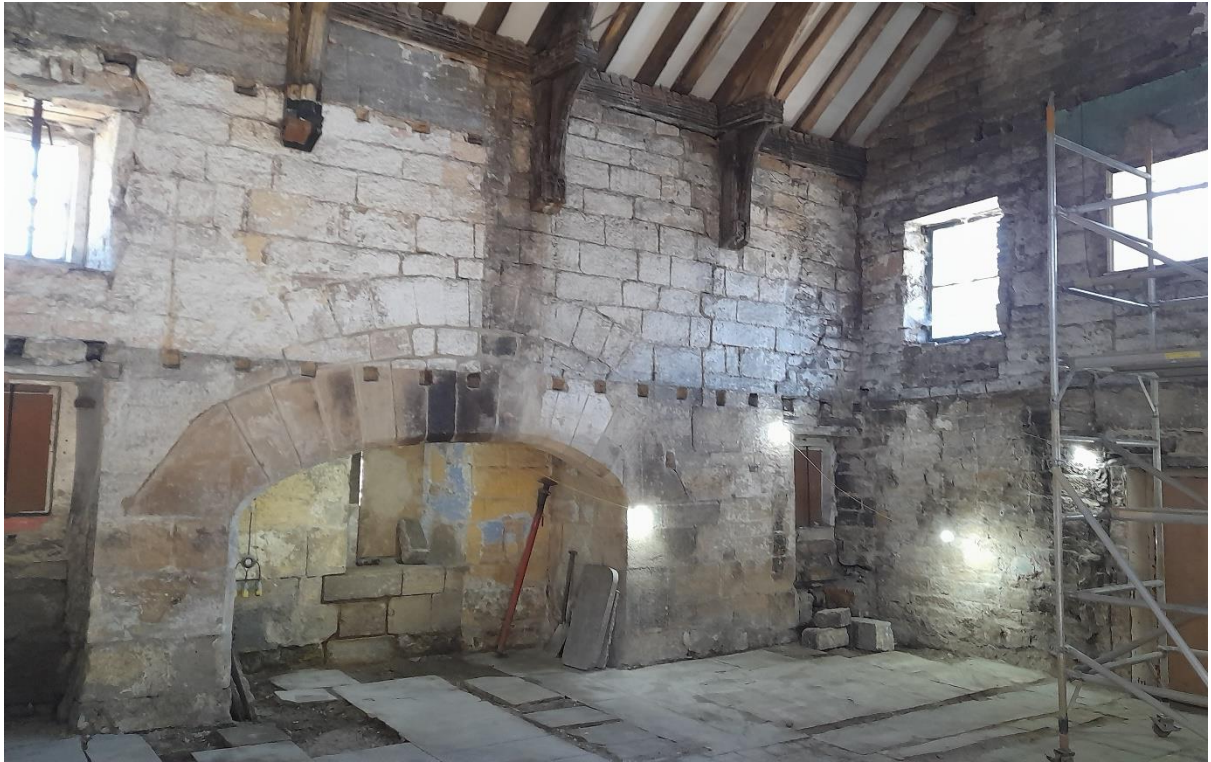
The flagstones in the Great Hall were all numbered, lifted and carefully re-laid after underfloor heating had been laid beneath a screed of limecrete. Recycled aerated glass was used as the underfloor insulation. Little of archaeological significance was discovered in the process.

The flagstones were carefully numbered and lifted prior to the installation of underfloor heating. This was done under careful archaeological monitoring but nothing of significance was found; in being built with the huge hearth with its integral flue, there was never an open fire. The heating pipes were laid on a layer of breathable blown glass fibre onto which the heating pipes were laid. This was then covered with limecrete slab, and the flagstones relaid exactly as they were. Only a few needed replacing. We deliberately left an area of red-stained flags as they were, a reminder of the traditional red polish used in the cottage era.

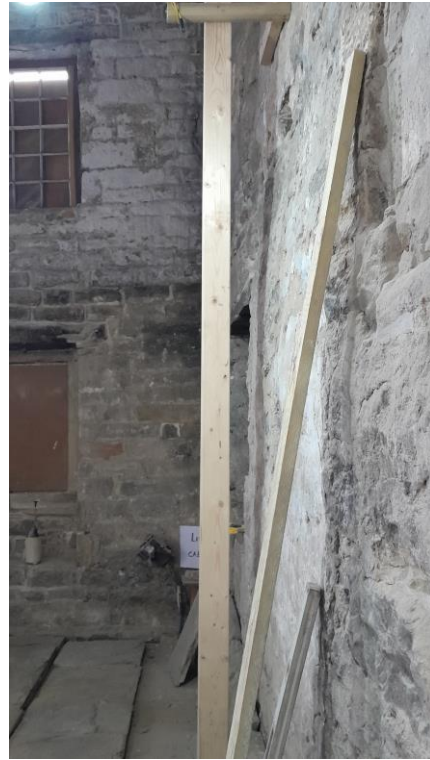
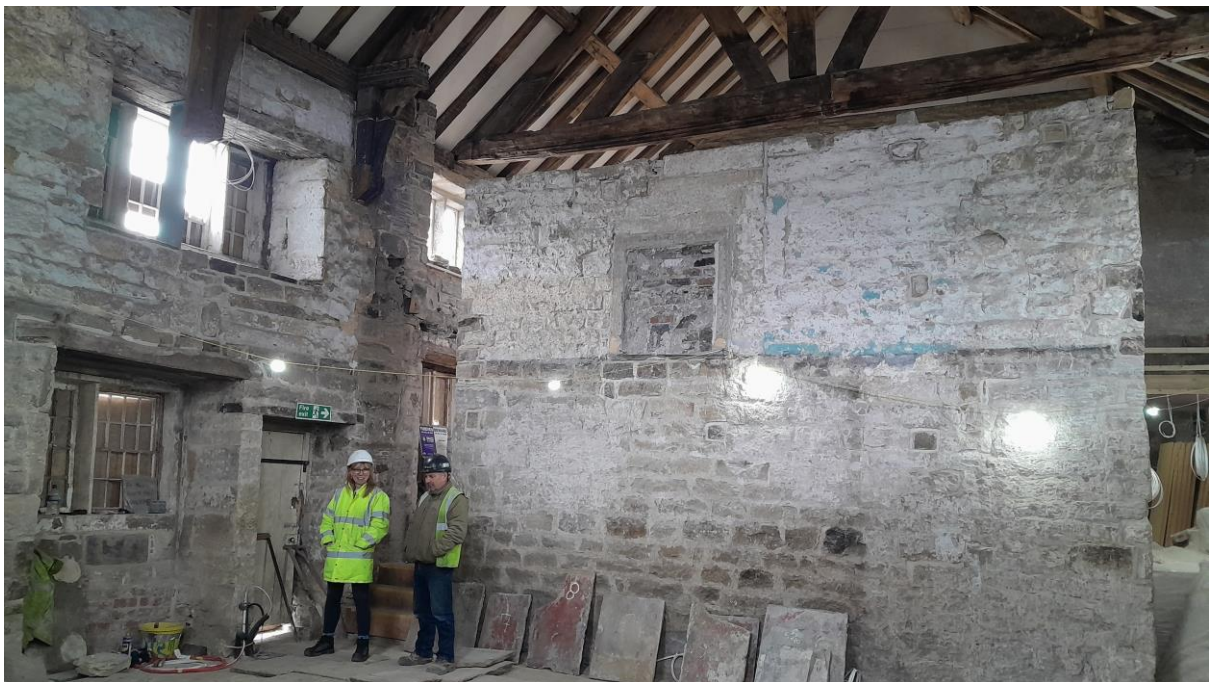
Linda Lockett and Andy Dewhurst contemplate the challenge of installing the panelling in the Great Hall. The image top right shows how far out of true the southeast wall was.

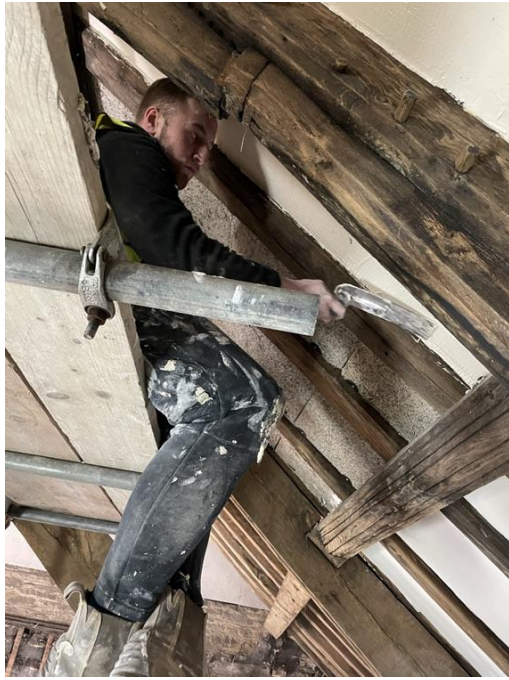
Applying the plaster skim onto the wood board insulation between the rafters in the Great Hall.

The Great Hall (its roof built of timber felled 1477-1497) was a nest of scaffolding until summer 2023. As the roof here was not stripped, insulation had to be installed from inside. Parvatherm insulation was introduced between the rafters, a layer of wood wool and then wood slab, given a thin skim of lime plaster. This has reduced the depth of the rafters by about two thirds, although the end result looks no different from below. Wood fibre insulation was installed behind the panelling around the walls and worth it for the increase in thermal efficiency. This has been increased significantly and also by installing secondary glazing to the windows, a simple, visually unobtrusive solution using Perspex sheets mounted on magnetic strips. There was extensive repointing. Services were laid in the cavity between walls and panelling. The flue to the huge hearth was lined and a woodstove installed. As was also true in the 1980s, we felt there was insufficient evidence to justify rebuilding the external stack that would once have served the hearth.

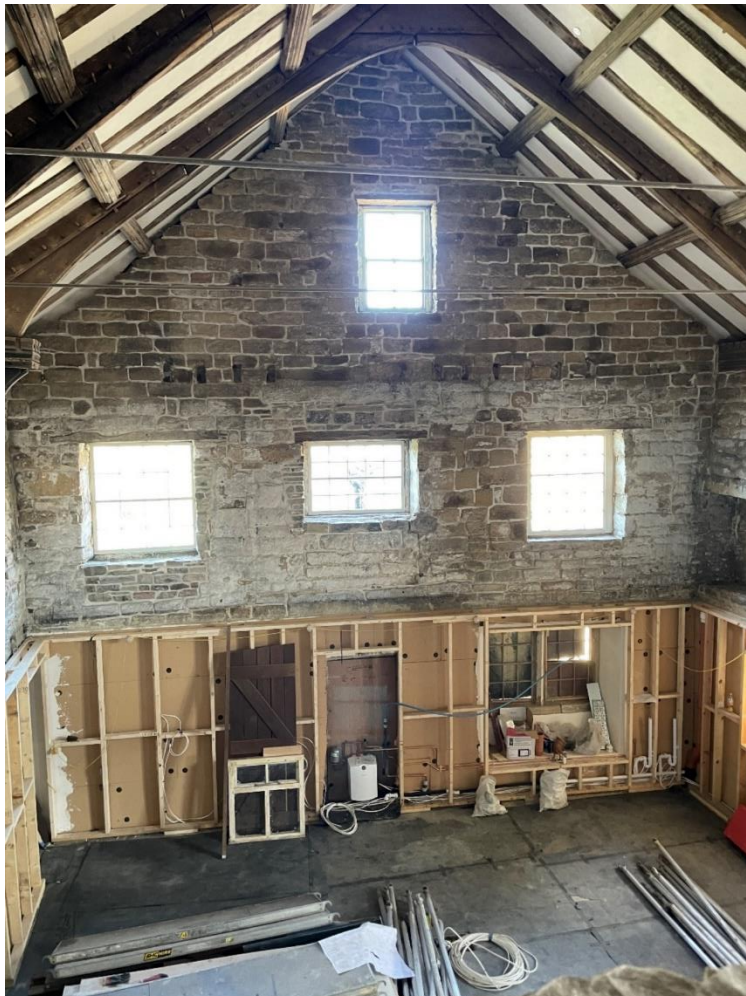
The framework in place for the panelling. The finished panelling provides additional insulation as well as holding pipework for the kitchen and electrical ducting, and being aesthetically pleasing by drawing the space together.

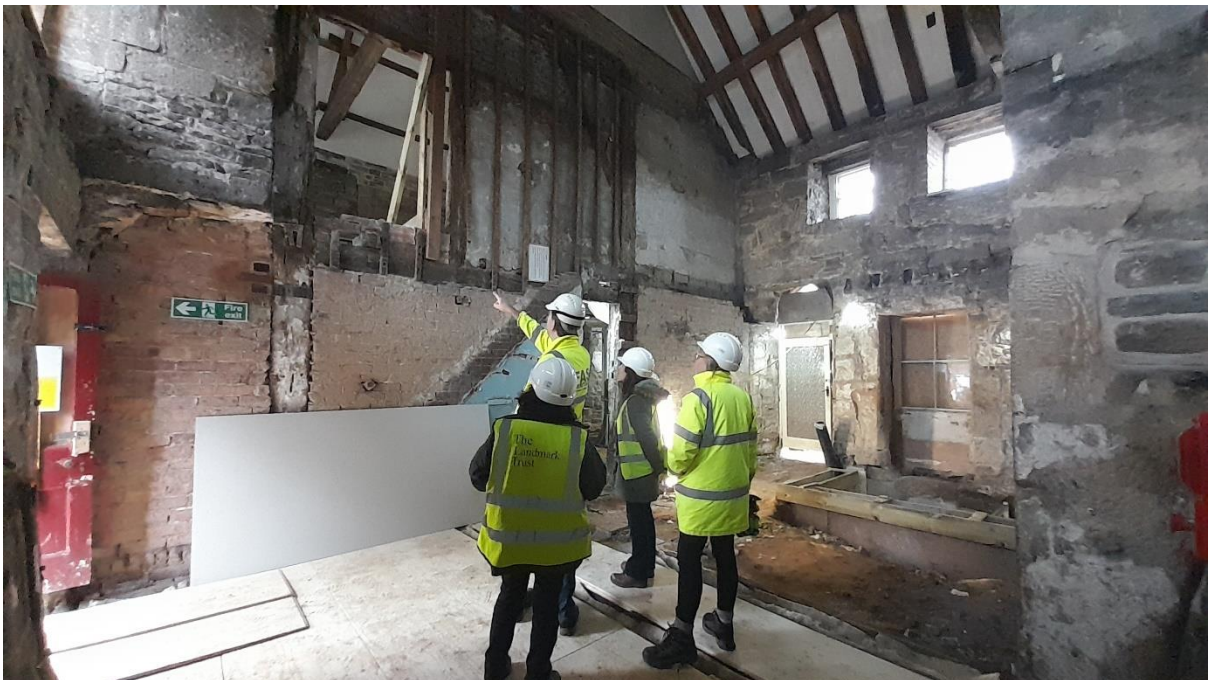
Analysing the evidence in the Entrance Hall, its cottage infill now removed. This was once the cross passage for the 1480s Great Hall. Before this hall was built, a narrow gallery would have run along the far wall, with an external staircase providing access to the 1320s first floor hall via the present doorway. The early cesspit that disproved the current Great Hall as the site of the original hall block was discovered against this wall, near the greenish door in this image. Above it, the timber frame has evidence that could suggest a long drop garderobe.

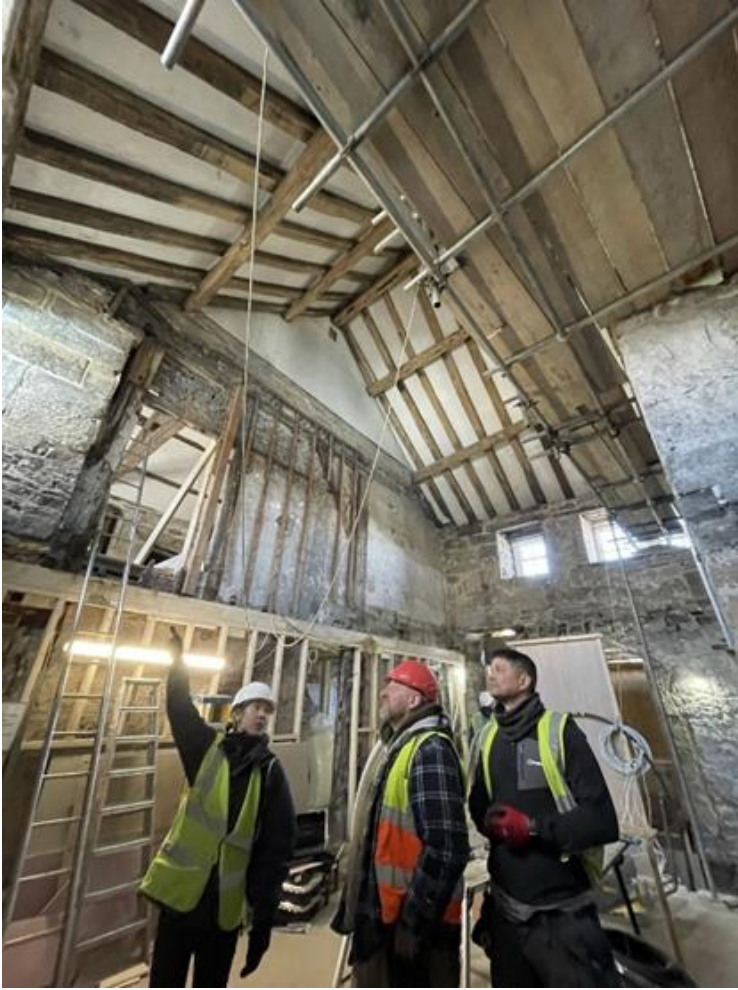
During the clearance of the cross passage, the original doorway into the first-floor hall was discovered in 1320s framing. Here, architect Karen Lim briefs Kevin Woods, plasterer (in the red hat) Michael Bloom, joiner

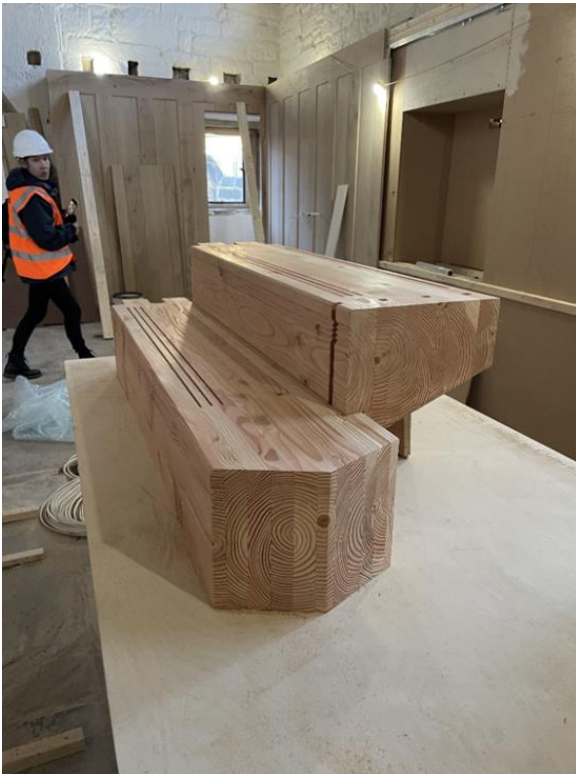
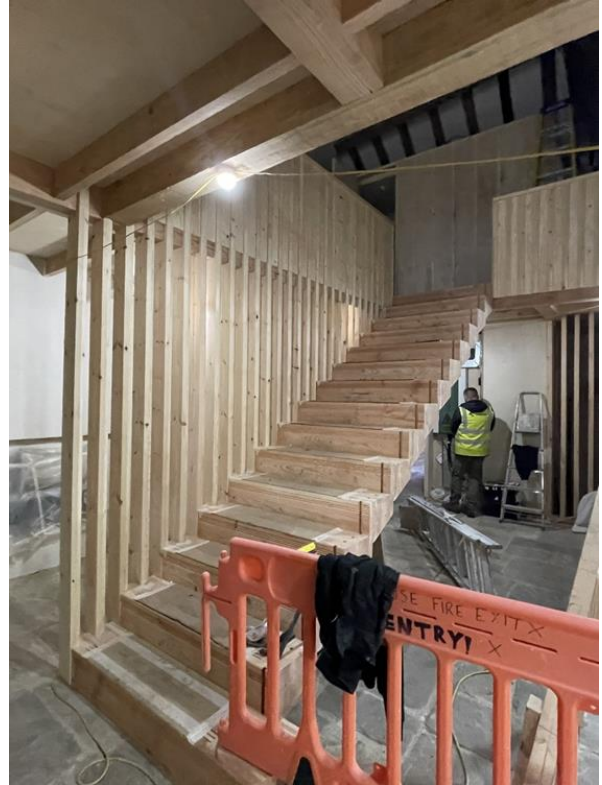
Below: the solid oak staircase under construction. Its treads are cantilevered so it is self-supporting and saves on circulation space.

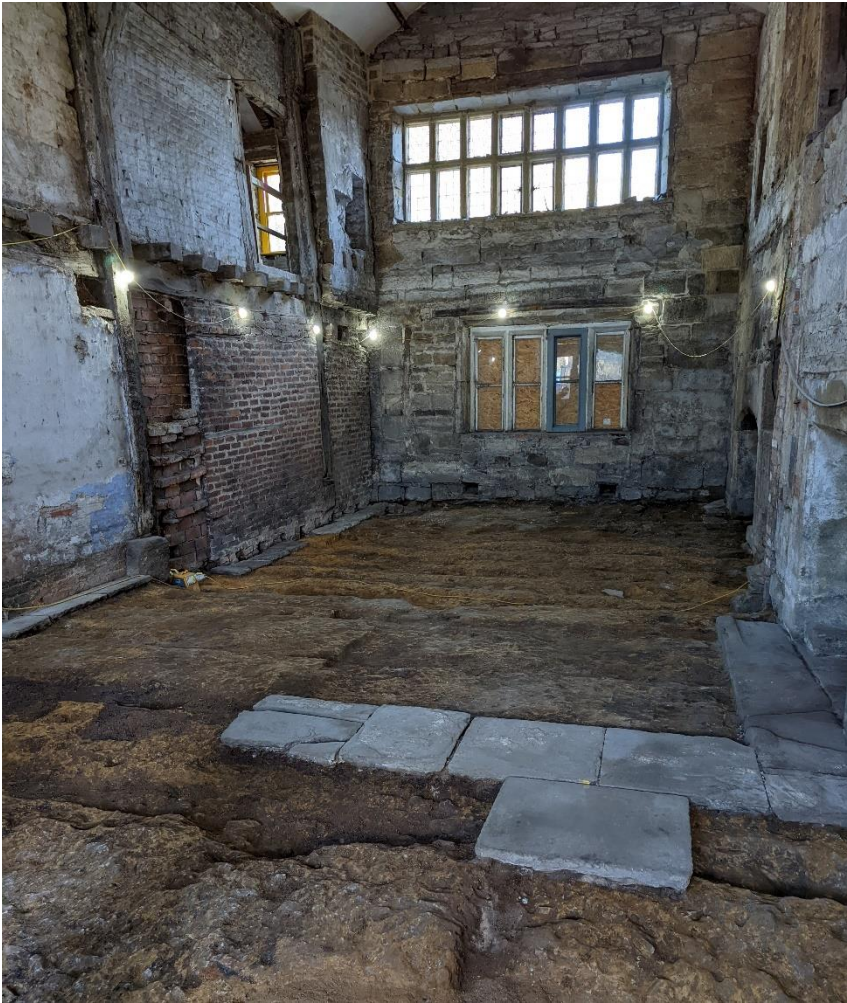
The Solar Block cleared for work to begin. An archaeological survey was carried out by students from Bradford University archaeology department, who also helped catalogue some of the many concealed objects that emerged during the project (below, using the Lodging Block, still semi-furnished as a Landmark).

The floor in the Solar Block was excavated for the installation of underfloor heating, after help from students from the University of Bradford with the preliminary archaeological investigations (nothing of significance was discovered).

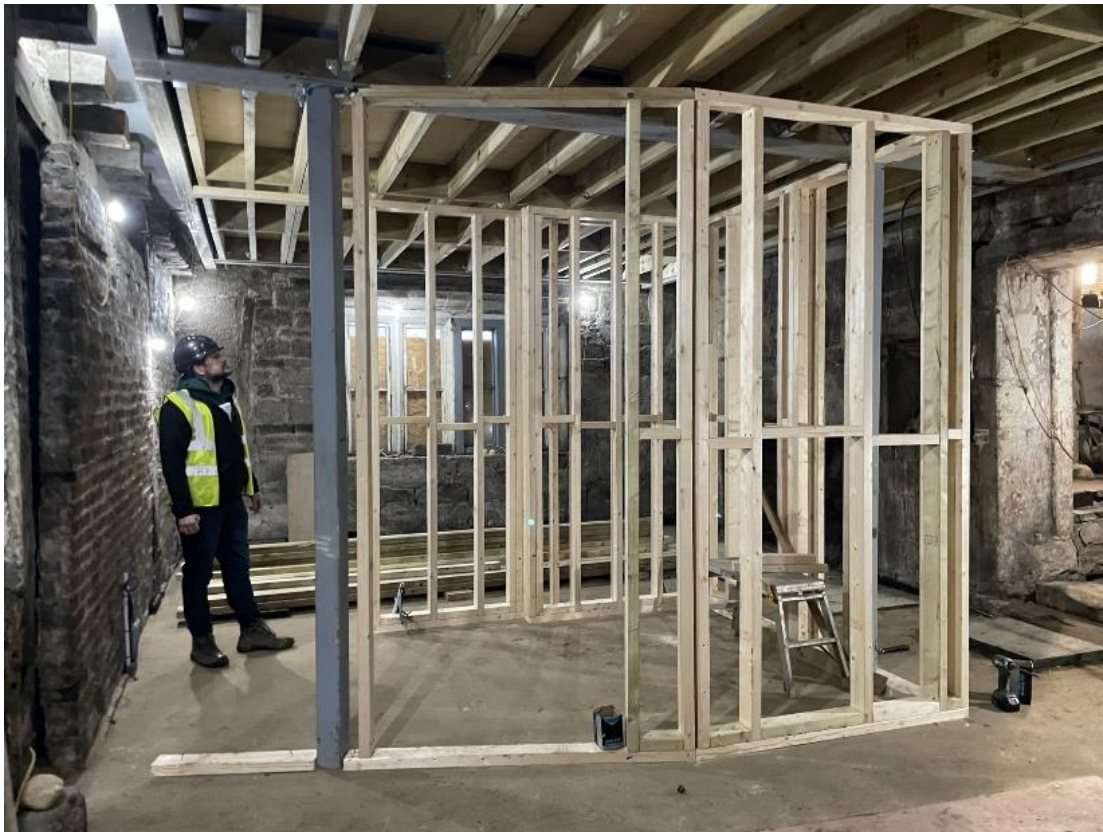
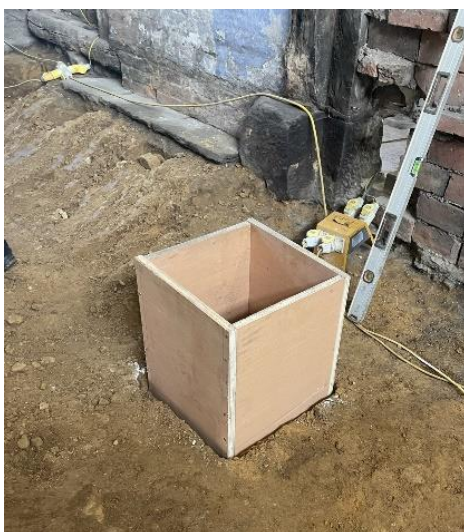
The huge steel frame that supports the floor in the Solar Block and around which the ground-floor partition walls are constructed. It mostly stands clear of the external walls.

A huge steel framework to hold the first floor was installed, resting on concrete pads; the architect's scheme envisaged this new insertion 'floating' within the ancient shell such that no damage was done to the historic walls, while at the same time providing a framework to tie them into. Beneath this frame, the partition walls for the two ground floor bedrooms and bathrooms were faced with Glulam. The divisions make best use of the spaces while still allowing the most significant architectural features to be visible. Movement sensitive lighting illuminates an otherwise windowless central lobby. A doorway was re-opened on the ground floor to lead up a couple of steps into the ground floor bedroom of the Parlour Block.

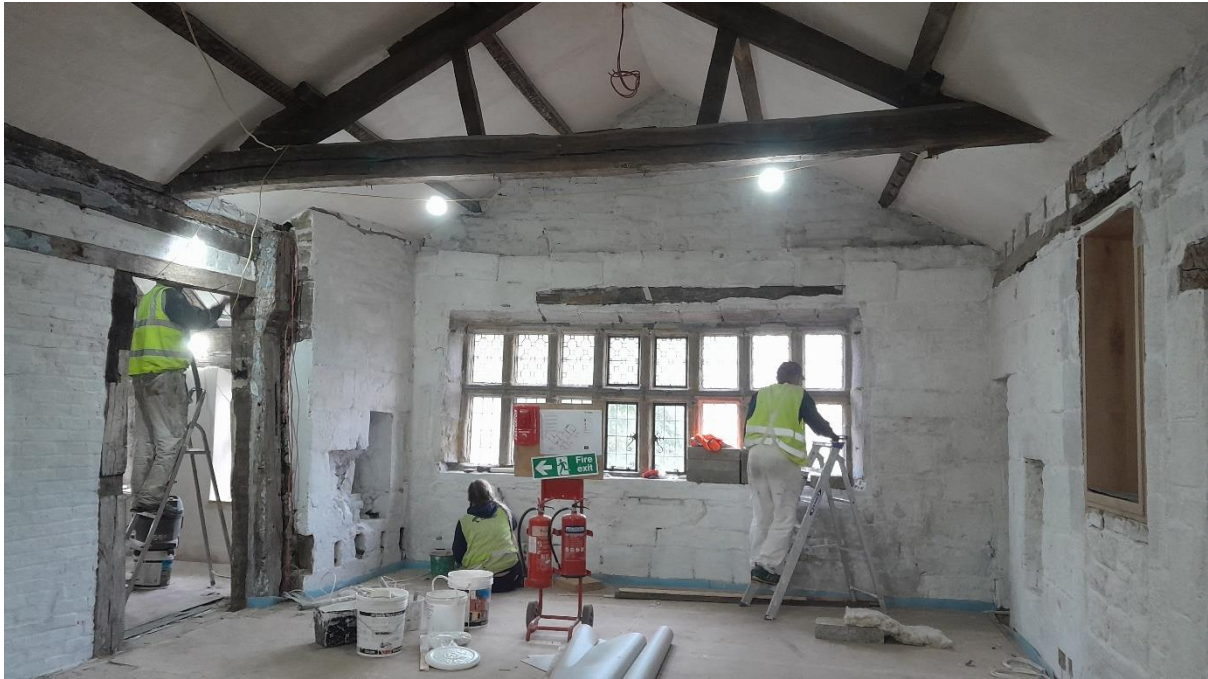
Redecoration of the sitting room under way.

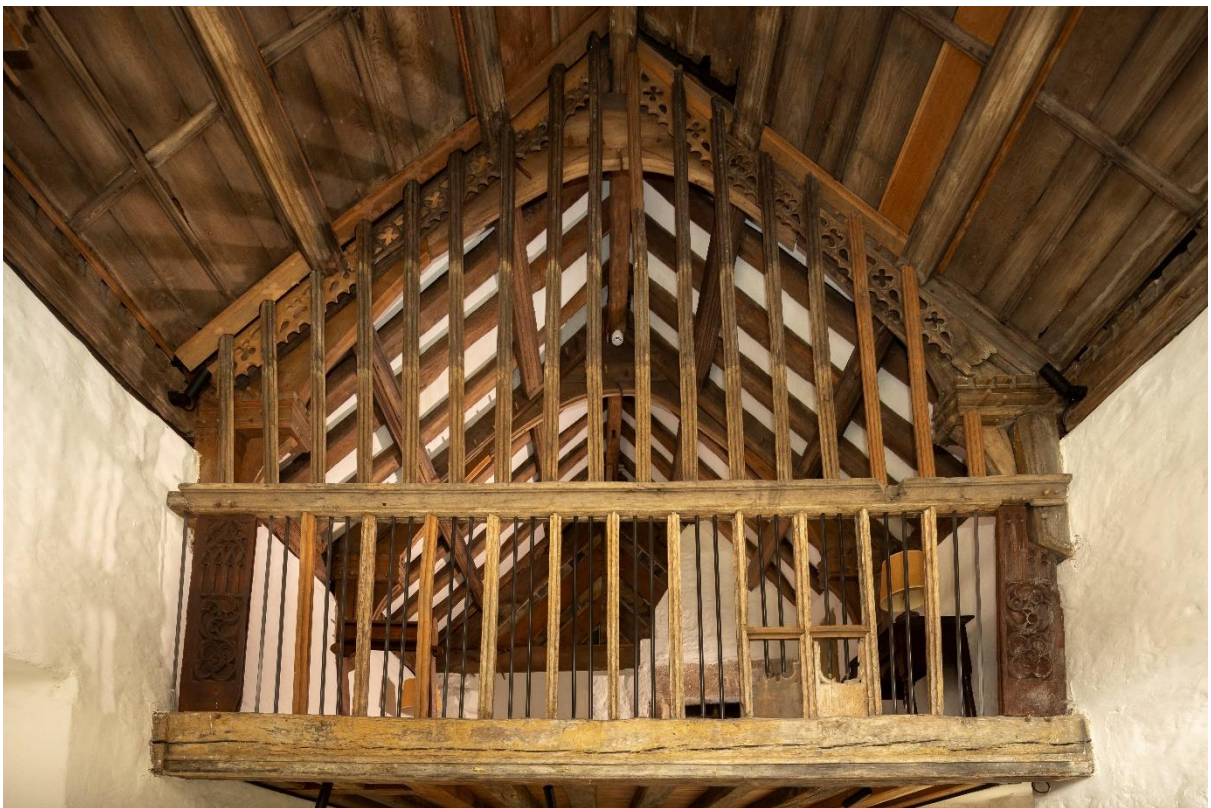
The chapel gallery seen from below, 2024.

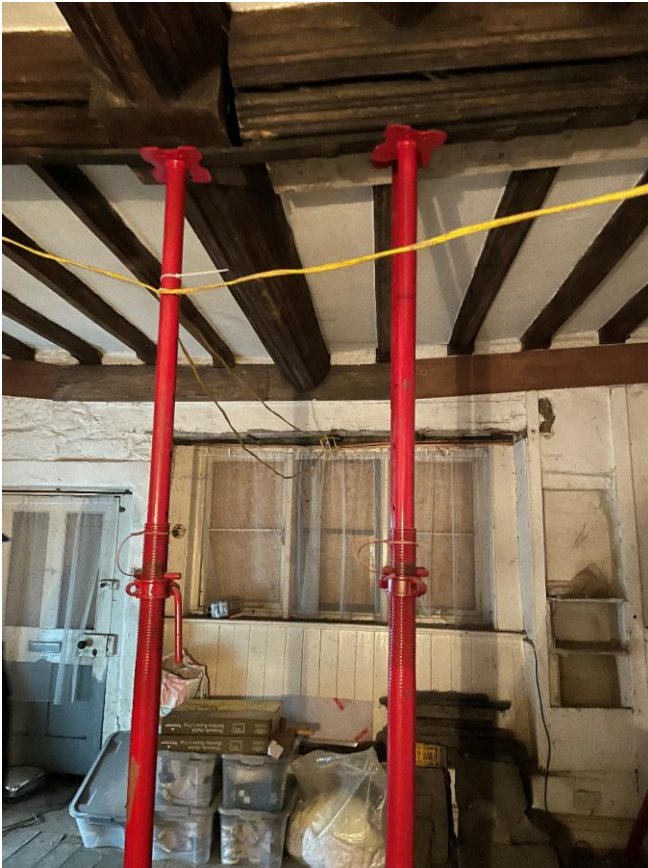
Left: the cottage sitting room (now a bedroom) propped as a precautionary measure. Right: the cottage stairs before removal. By now, the wall paintings had been discovered in the room above and can be glimpsed beneath protective Perspex on the left. Below: the room midway through works. The former breach in the ceiling for the staircase has been made good. The far wall has yet to be finished. The new staircase for the adjacent cottage is under construction.

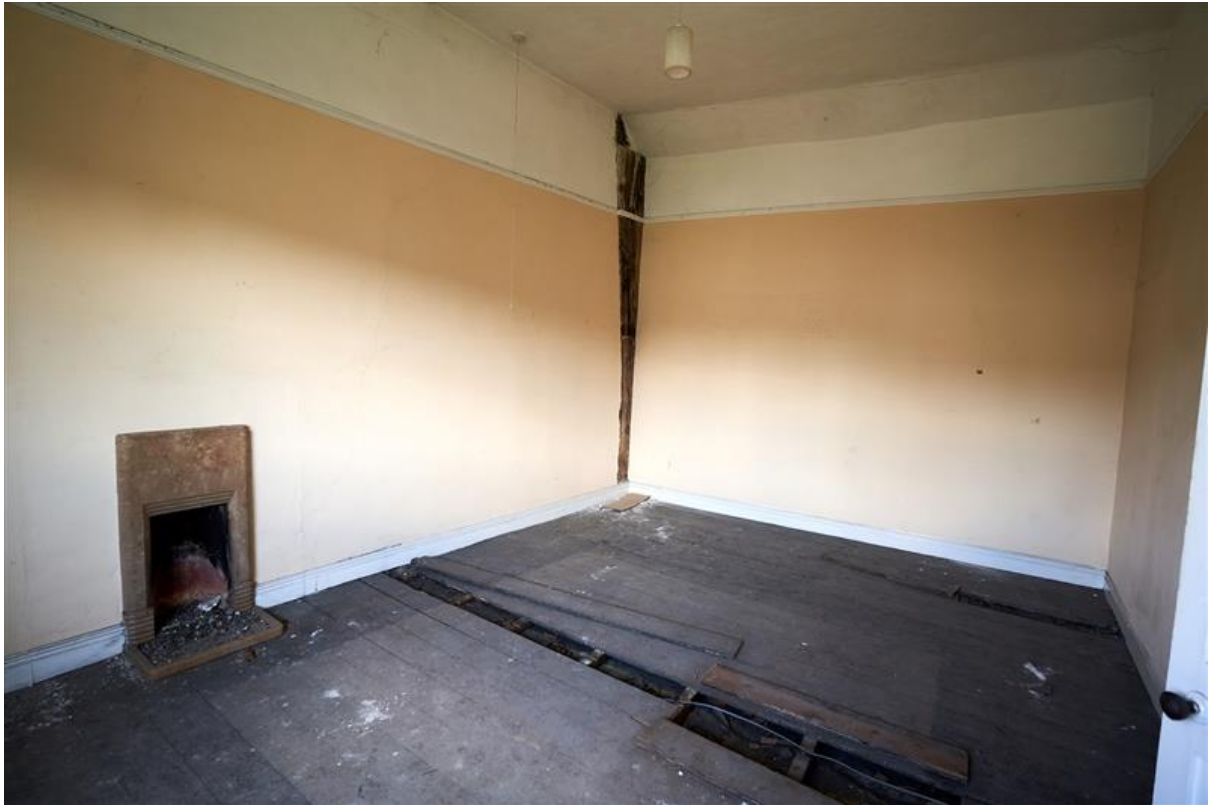
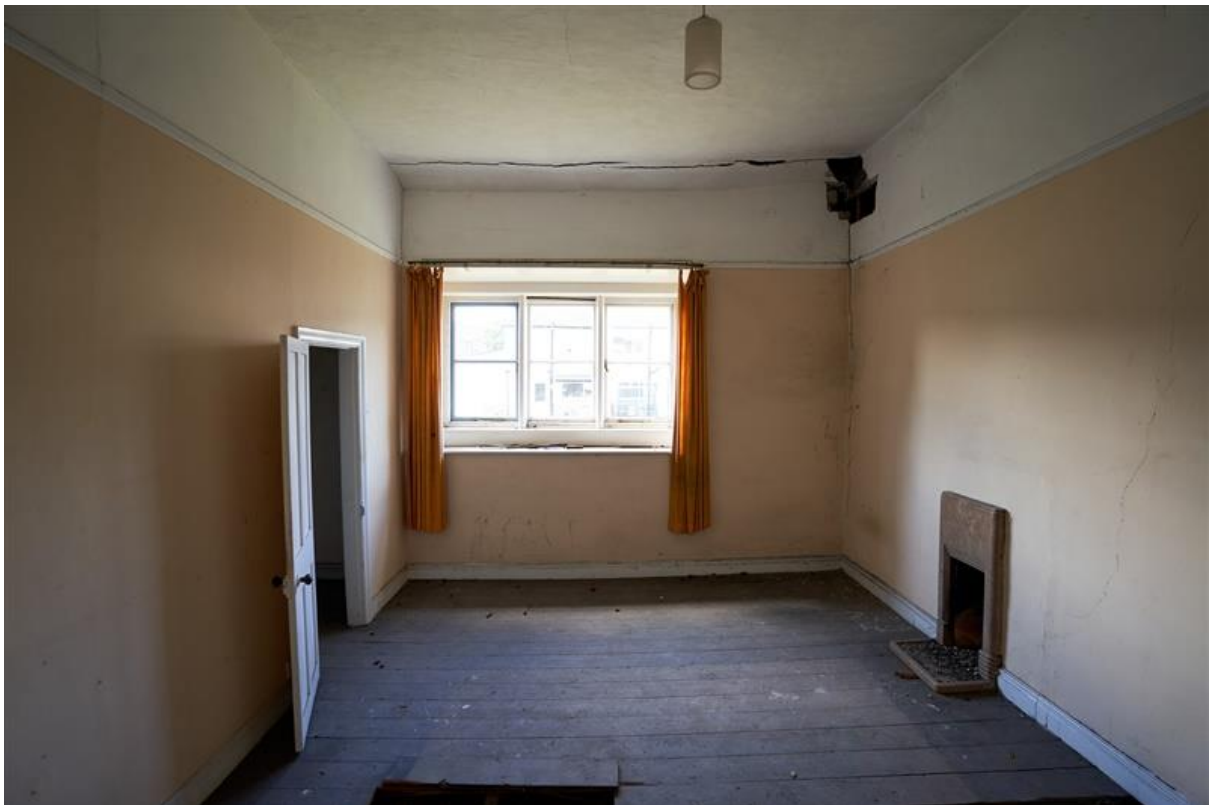
The Painted Chamber as cottage bedroom in 2019. Apart from the corner jowl post and hint of a coved ceiling in the top picture, there was little suggest that there was anything of significance. Only the small mid-20th fireplace and slight shadowing in the plaster hinted at a bigger hearth.

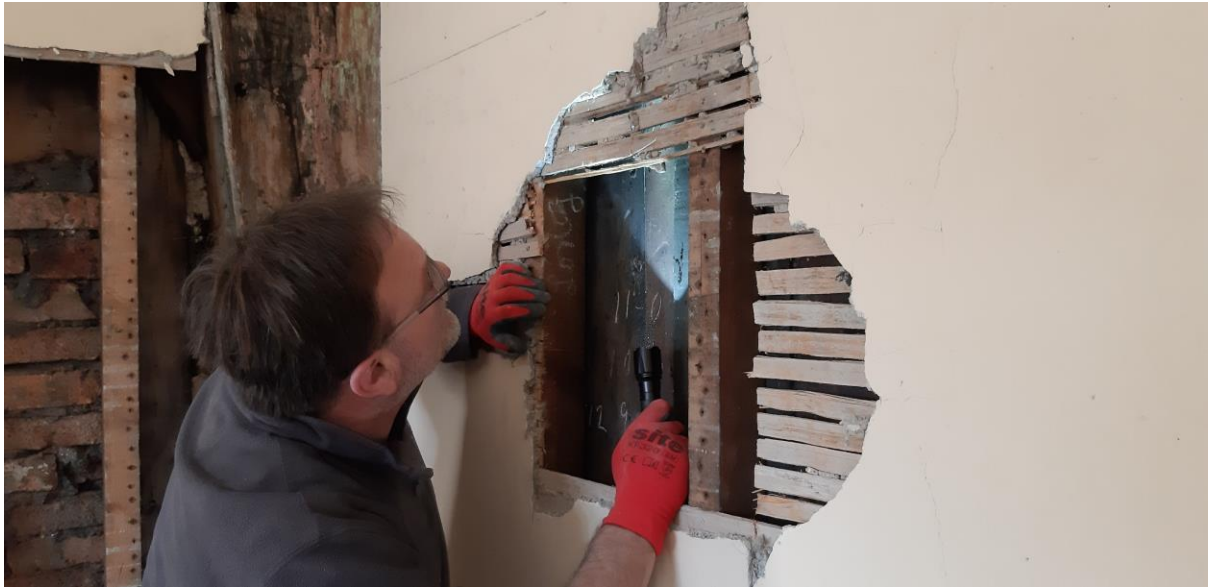
With traces of paint clearly apparent on the revealed corner jowl post, investigations were taken further.

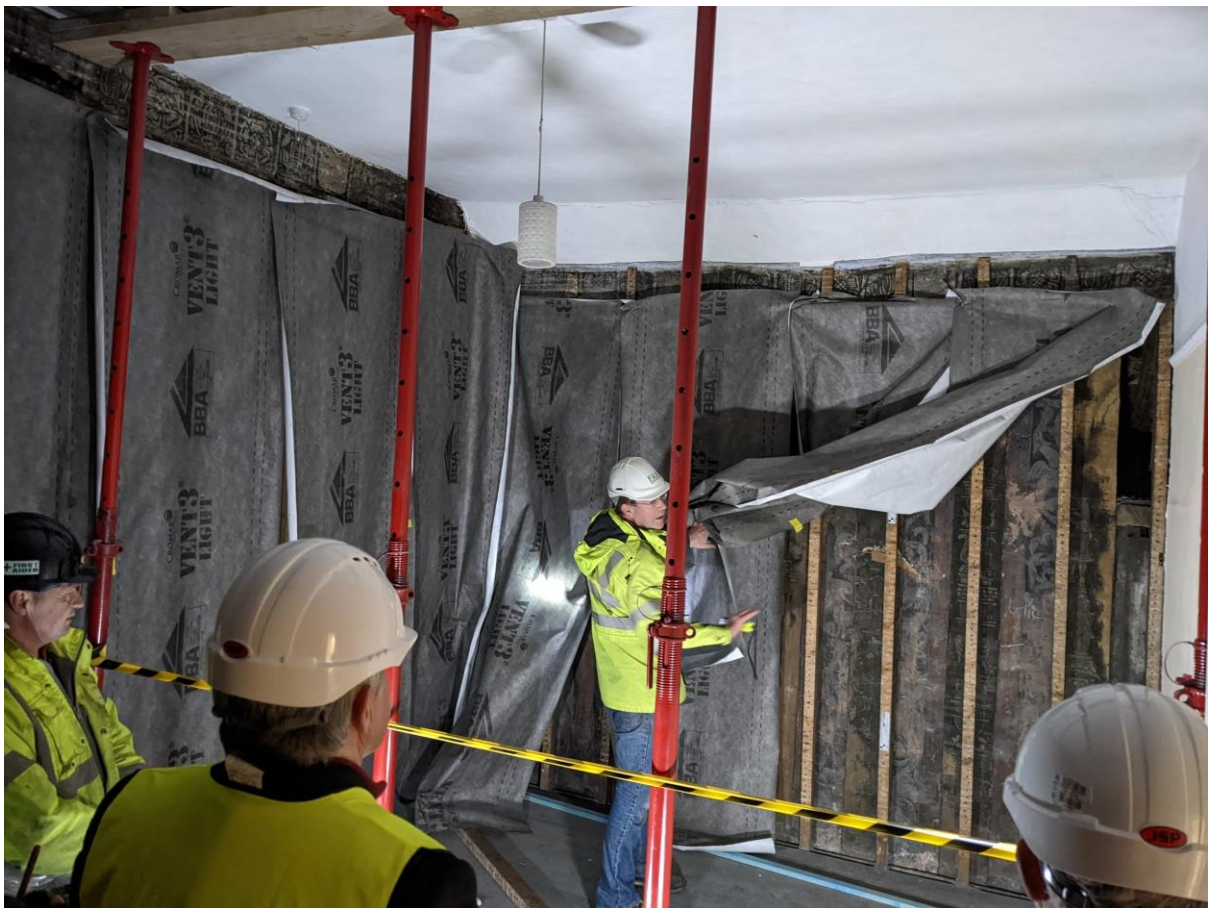
With permission to remove the lath and plaster walls, but the supporting stud work still in place for now, for a couple of years the wall paintings were carefully protected, later with Perspex sheets, revealed only occasionally.

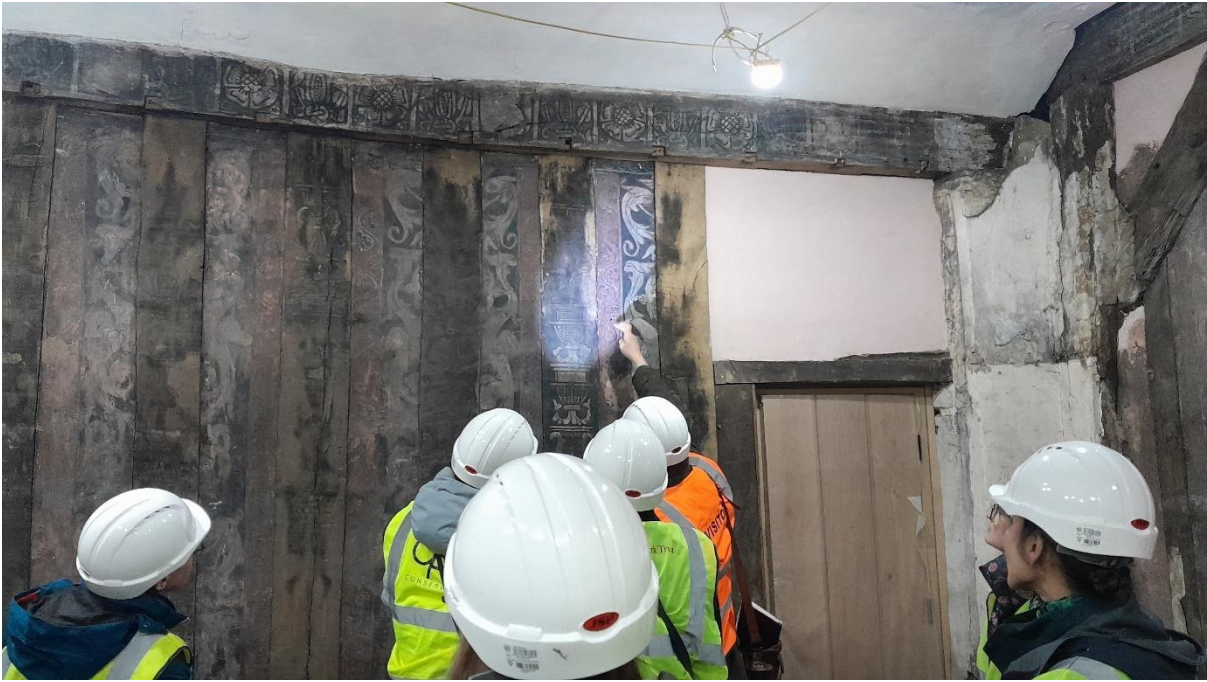
Above: an expert study day was held on the wall paintings in their as-found condition in November 2023, to consult specialists in the field prior to drawing up a Conservation Method Statement. By now, lost areas of plaster had been honestly patched in by Dobsons in like for like gypsum-based mortar under specialist supervision. This earlier, but not primary, doorway into the Solar Block had also been opened up. Behind this door is an awkward but atmospheric space, with a view of the huge 1320s stone chimney that served the early hall block, and also of the usual use of slate slabs instead of lath and plaster for the ground of this painted wall.

The furnishing of the room and conditions for using it are also designed to protect the wall paintings. Daylight levels must be very carefully controlled to prevent damage to the paintings and so a specially-designed louvred oak window shutter was installed to prevent direct sunlight falling on the walls. The finished effect is much like a traditional mullioned window in appearance. Bronze casements sit behind in the room itself. The doorframes are constructed independently of the walls, to prevent vibration. There is minimal furniture and a wooden rail runs along the floor around the outside of the room to prevent furniture being inadvertently pushed against the wall. The spotlights, fixed with minimum disruption to the ceiling as-found, are kept at a light level that illuminates the paintings without causing harm. A fuller account of the Painted Chamber and its treatment can be found in the dedicated album volume kept in the room itself.

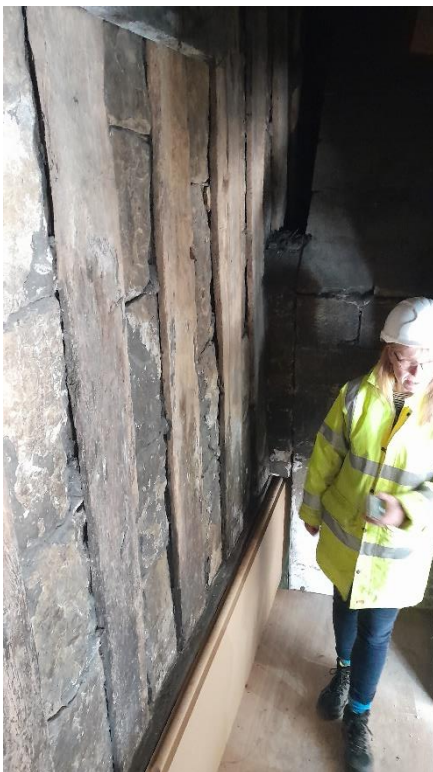
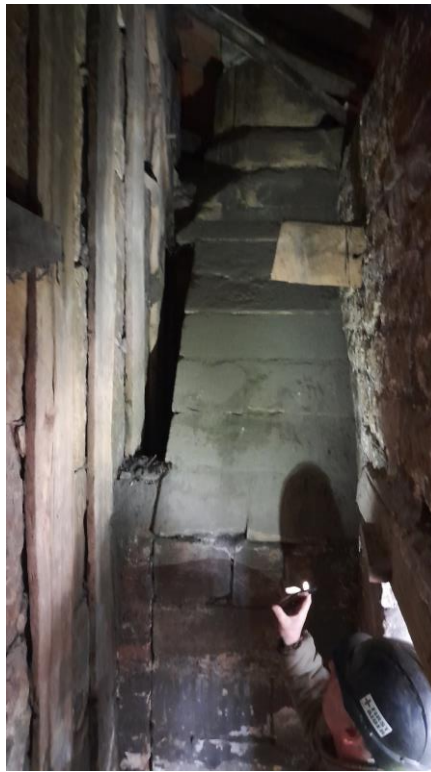
The void between the walls of the Parlour and Solar Blocks at first floor level. Left: slate slabs form the partition wall of the Parlour Block, and the ground for the gypsum plaster on which the paintings are done.

Right: the glimpse of the 1320s chimney.

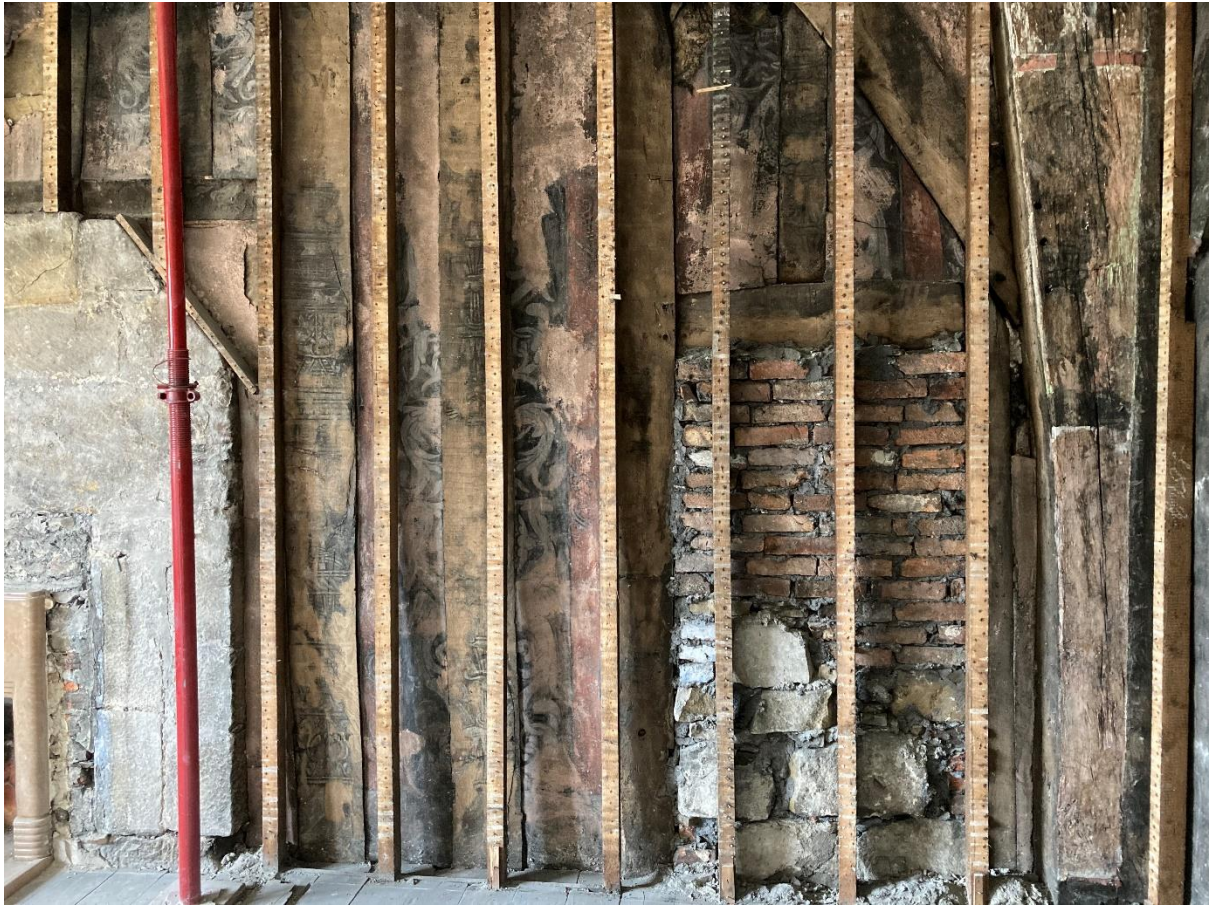
**Top: the northwest wall as first revealed.
Below: conservation work under way by Opus Conservation in summer 2024.**

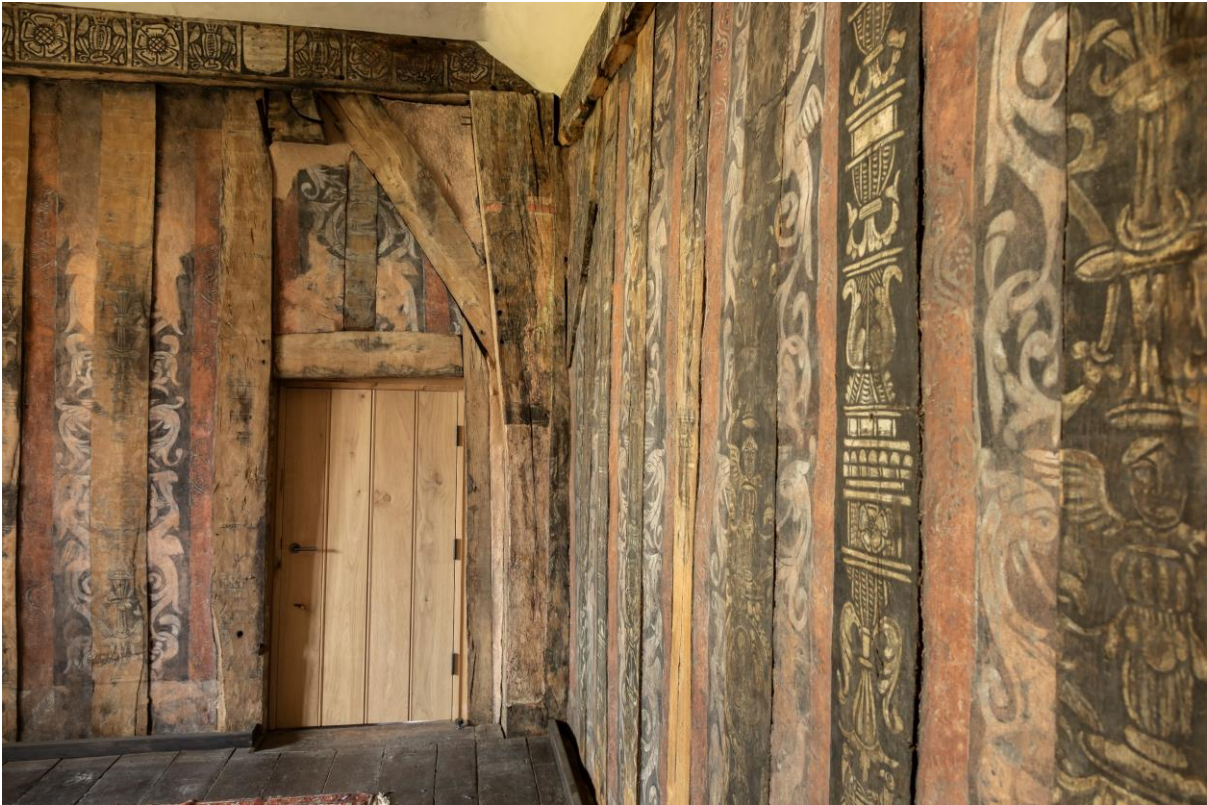
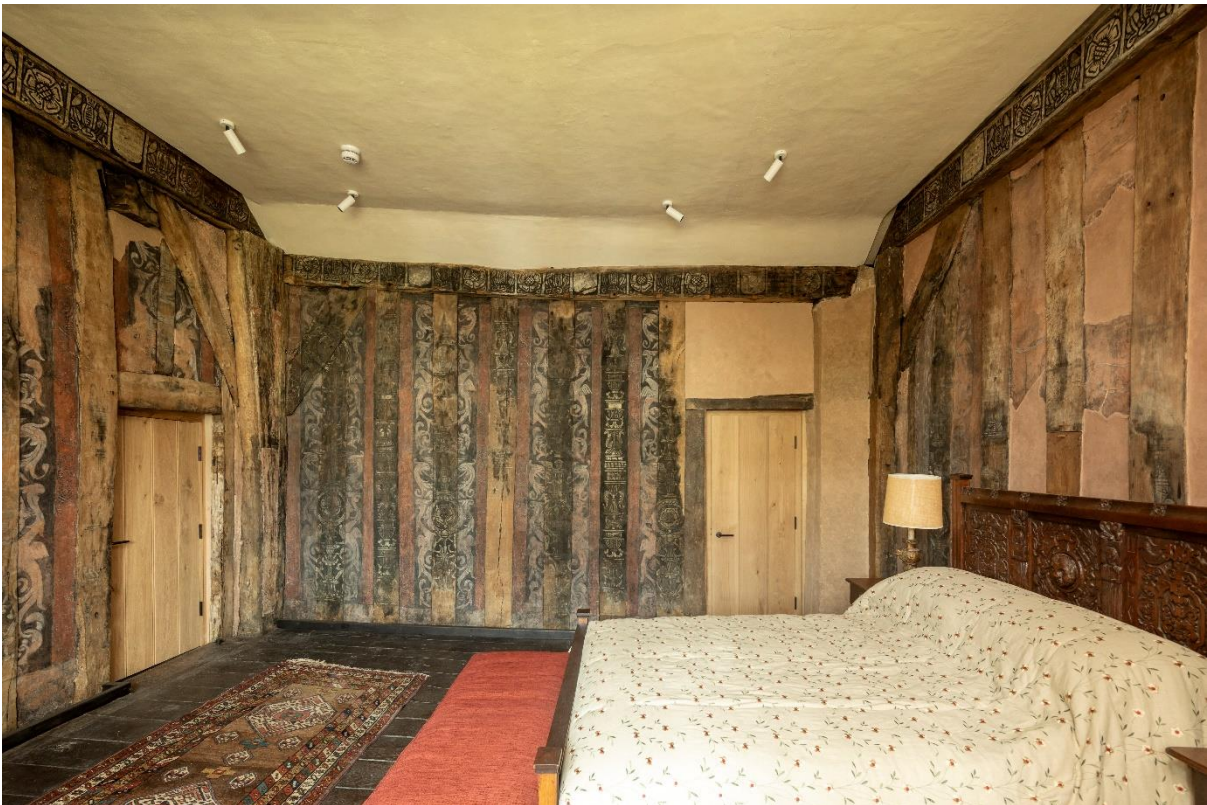
The Painted Chamber after conservation and gentle repair in 2024.
