CALVERLEY OLD HALL

History Album

Volume II:

Repair & Conversion

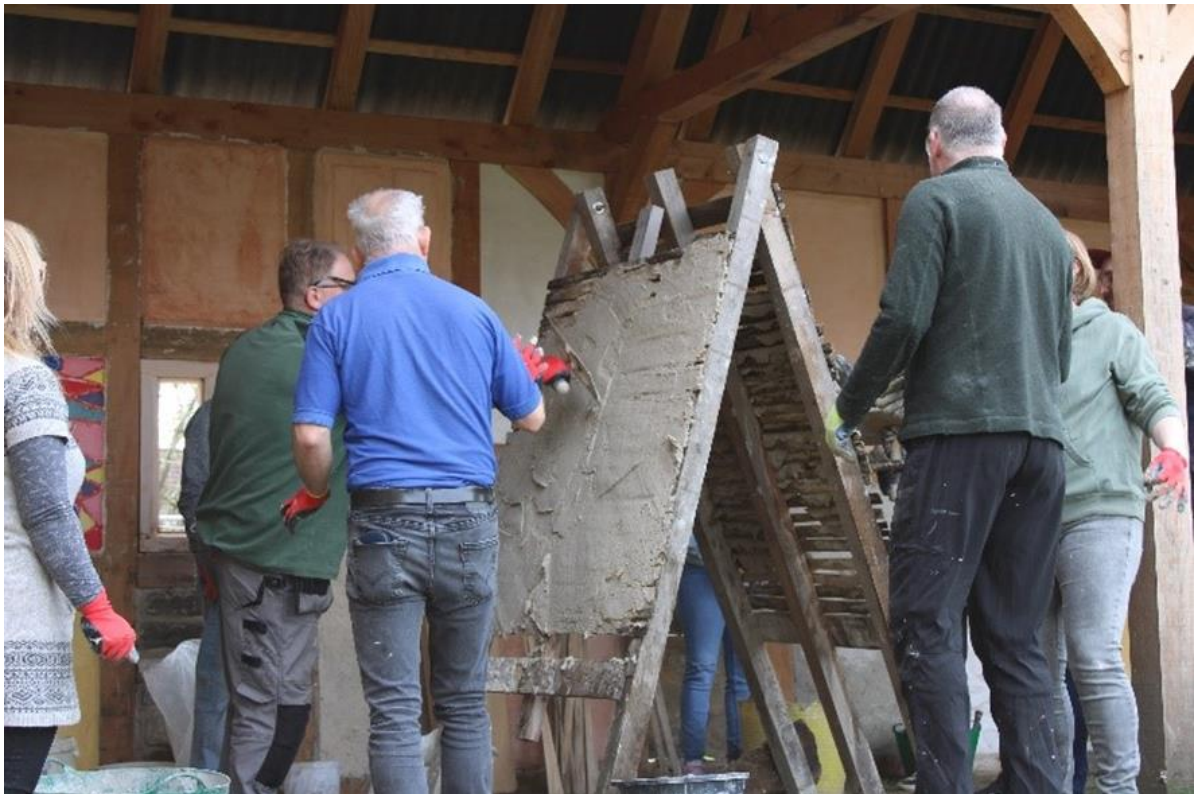
Participants in our 'Care and Repair' days received a mixture of theoretical and practical tuition, here learning to use traditional lime plaster.

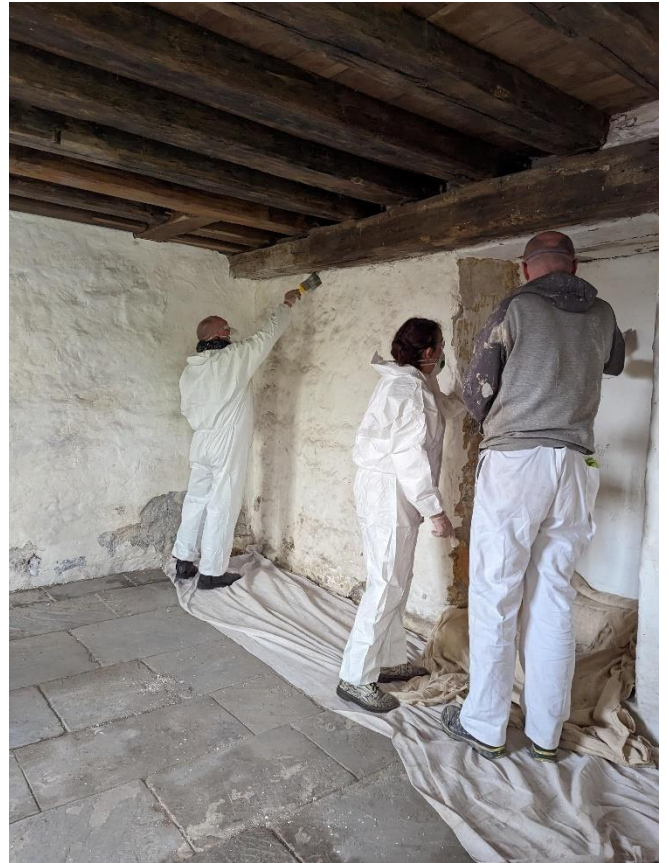
Volunteers learnt about limewash and then used it to redecorate the chapel walls.

Another highlight of the programme included a series of limewashing sessions, for volunteers to learn a little about some of the historic techniques that we use in repair projects like Calverley Old Hall, and to help us to limewash the interior of the late-15th century Chapel. We were delighted to

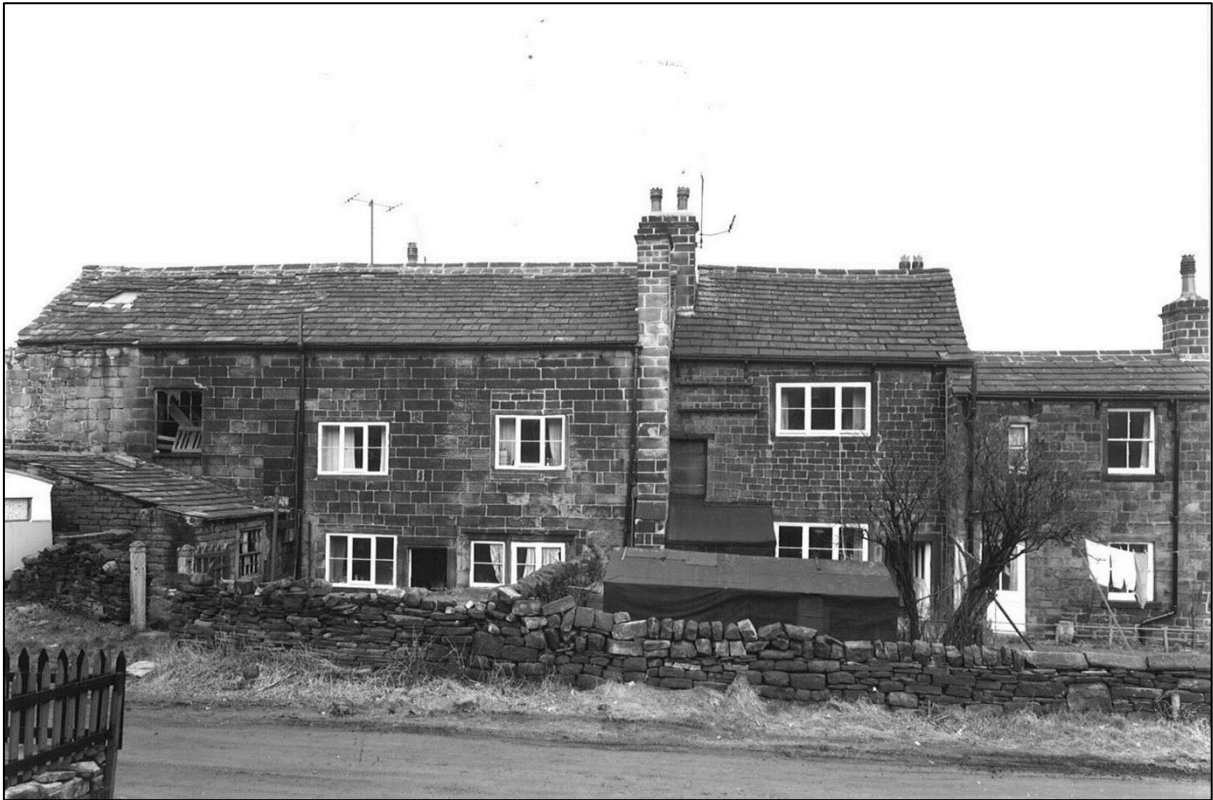
The north wing [Lodging Block] from the west in 1965. The North House was ruinous but not yet burnt out.

The walls at the north end of the north wing, badly damaged by fire, were rebuilt. The roof and gable chimney here were reconstructed, stone tiles being used to match those elsewhere on the building. A section of the west wall, under the long mullioned window, had to be underpinned. A later chimney built at the south west corner was taken down and the roof made up. The walls were repointed where necessary.

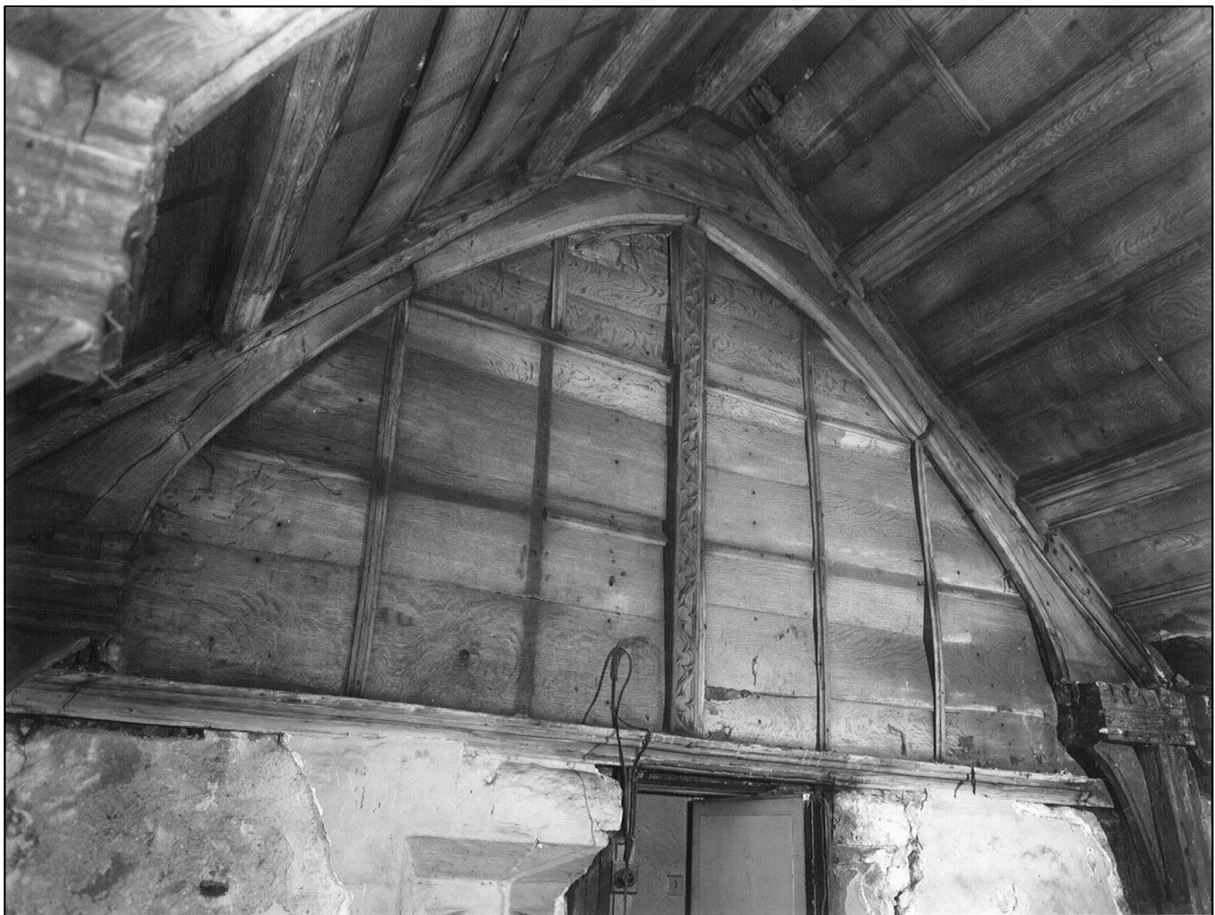
The south end of the chapel in 1977

The south wall was found to be very unstable; it was thought that when the stone slates were put back on, there would be some danger of collapse. Steel ties were inserted between the second and third trusses to avert this possibility.
