# The Landmark Trust

## CALVERLEY OLD HALL

### The Painted Chamber:

Guidance for Use,  
Historical Background  
& Conservation

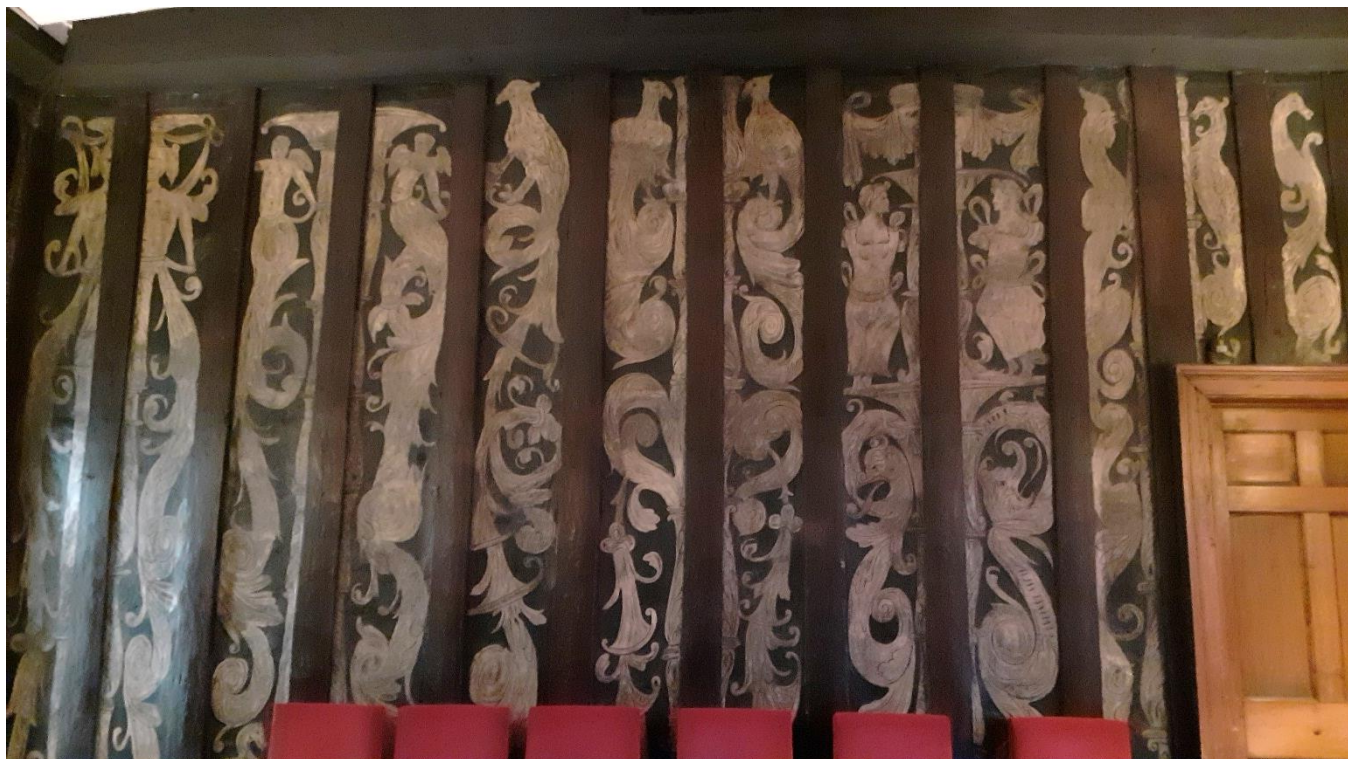
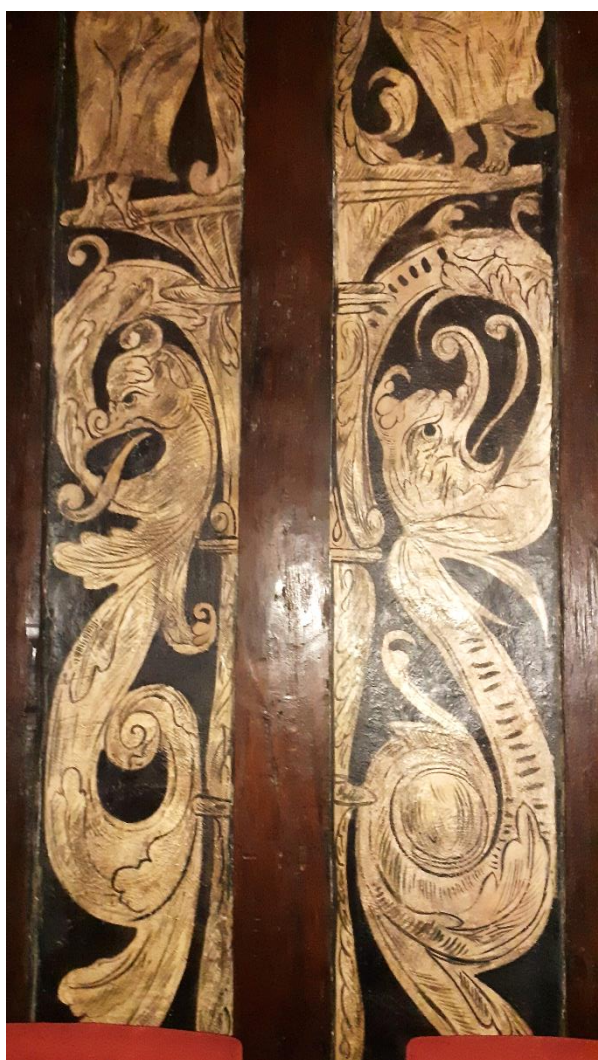
**The grotesque-work grisaille scheme at 20 Dean's Yard, Westminster, is the only survival found to date that shares the tight verticality of the Calverley scheme, but is arguably less accomplished in laying out.**

**These paintings are believed to date to from the 1550s. They were heavily restored in the 1880s and later, when misunderstandings of the original appearance, nature and date of the paintings led to some falsification in their restoration.**

The only known Antique scheme with a verticality that approaches that at Calverley is a room on the first floor (now called the Committee Room) at 20, Dean's Yard in Westminster, which was once the house of the Cellarer to Westminster Abbey. After the Dissolution of the Monasteries, the house passed to Thomas Wentworth, 1<sup>st</sup> Baron Wentworth, and in 1551 to his son. The paintings are thought to relate to the 2<sup>nd</sup> Lord Wentworth's time. While still an extremely rare survival (thought to be the only painted scheme to survive in London), these paintings were unfortunately heavily restored and varnished by the Victorians. Despite their vertical arrangement, the grotesque figures already show the freer hand typical of the Elizabethan period and serve only to highlight further the skill of the unknown artisan who created the design at Calverley, for a member of the local gentry rather than a leading aristocrat at the Court.

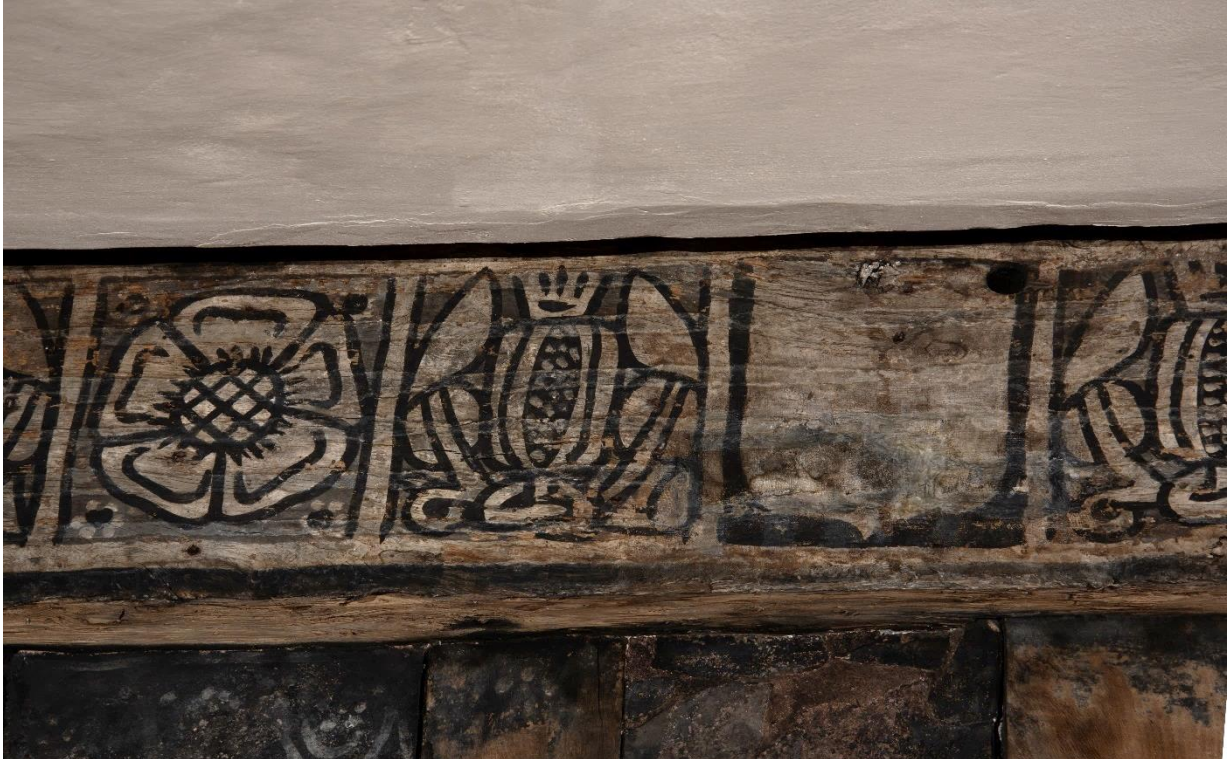
**Detail of the grisaille frieze that runs round the wall plate at Calverley, of Tudor roses and pomegranates and blank shields. It was perhaps added in the primary phase of the Parlour Block, before the main painted scheme on the walls.**

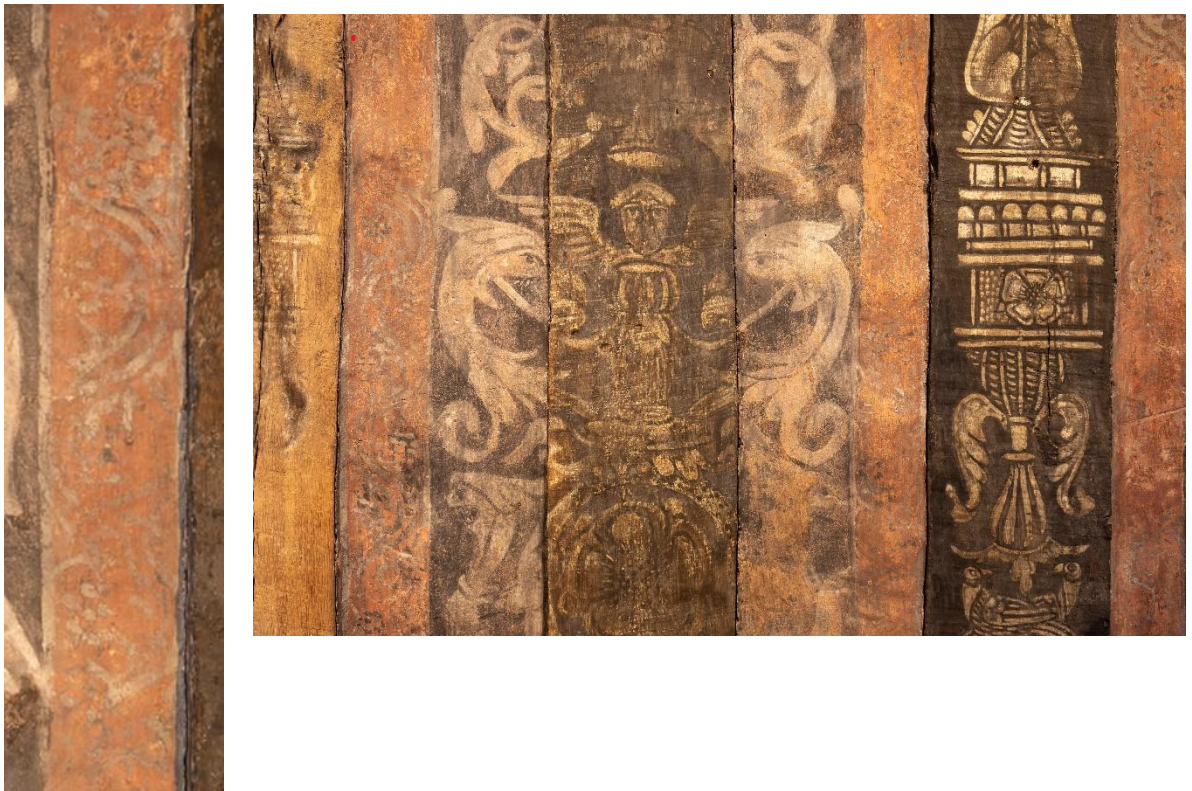
**The repeat pattern of the Calverley wall paintings: red guilloche bands separating wide and narrower grisaille panels.**

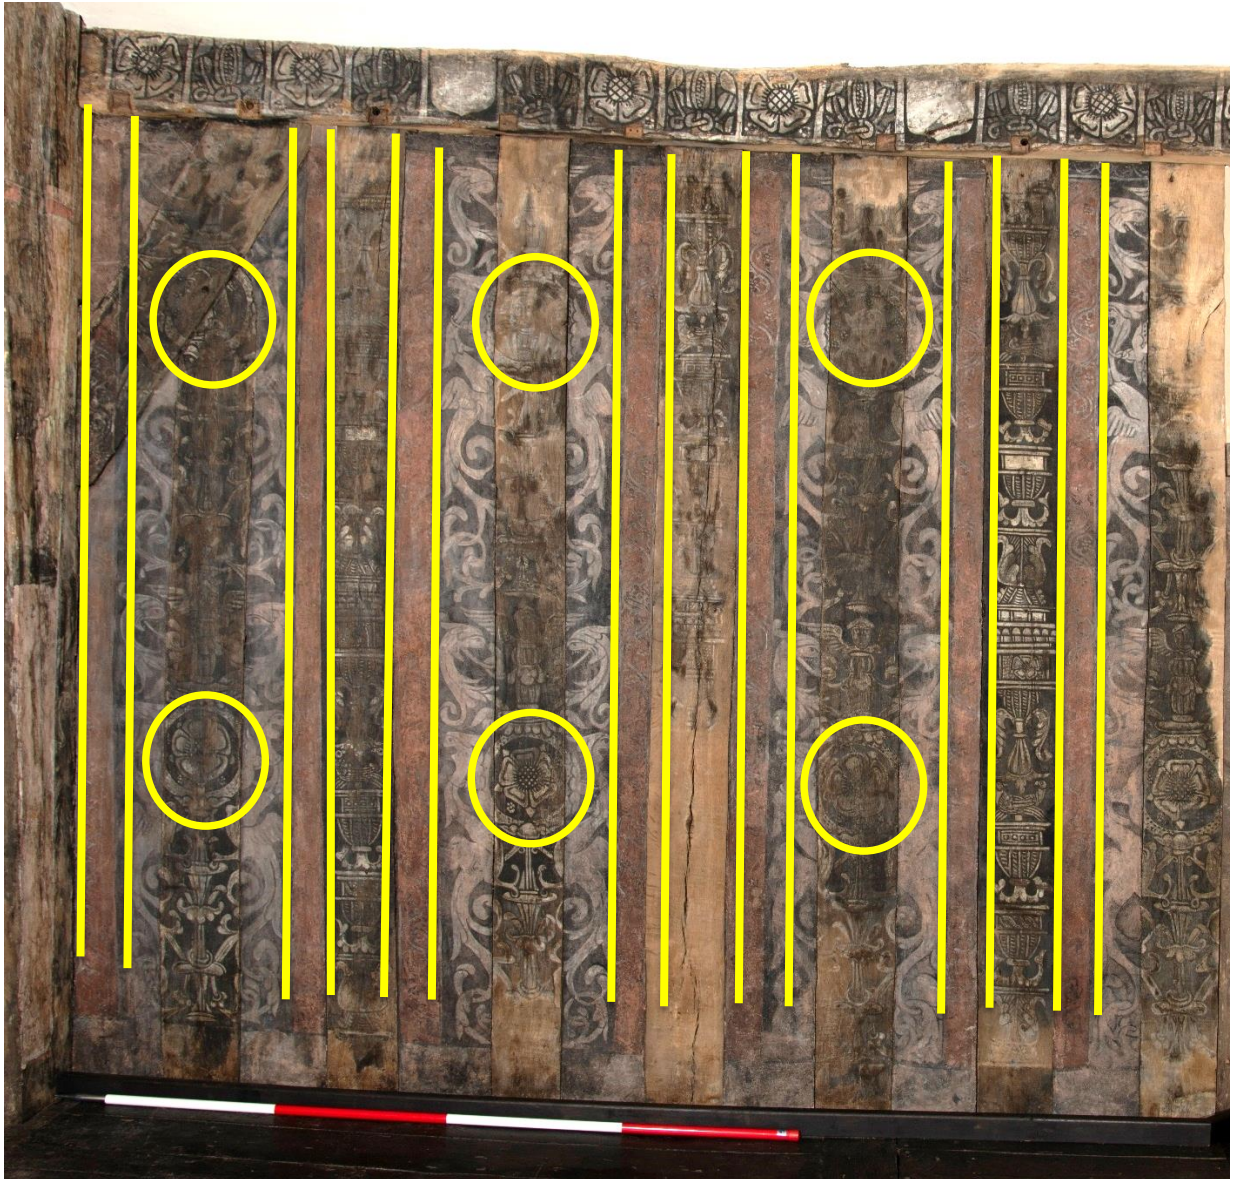
**The repeat pattern of the Calverley scheme. Alternating panels of wide and narrow grisaille work are separated by narrow bands of red 'fretwork'. On the wider panels are two rows of roundels, the top row containing human or animal heads, the lower one Tudor roses.**

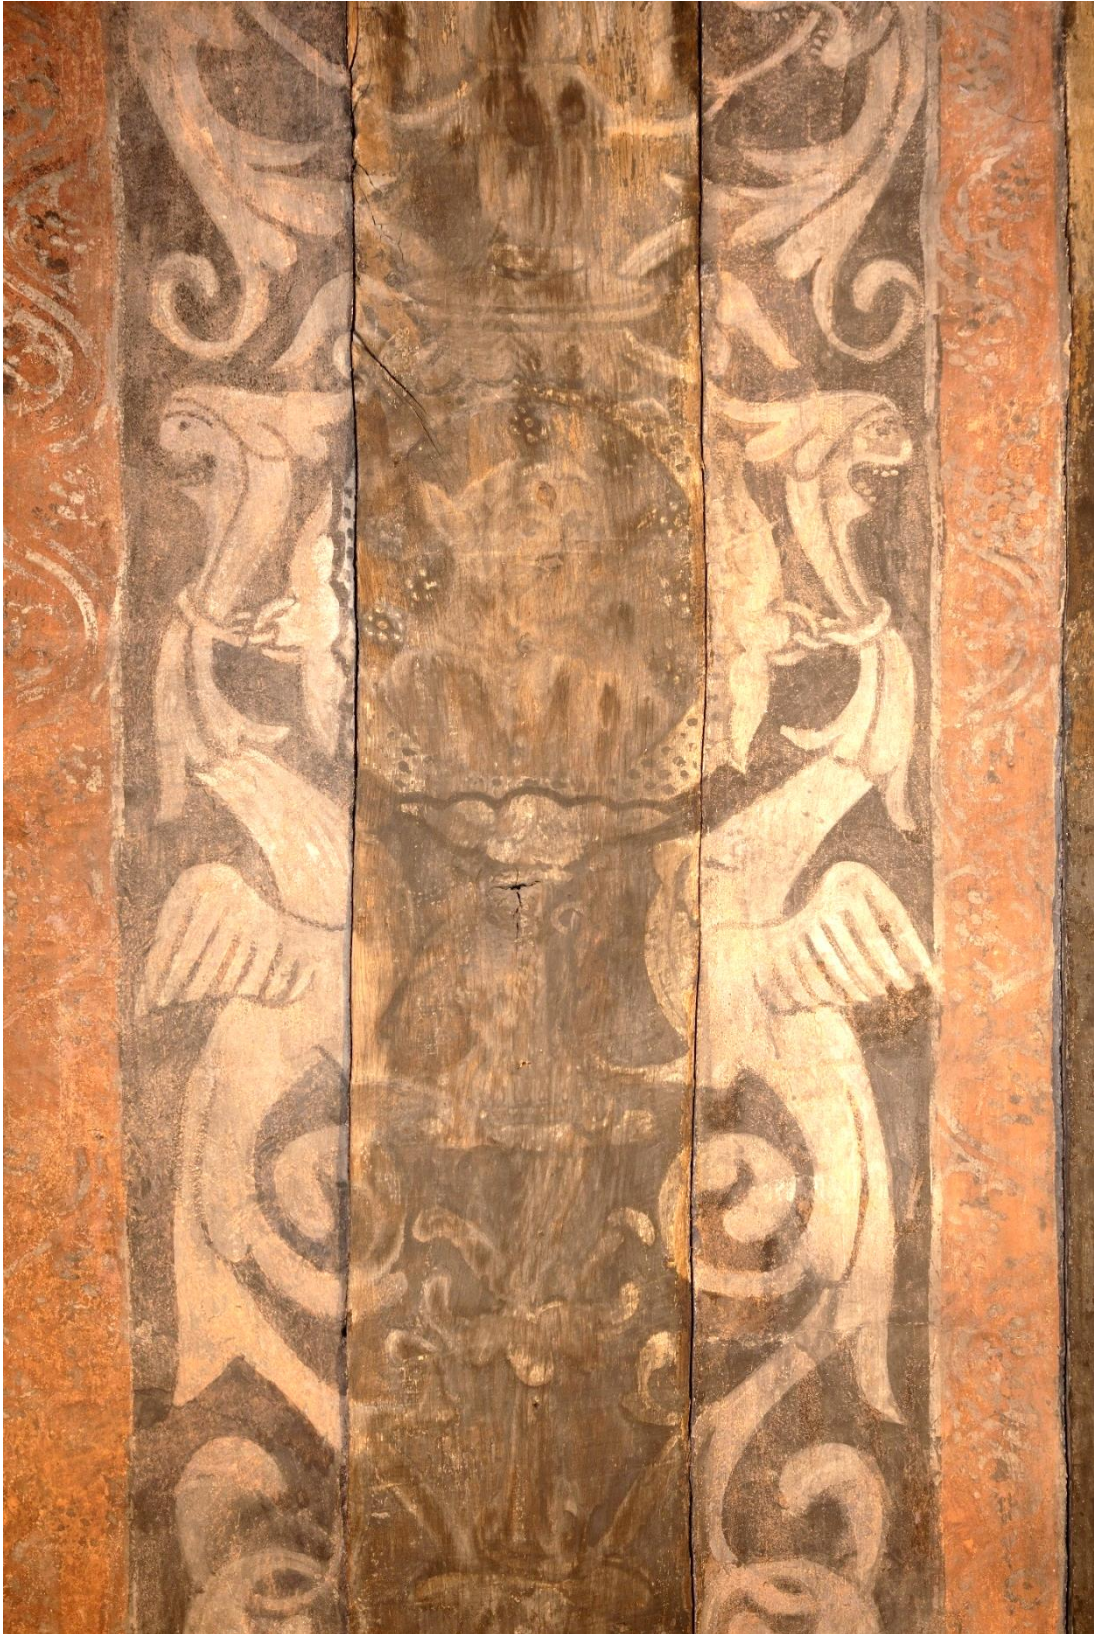
**The central panel on the northeast wall, with 'jester' roundel – or is the figure crowned, or wearing a knight's mail coif?**

Next, in the central roundel, is a mysterious figure who appears to be wearing a horned cap. This could be a jester, or a folk figure, perhaps a *memento mori* calling attention to life's absurdity. Or it could be a bearded man in a chain mail cowl topped by a crown. If, as seems possible, a table for business papers was centred in front of the window, this figure would have been in immediate gaze.

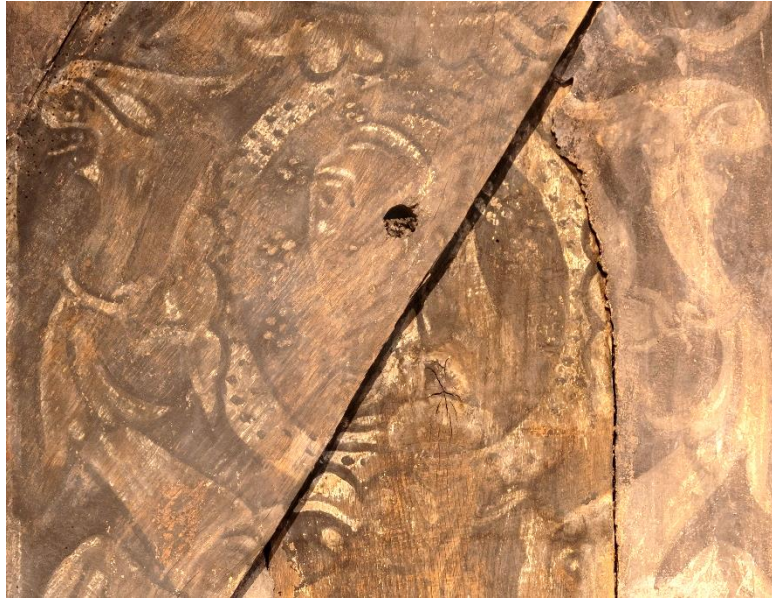
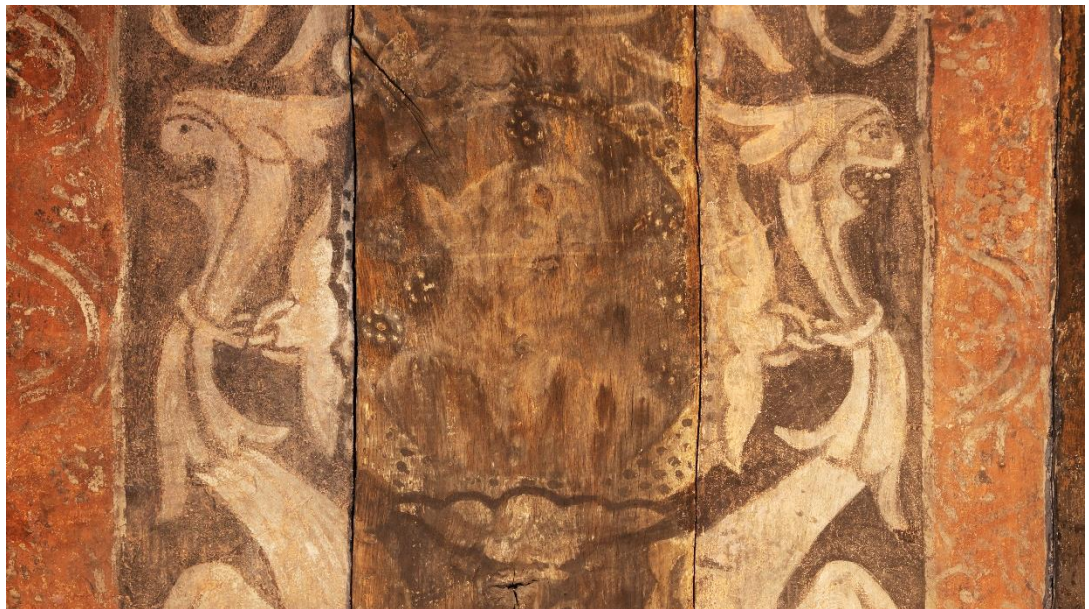
**The Calverley portrait roundels, from the northeast wall. The top two are plausibly portraits of Sir William Calverley and one of his two wives.**

To these portrait roundels, elongated, toothed birds are chained round their necks, perhaps a representation of harpies, the half-human, half-bird creatures in ancient mythology. They face away from the roundel. Harpies were believed to be a personification of storm winds, or sometimes death and the underworld, and feature in Homer's poems. Here, they are chained, and so tamed. Perhaps these chained 'harpies' represented the taming of the human temperament to Reason. Photographed in UV light, the faces of the 'harpies' are revealed as carefully shaded and include round cheek spots. Above them are similar heads, but with long curling tongues, this time facing each other.

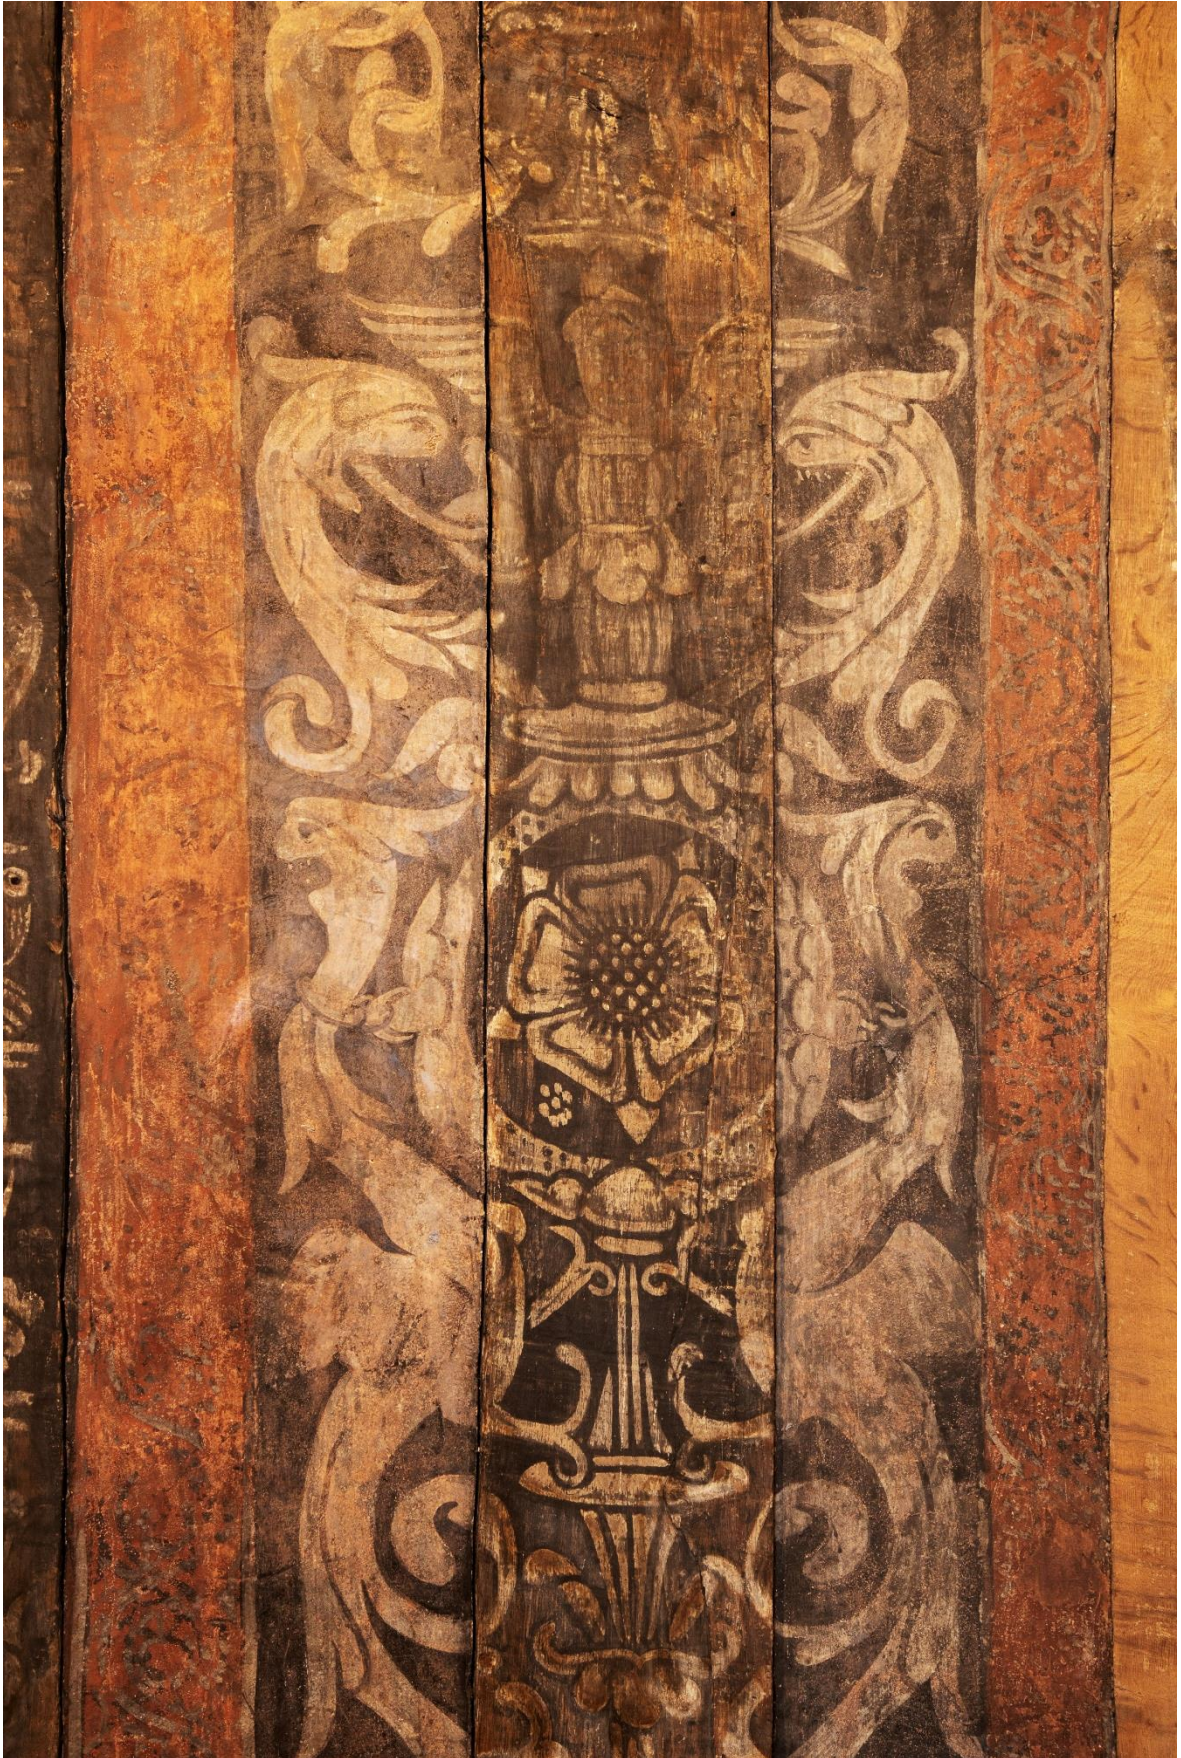
**The winged figure and Tudor rose roundels.**

Below this grouping of roundel and 'harpies' is another repeating figure, this time a composite of the human and architectural: a clownish face wearing a pointed helmet or hat flanked by wings, with a carved baluster for a body. Above his head hovers a kind of cupola or bell. On either side of this figure are another pair of bird's heads, linked to the baluster by their curling tongues. It is possible that this figure is a much-transmuted representation of Mercury, god of messengers, who wore a winged helmet. The baluster-torsos stand on a third sequence of roundels at low level, this time holding a Tudor rose. The sequence as a whole is both carefully planned horizontally for the available space, and vertically integrated as an entire run. The panels run straight into the floor, with no suggestion of a skirting band.

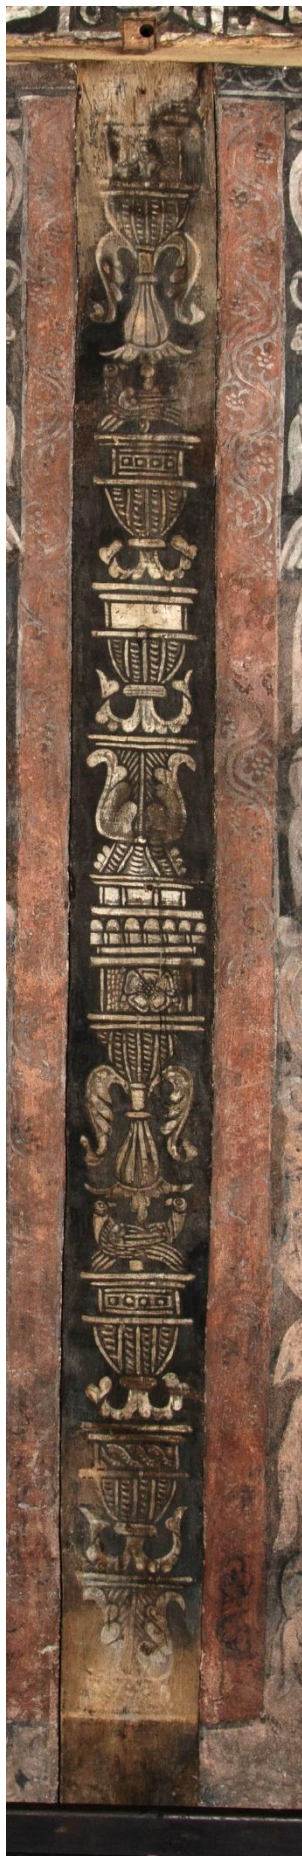
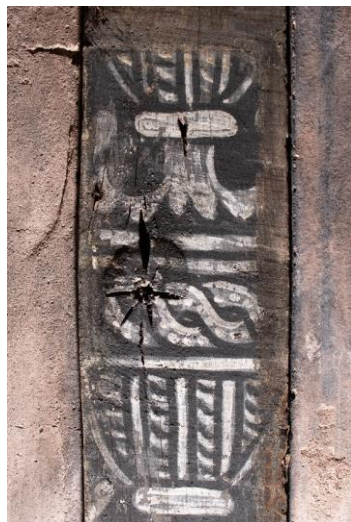
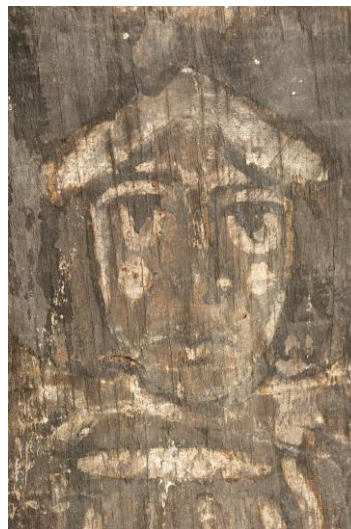
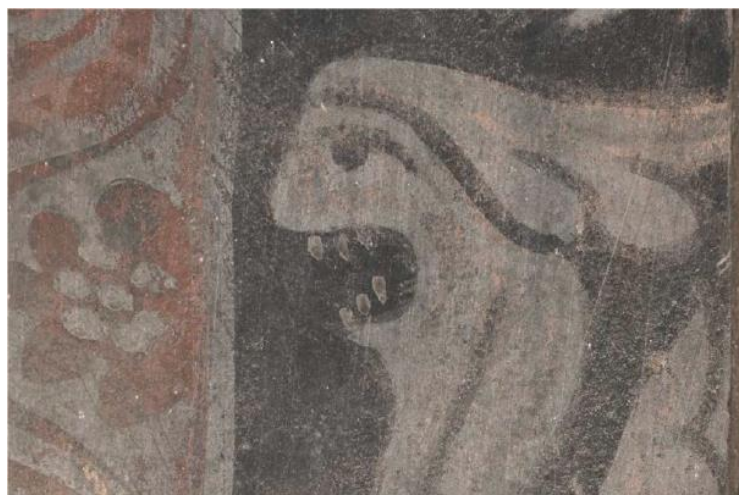
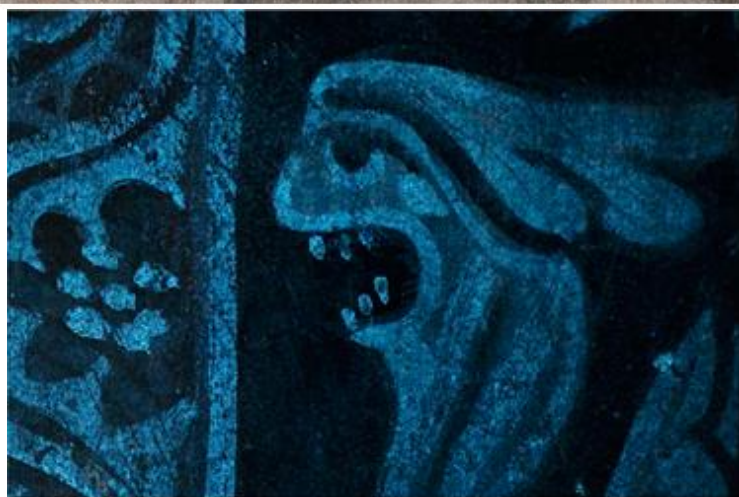
**Left: the full run of the narrower, 'architectural' grisaille panel. Note the pair of doves.**

**Right: details after cleaning, showing the subtlety of the shading and highlighting, including under UV light (lower harpy).**

The narrower grisaille panels are more soberly architectural in subject, a vertical stack of fantasy urns, vases or balusters elaborated with foliage. Around waist height and level with the Tudor rose roundels, are pairs of doves sitting on an urn.

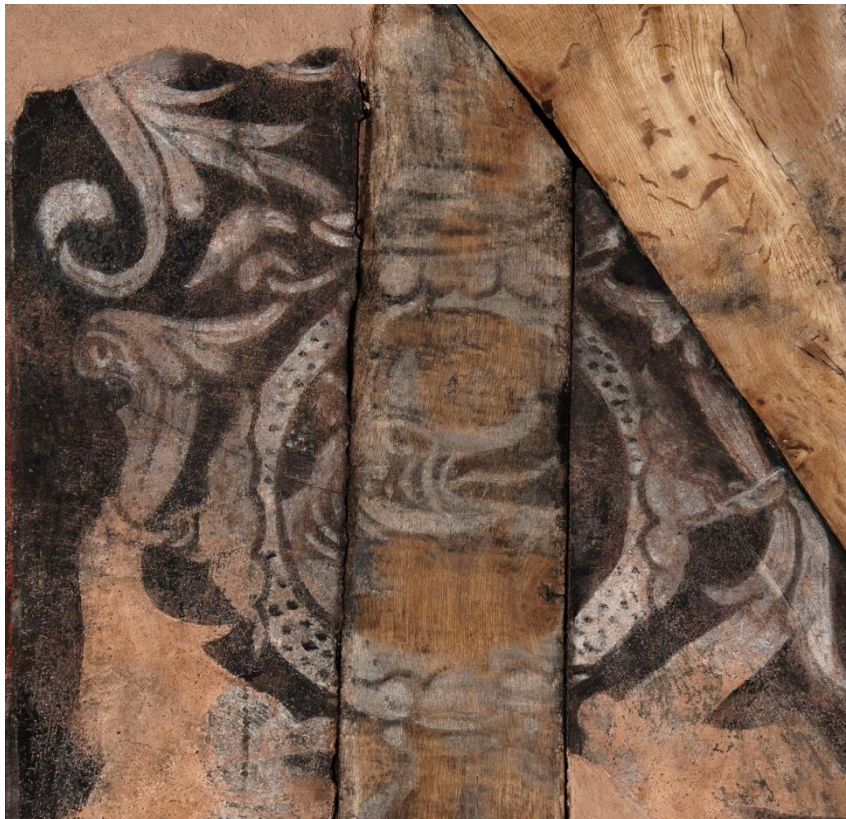
**The dog roundel above the primary doorway.**

Above the door that led (then) into the 1320s solar range and today into the late-16<sup>th</sup> century Lodging Block, there is a formal group all its own. This roundel holds an open-mouthed dog (?) flanked by the usual 'harpies'. The roundel is possibly topped with a knight's helmet. This was originally the only entrance into the room and probably formed the starting point for the setting out of the room.

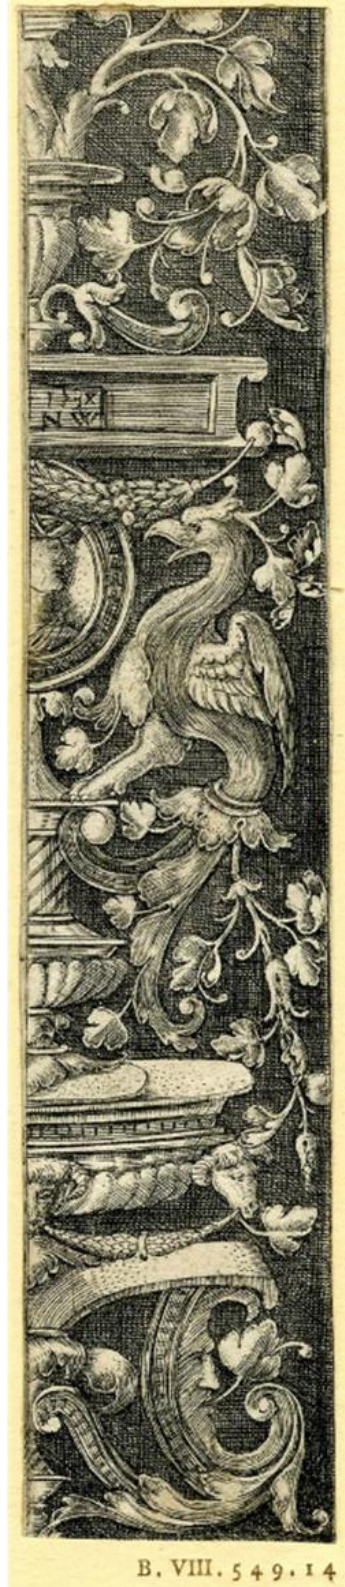
**A possible source for the Calverley paintings:  
a print by Nikolaus Wilborn, a German  
engraver, c.1534. British Museum.**

The obvious question now arises whether any likely sources can be identified for the Calverley paintings. This was one of the topics under discussion at the expert study day we convened on the paintings in November 2023, when Anthony Wells-Cole, the acknowledged expert on printed sources of the period, was among the participants. While grotesque was, almost by definition, an exercise in the artist's imagination, Anthony's expertise yielded one print in particular as a plausible influence, published in 1534 by the German engraver, Nikolaus Wilborn (overleaf) in the British Museum. Here, a winged, beaked creature with trailing tail of foliage rather than feathers flanks a roundel with a human portrait. The Calverley artist has added their own interpretation, in chained collars and 'ermine' rather than laurel wreaths to form the roundels, but the similarity of the composition is clear.

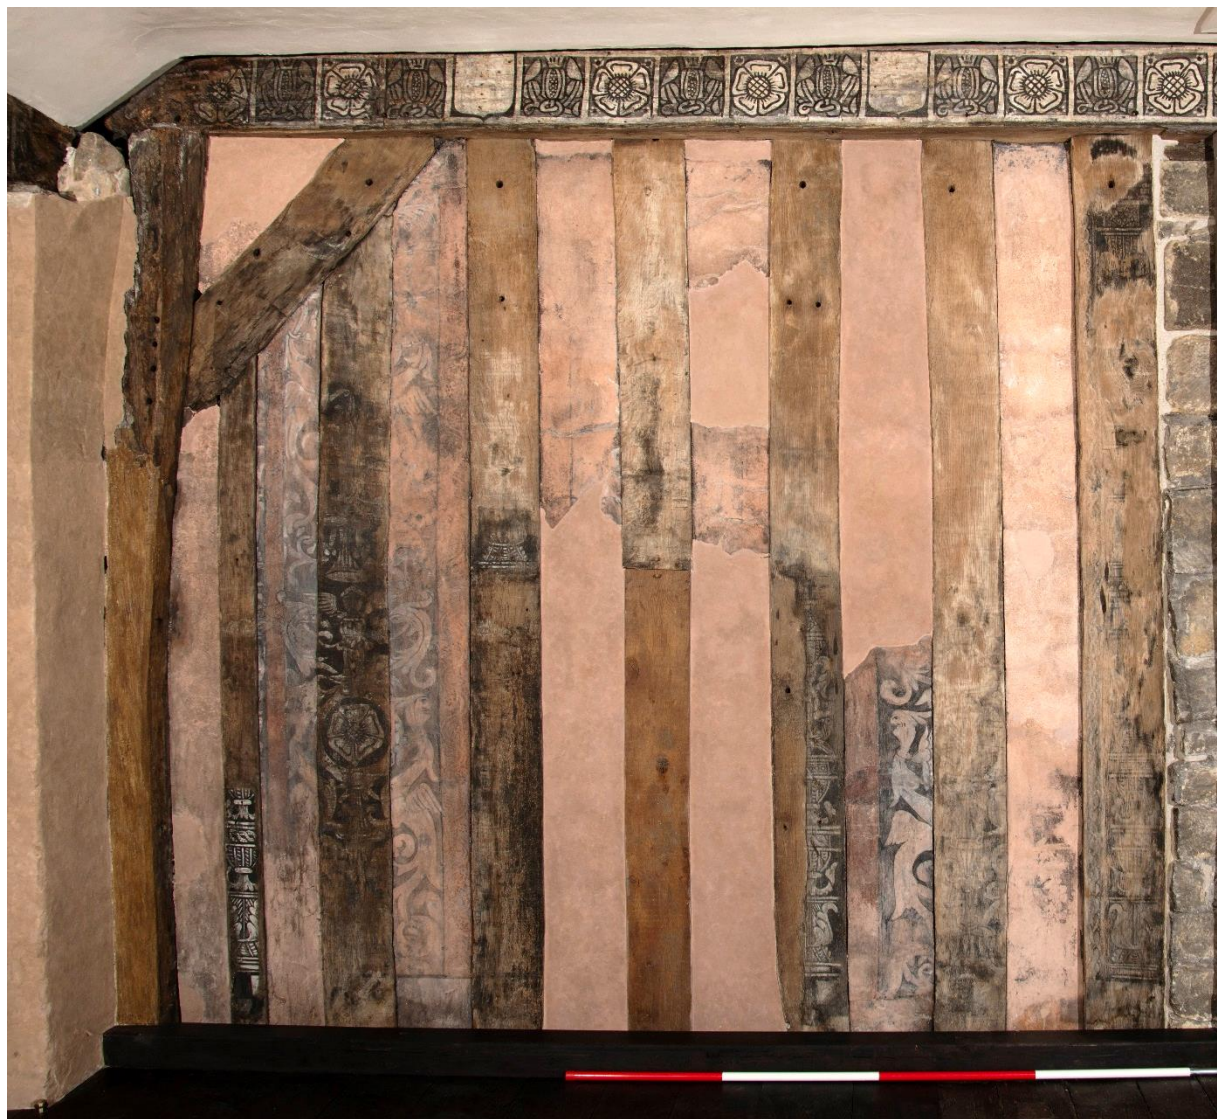
**The southeast wall (detail). To note:**

- Dowel holes along the top, possibly once supporting a bed canopy.
- The cramped setting out in the left hand corner.
- An exceptionally well-preserved strip , bottom left (untreated).
- The hard edge to the painted decoration on the fifth stud from left, indicating a lost door architrave. Early plaster was missing here, and the fourth stud was partially replaced during the repair works, being found to be badly split.

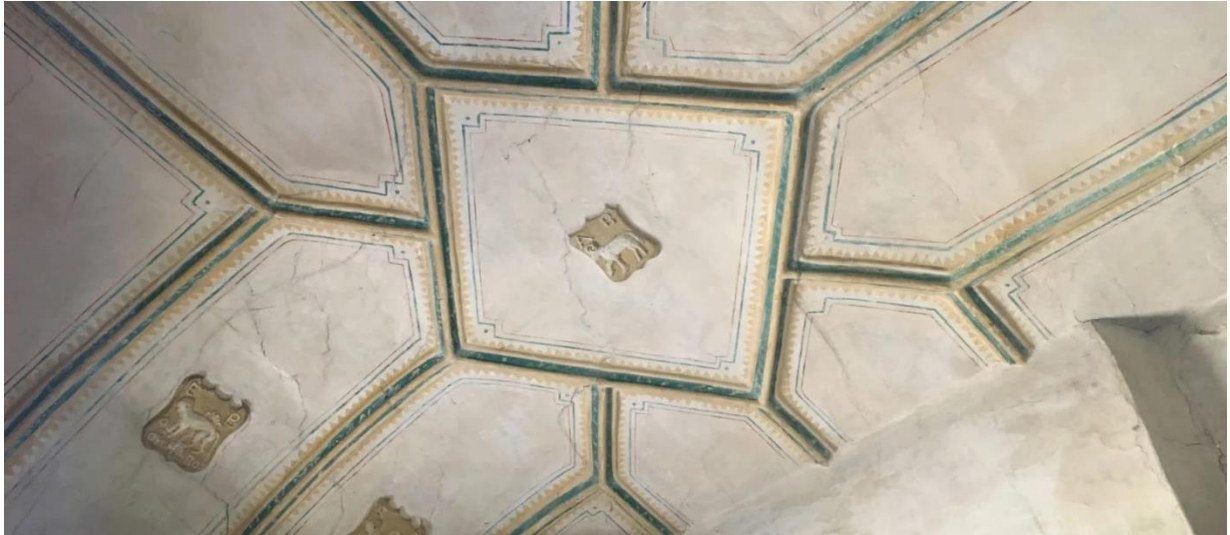
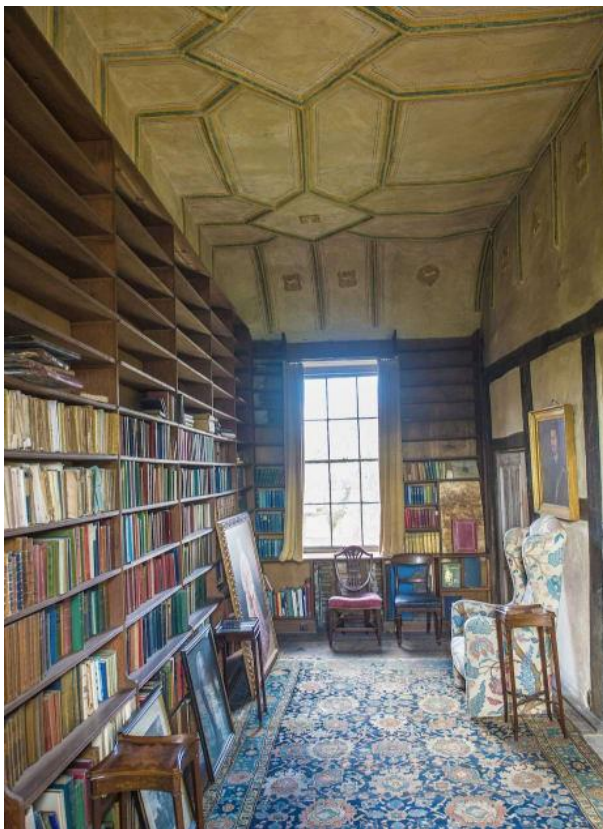
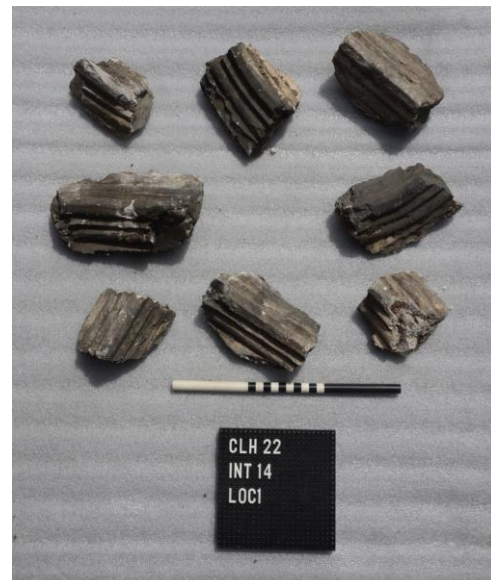
**The Geraldine ceiling at West Horsley in Sussex, 1547/8. The Calverley Painted Chamber may have had a ceiling of similar form, judging by the fragments of plaster found around the wider site (above).**

Many fragments of ribbed plaster were found ex-situ on site at Calverley. While it is impossible to say with certainty whether these fragments came from the Painted Chamber, no other room retained evidence for a plaster ceiling being inserted and subsequently removed.

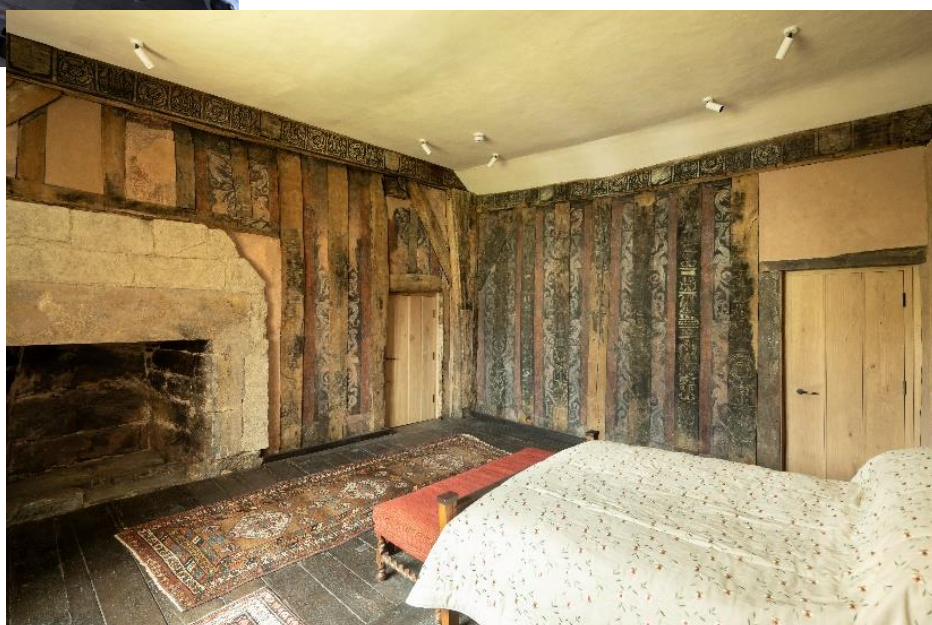
**The Painted Chamber in 2017, with the small 20<sup>th</sup>-century fireplace, and the same view today.**

Like the wall paintings, the massive stone fireplace was also found behind the later lath and plaster and the tiny mid-20<sup>th</sup> century tiled fireplace that had eventually superseded it. The timber framing (and therefore decorative scheme) sails over masonry blocks set above this fireplace itself. It is possible that the stone hearth and masonry once held an elaborate plasterwork or carved wooden chimney piece and overmantel. If so, it was most likely in the grotesque style too.

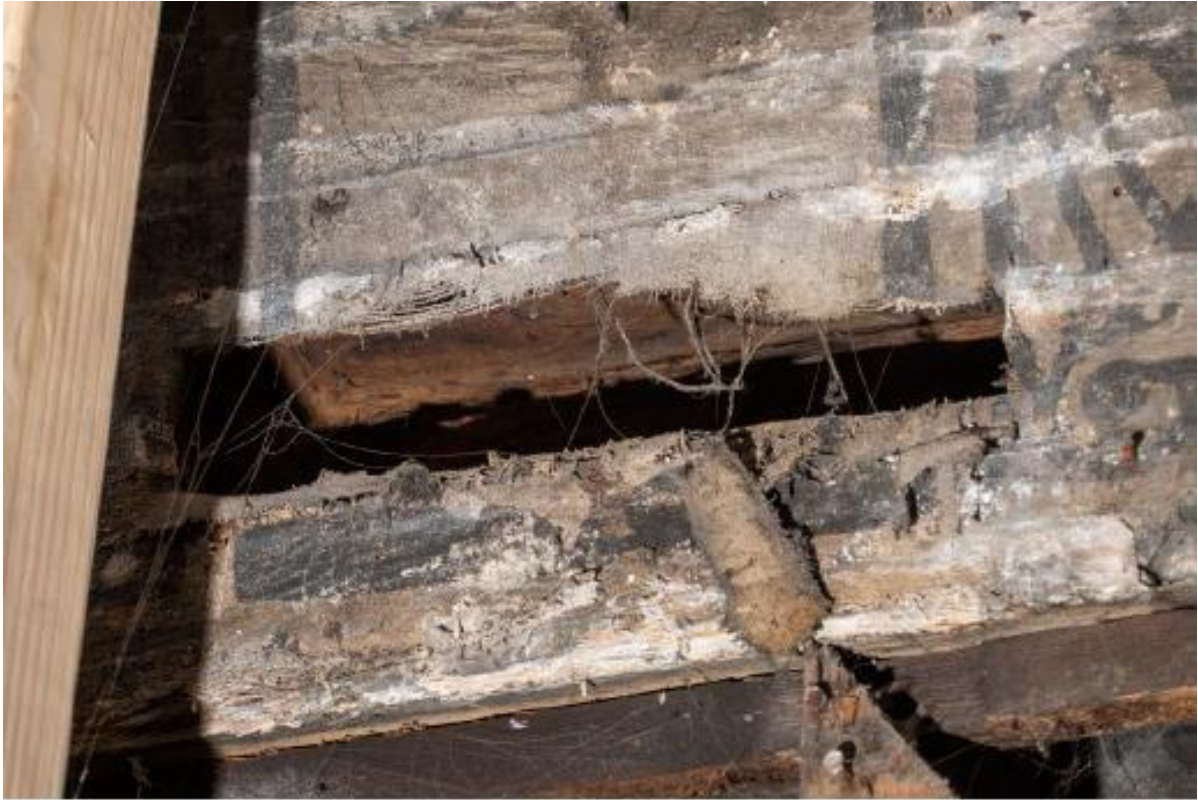
**Remnants of a canvas patch used to disguise a mortice hole in the wall plate, tacked in place by the Calverley artist.**

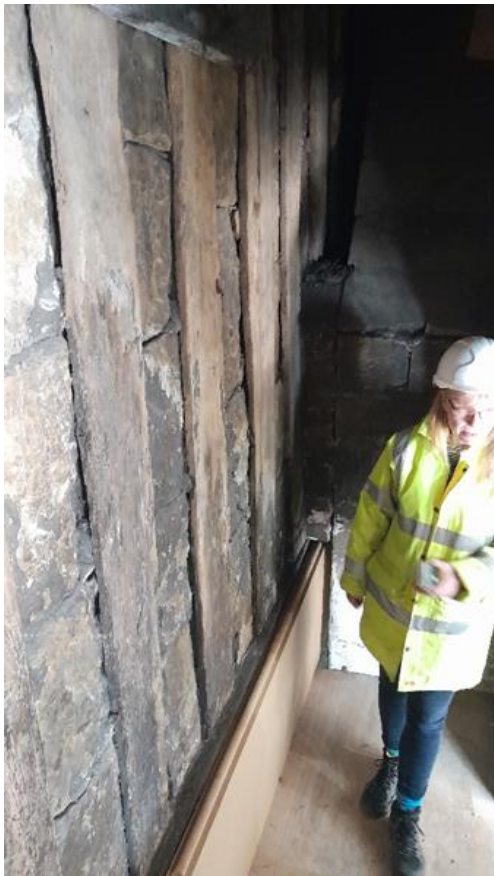
**Sandstone panels have been slotted into grooves in the studs. With a thin skim of gypsum plaster, this forms the ground for wall paintings.**

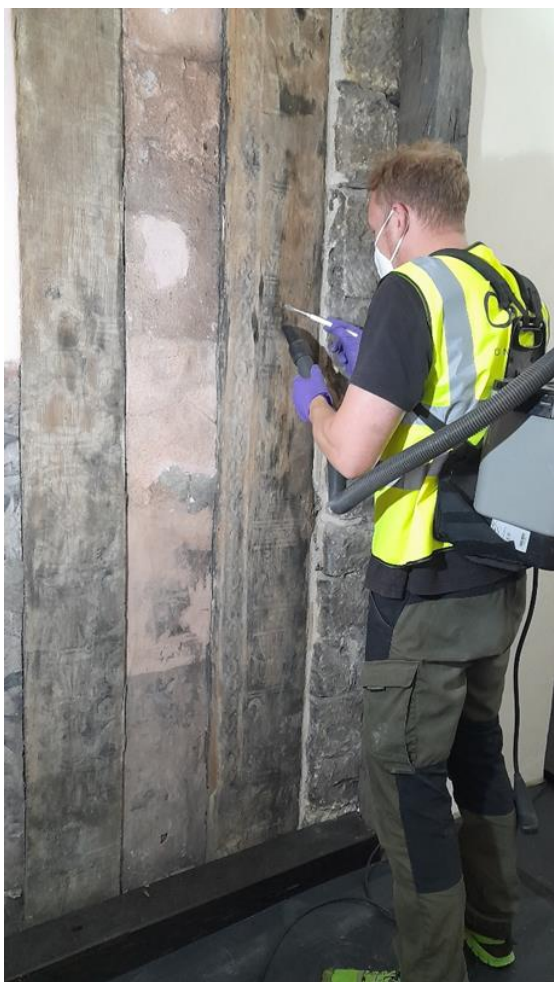
**A week or so was spent very gently cleaning dust from the surfaces with special vacuum cleaners. Even this had a noticeable effect.**

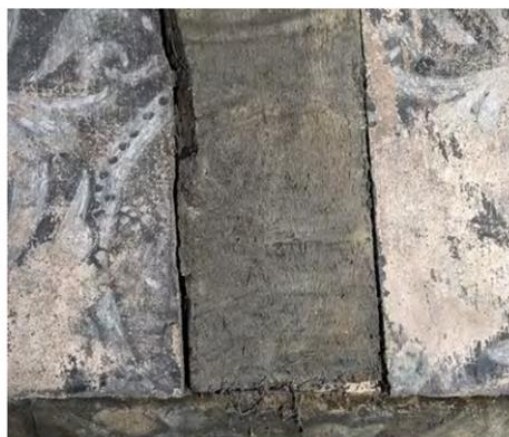
*Fig.17 Thick dust on the wooden stud.*

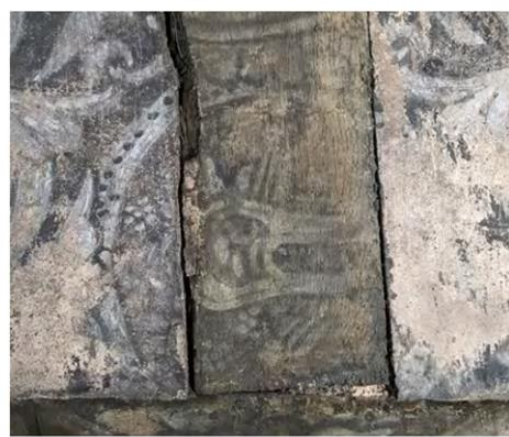
*Fig.18 Animal in roundel legible after dust brushed off*

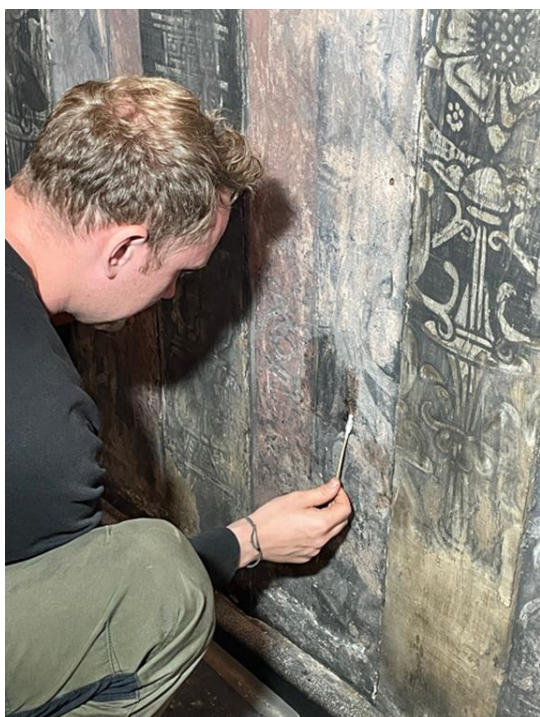
**Next, cotton buds dipped in a cleaning agent were gently rolled over the surfaces to remove surface dirt (as the 16<sup>th</sup>-century paints used were water-soluble, water was not an appropriate cleaner here).**

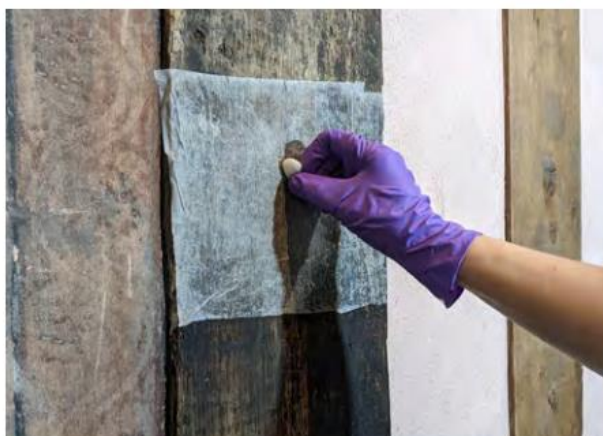
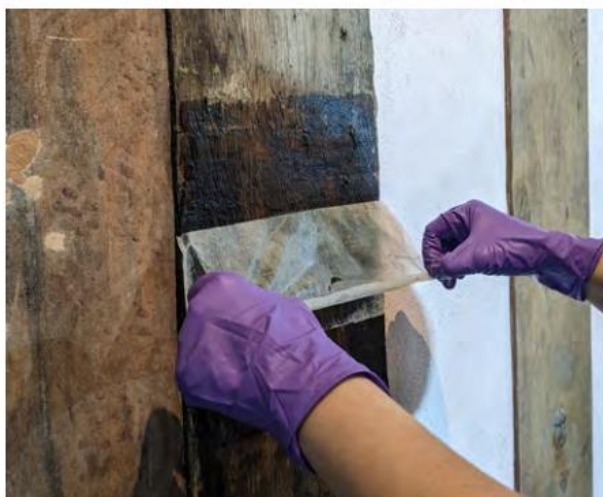
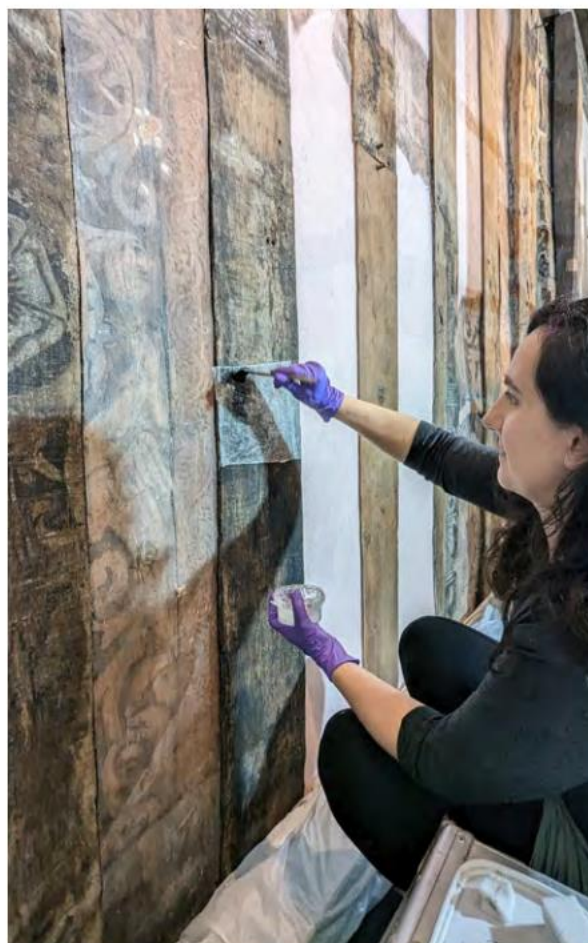
**Third, a consolidant was applied through small poultices of special conservation tissue. This soaked through into the painted surface and both consolidated the paint surface as well as reabsorbing more dirt back into the tissue, which was then carefully peeled away. In places, the overall cleaning process had the effect of revealing areas of the gypsum substrate where the pigment had dissipated and that the dirt of centuries had masked. These bright areas of plaster now tended to distract from the legibility of the painted scheme as a whole.**

**After further consultation with the Landmark team on the philosophy of repair, the decision was taken to tone in the paintings very subtly on these small areas where the loss of pigment was distracting the eye. An example of a 'before and after' of this treatment is shown below. Record photos were taken at all stages and have been deposited with the West Yorkshire Archaeology Advisory Service (WYAAS).**
