LLWYN CELYN

History Album

Volume II: The Buildings,
Restoration & Engagement

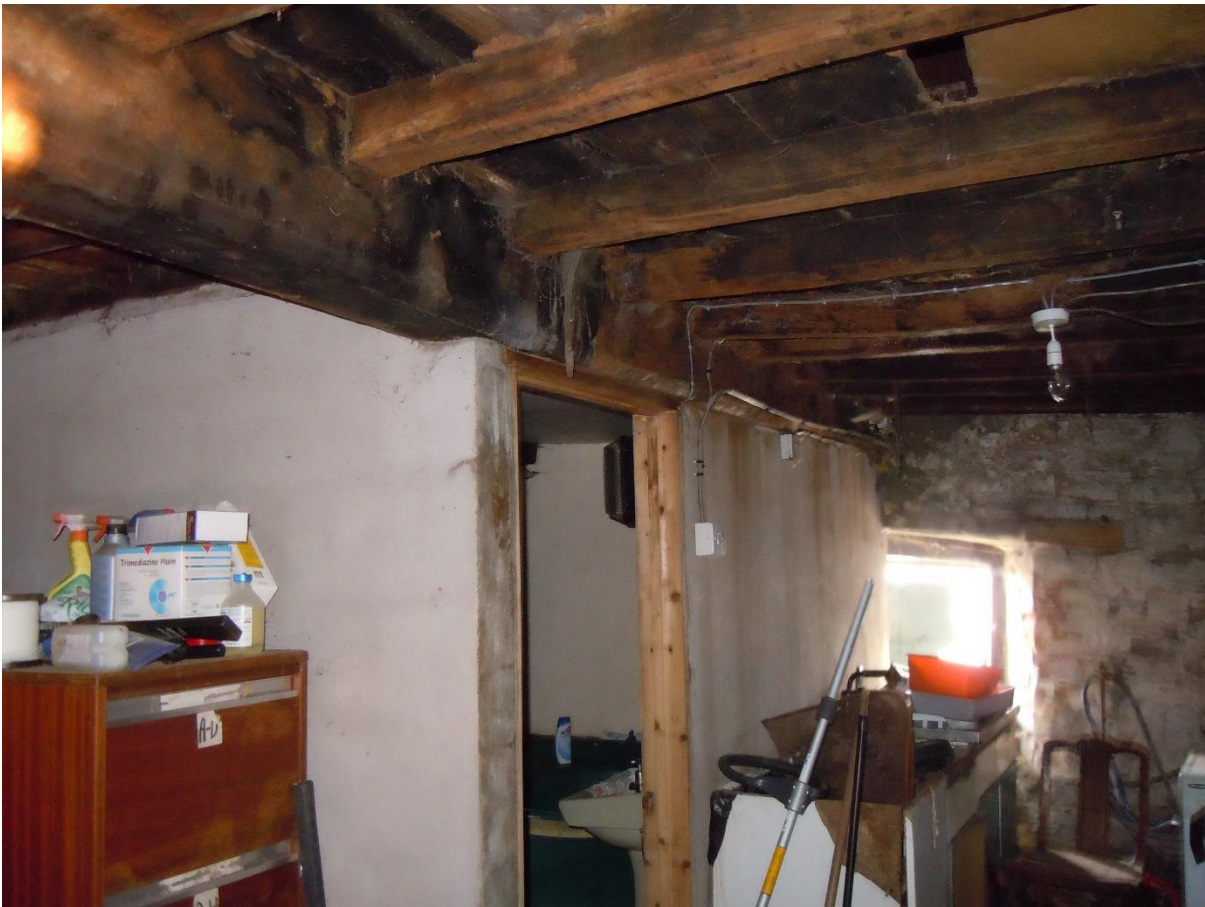
The rear kitchen was largely filled by partition walls containing a bathroom. There was no inside lavatory.

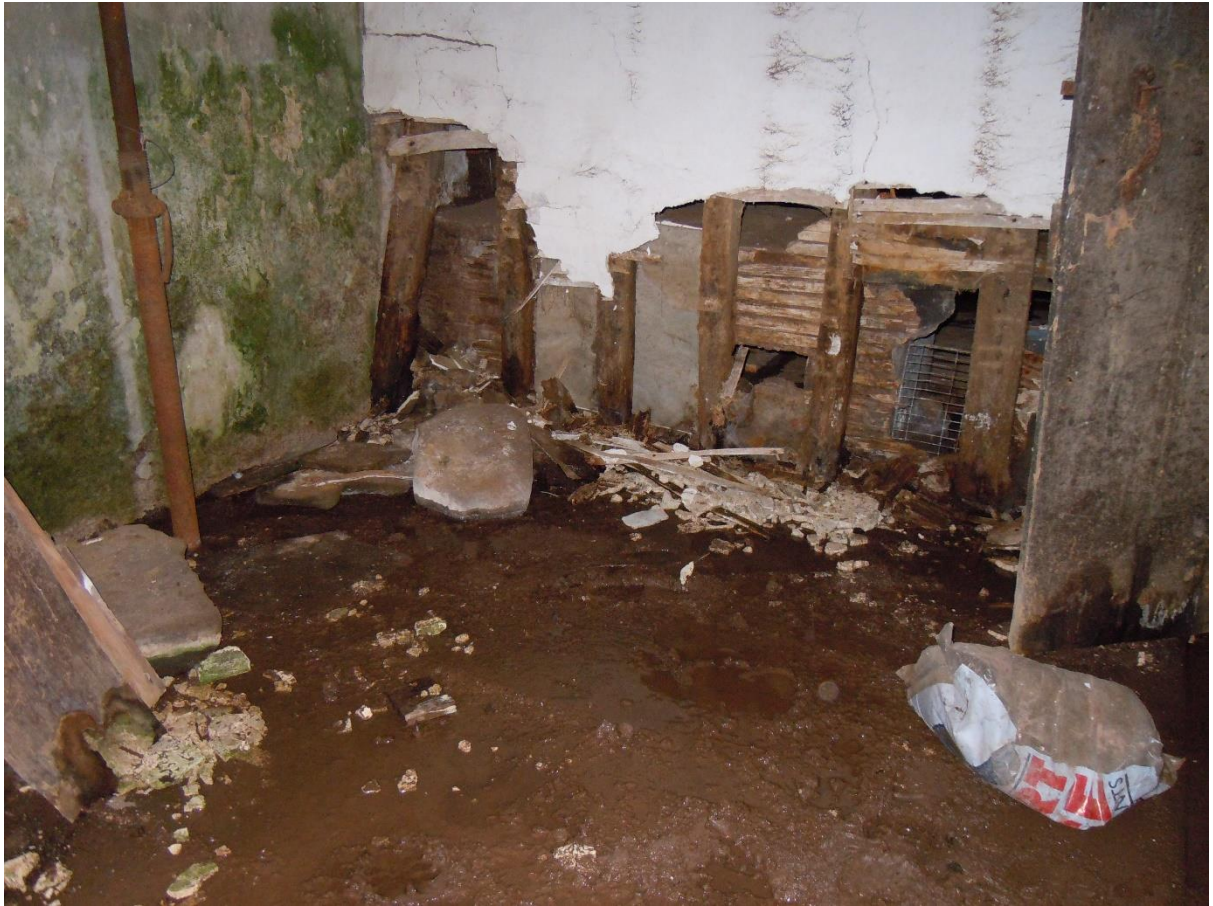
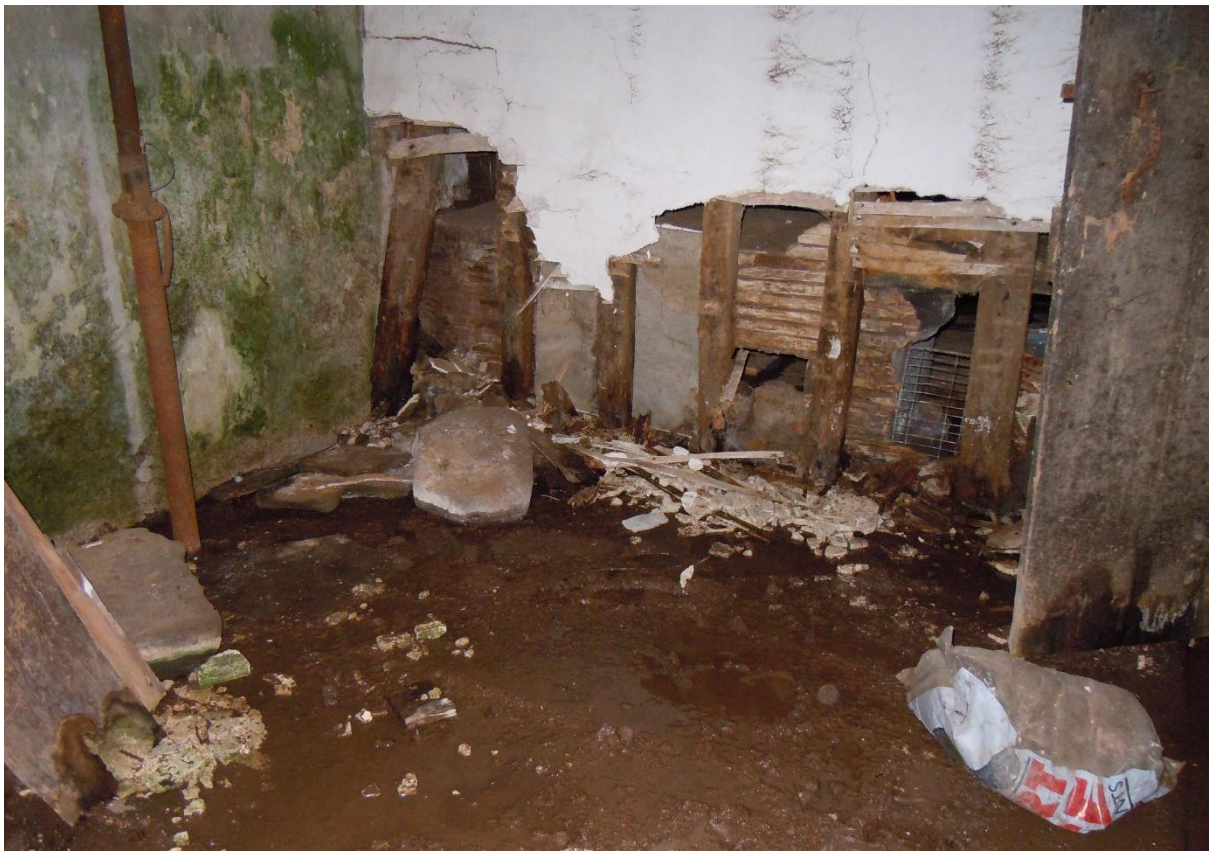
There was standing water in today's solar end bedroom (top). Today's ensuite bathroom was equally un-usable (above).

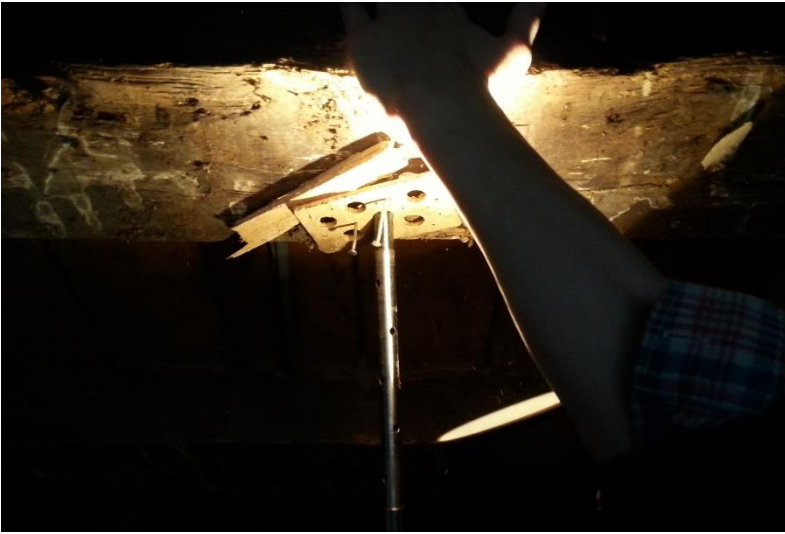
Drilling for cores. While avoided if possible, if a core breaks it can be carefully taped back together. For conventional growth ring analysis, a sample must include the sapwood at the edge of the bark. Ideally, a run of at least 50 growth rings is required per core. This can prove tricky if the growth rings are wide.

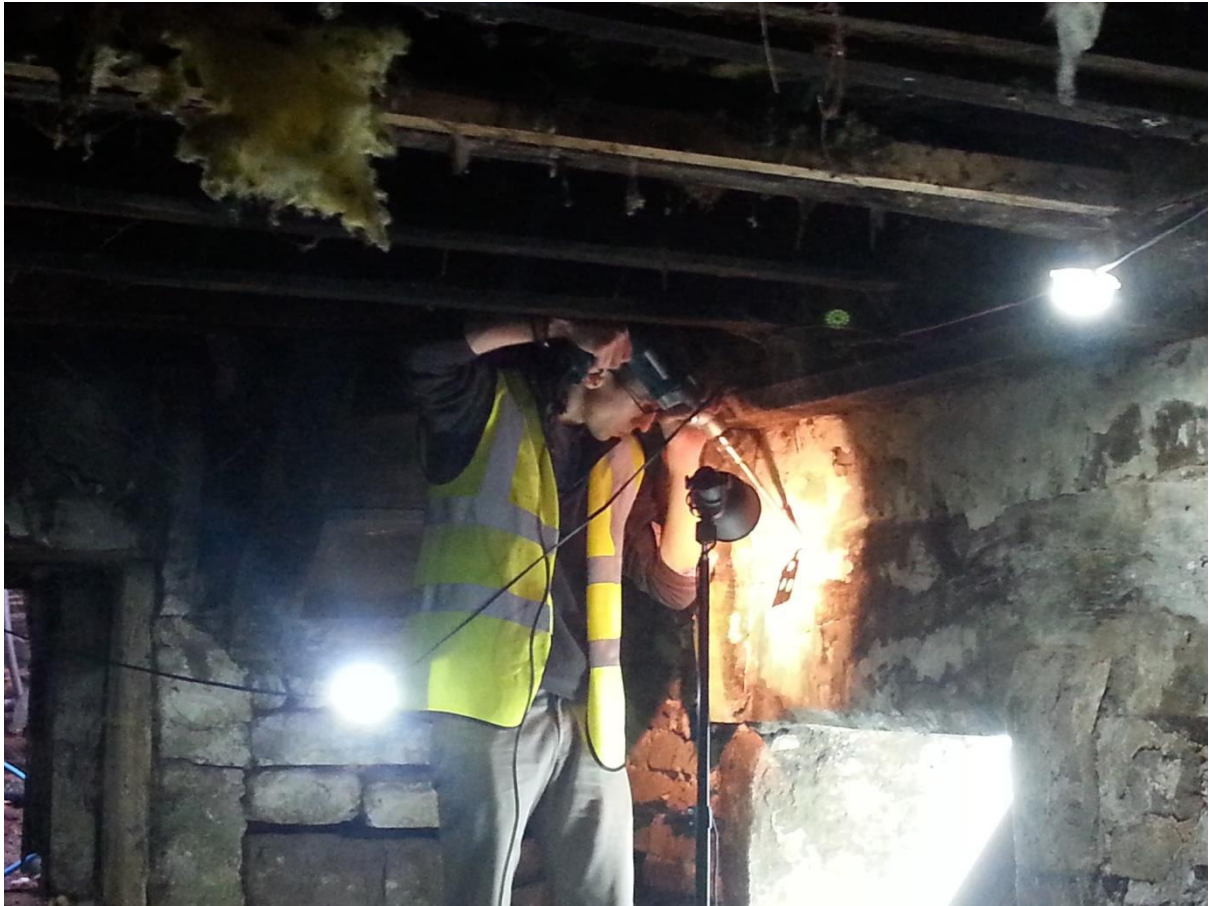
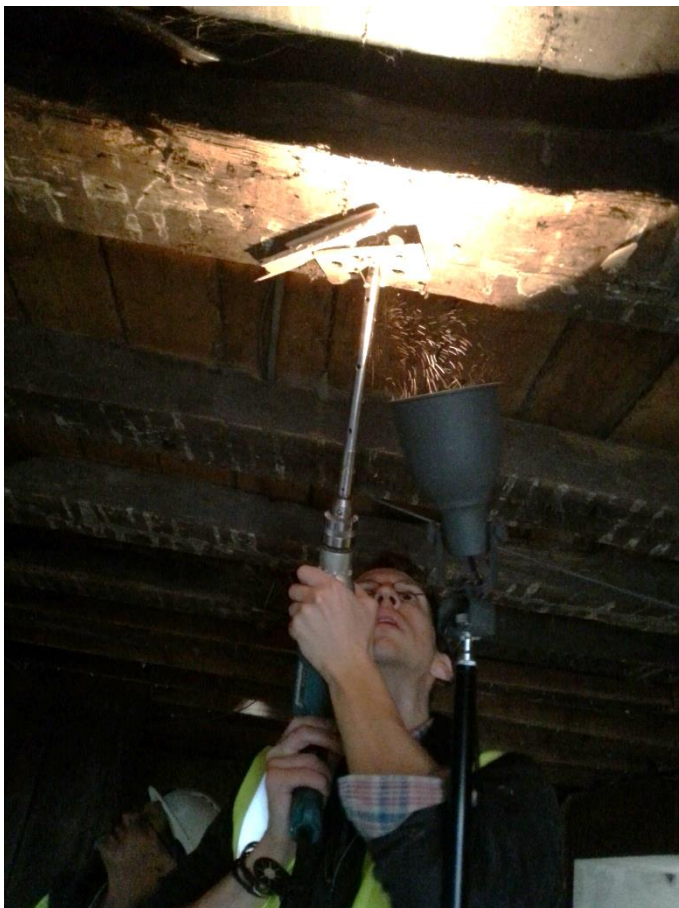
Drilling timber cores in the rear kitchen (above) and snug (below) in 2014.

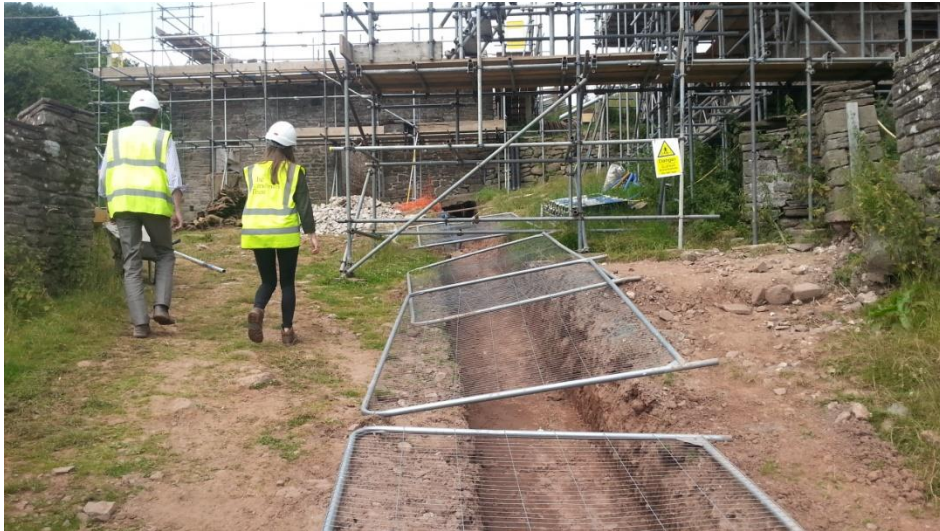
Service trenches going in, carefully overseen by archaeologists. Sadly nothing of interest was found to illuminate the site's earlier history.

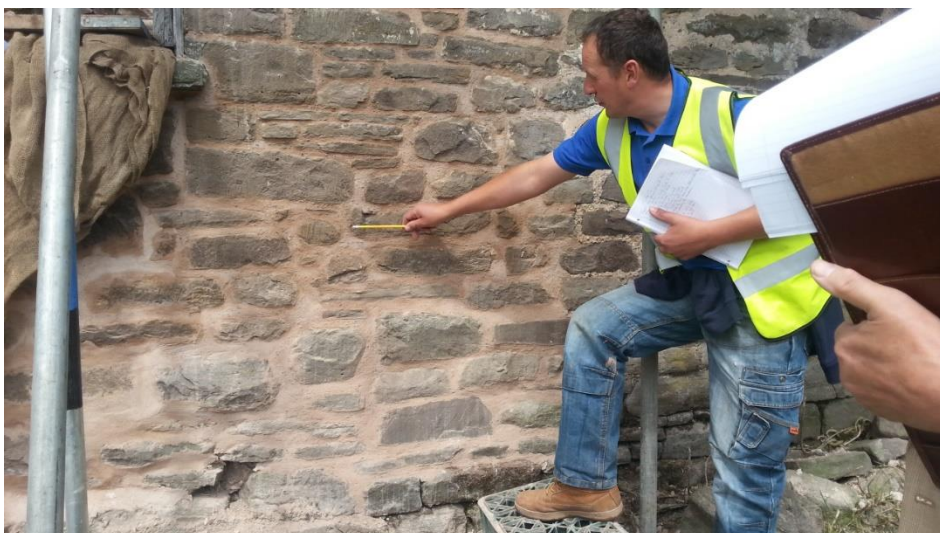
Discussing pointing samples. The red earth on the site was used as aggregate in the lime mortar, ensuring that the external pointing blended well with the stone and the landscape.

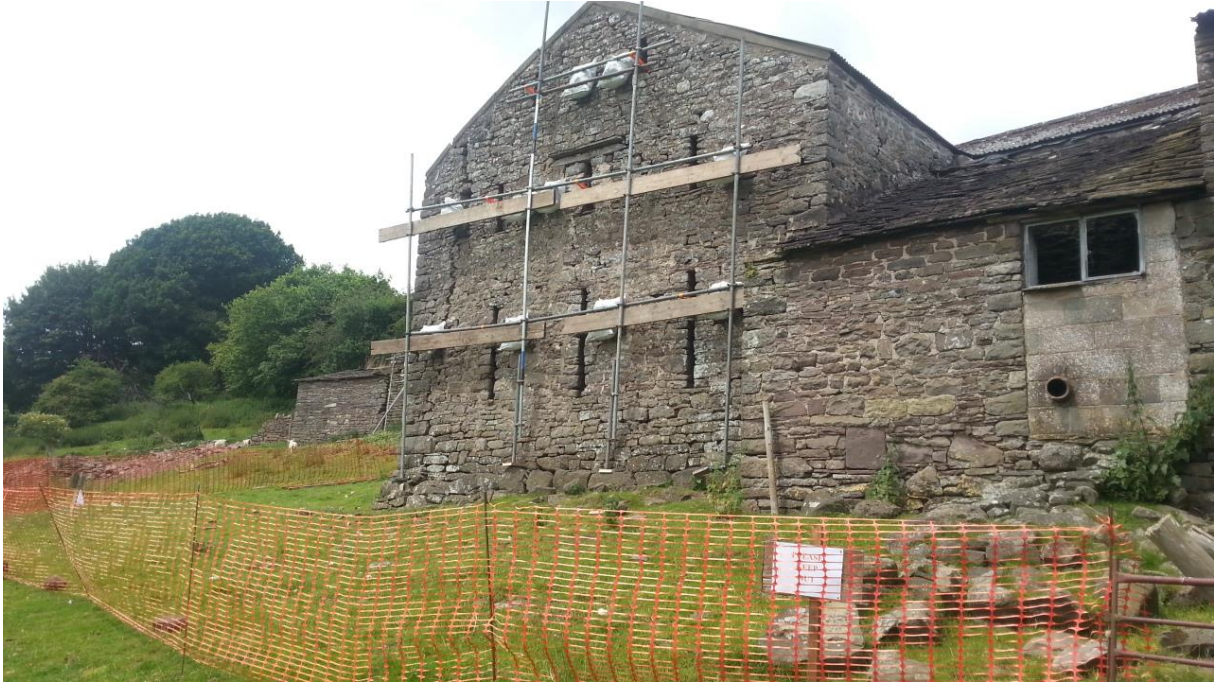
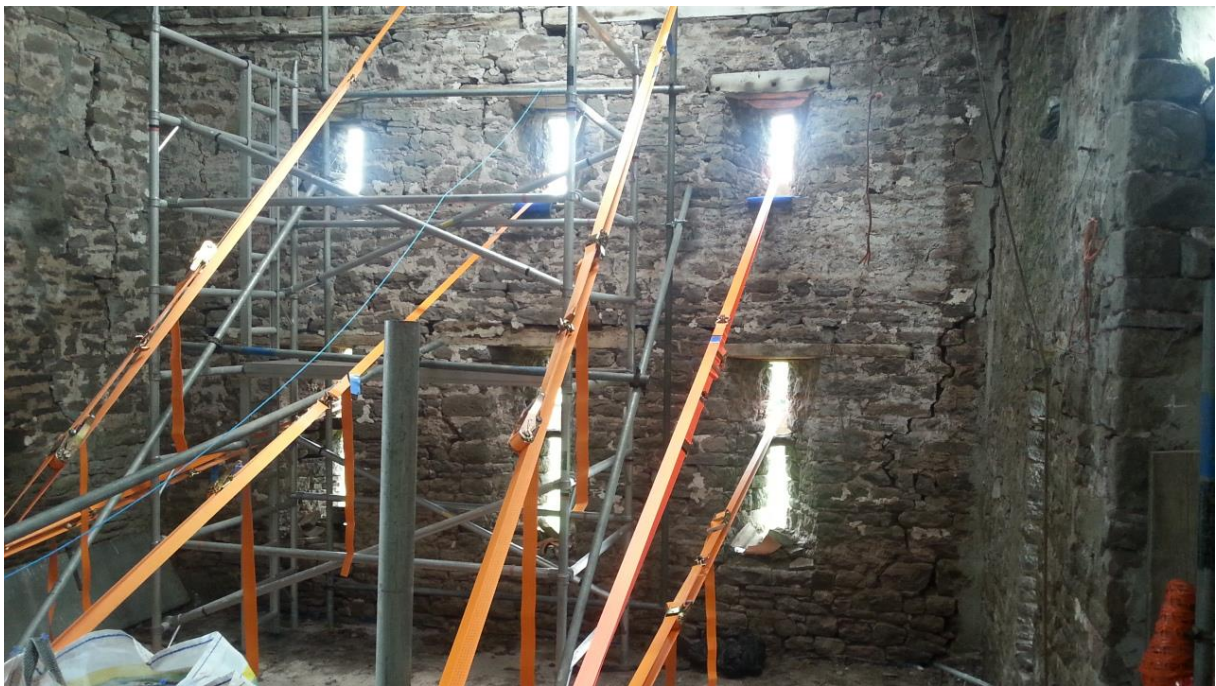
The Threshing Barn was found to be in danger of slipping down the slope. Structural engineer Tom Hill prescribed a cat's cradle of scaffolding and orange nylon strapping to hold gable in place until it could be fully consolidated.

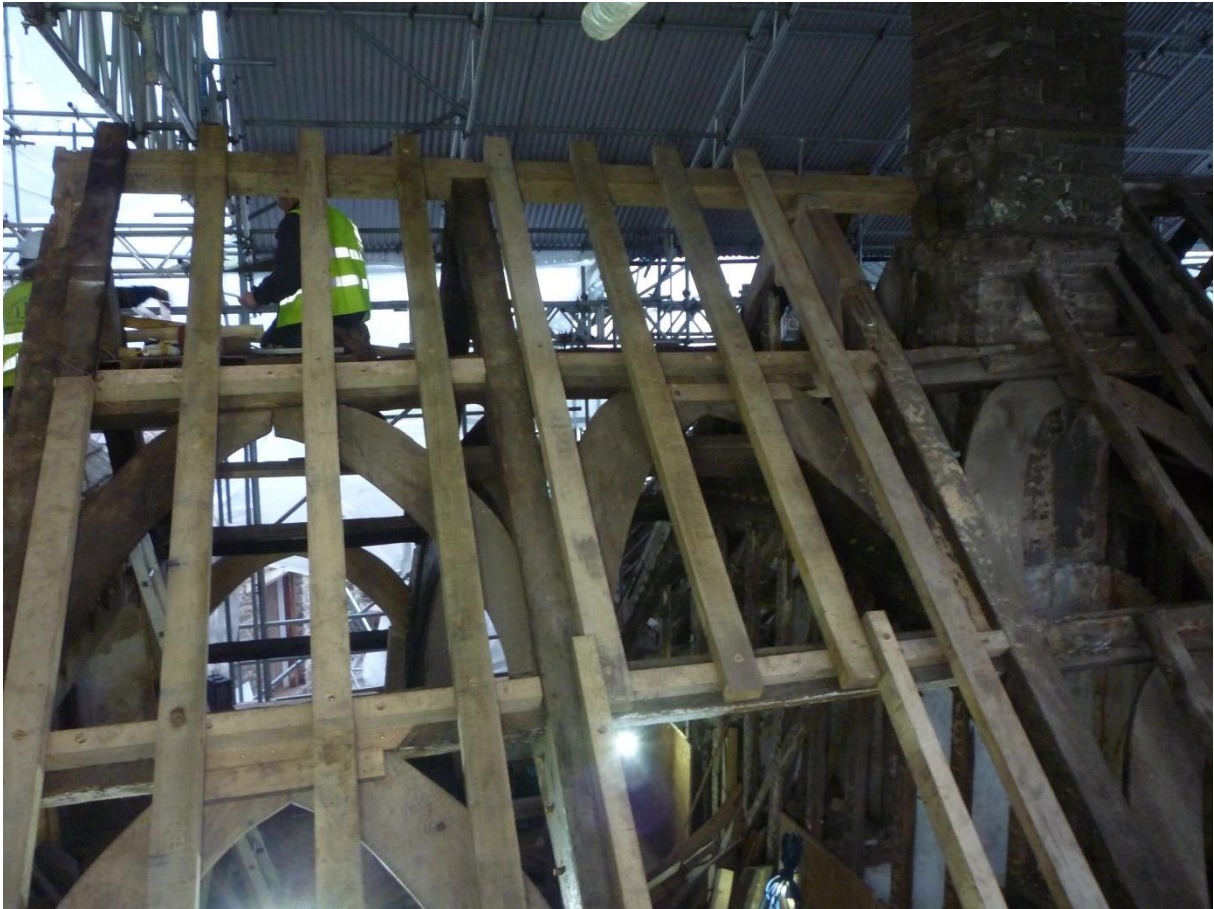
Roof tiles all stripped, the fine wind braces of the once open hall and inserted chimney stack are clearly apparent. Rotten pegs meant this roof truss had to be inched back into position. The difference in colour is clear between the smoke-blackened timbers of the undersides of the roof and the clean oak on their topsides.

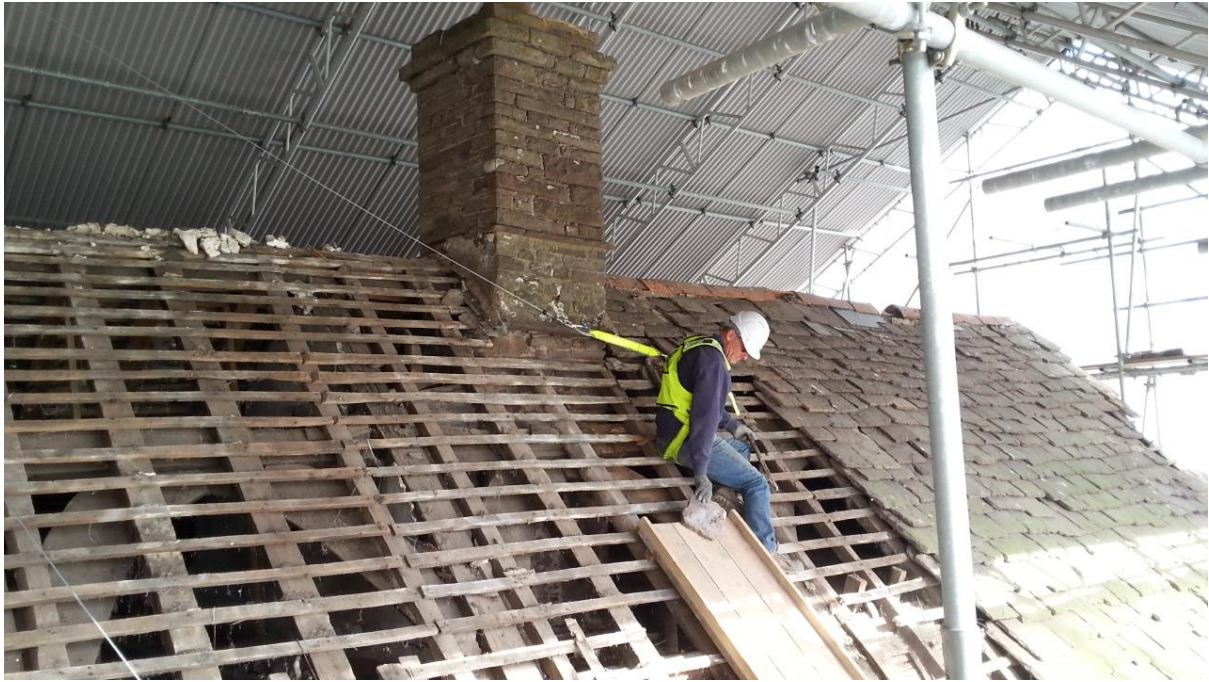
Autumn 2016. When the roof was stripped, each tile was individually removed by hand, and passed down a chute just as it would have been in centuries past.

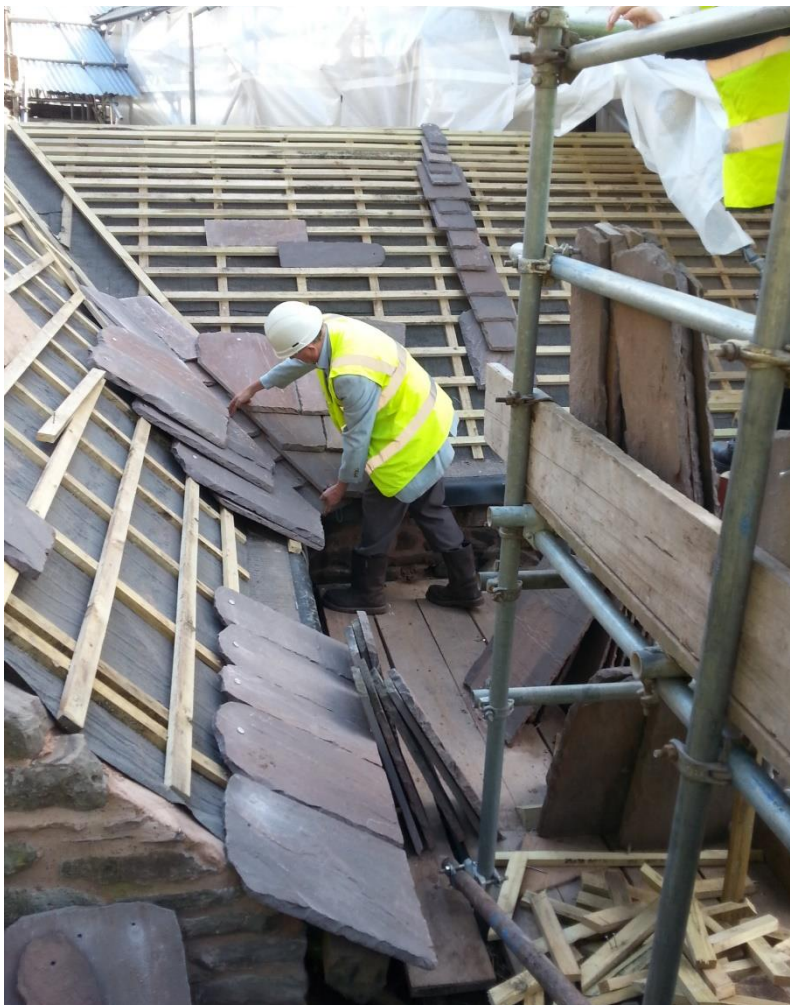
Project architect John Goom laying out a Welsh valley, a traditional solution to making the junction between roof slopes watertight. The massive stone tiles, which run in diminishing courses from the roofline, are Devonian Old Red Sandstone. They were quarried from near Longtown. Where sound, salvaged tiles were re-used among the new ones.

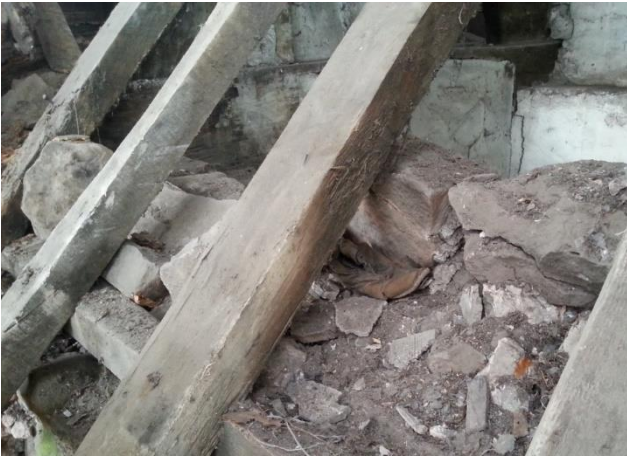
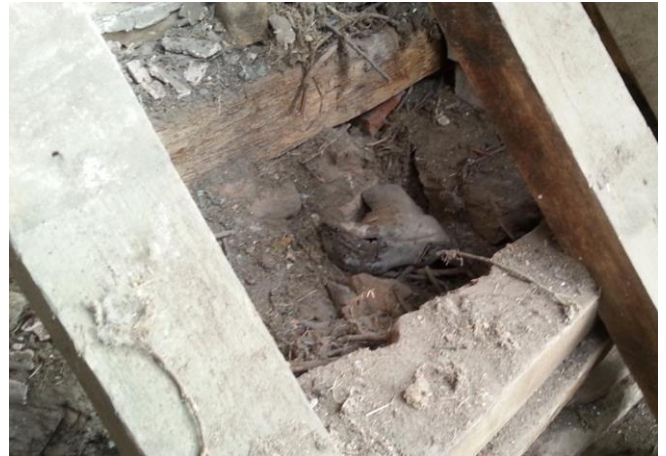
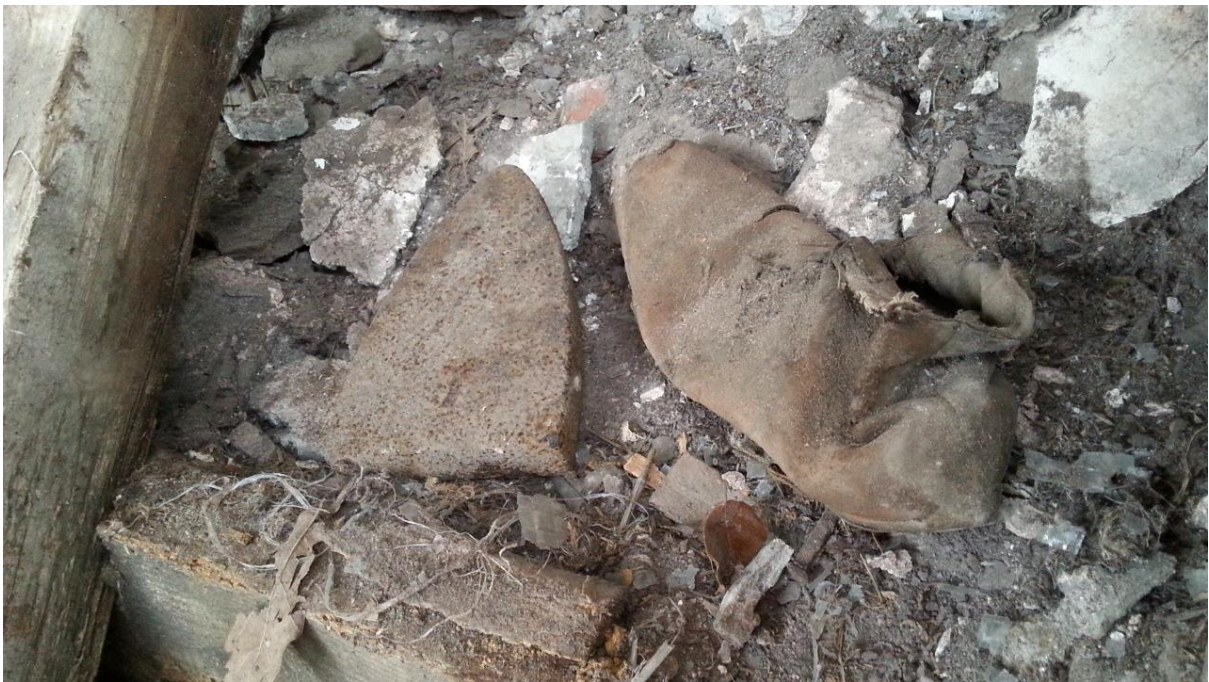
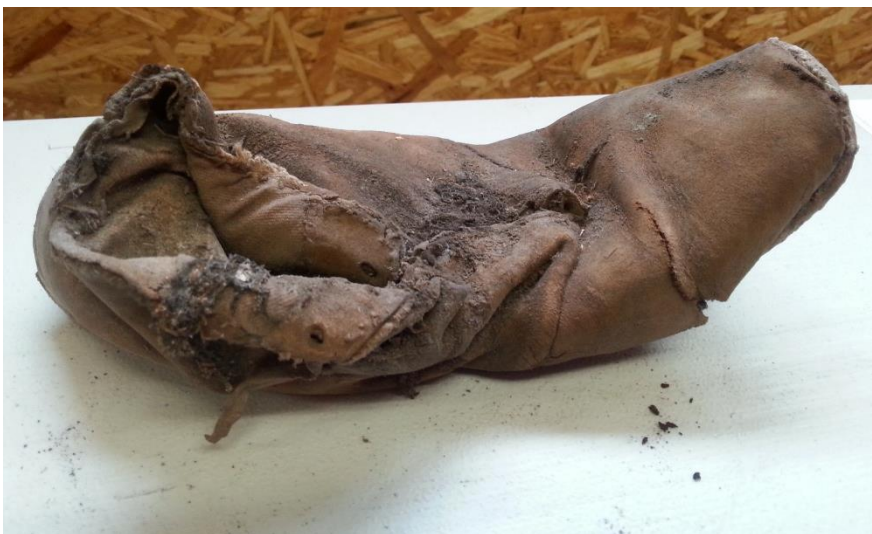
Two old shoes were found carefully concealed on the wall heads. This was traditionally done to ward off evil spirits. This one appears to be 17th-century, perhaps relating to the Watkins' works. After careful recording, the shoes were replaced in situ, where they remain.

This shoe was small and narrow, probably a woman's. Very well made, it is cloth lined and neatly finished, with two leather soles. Its heel (probably a raised one) was missing.

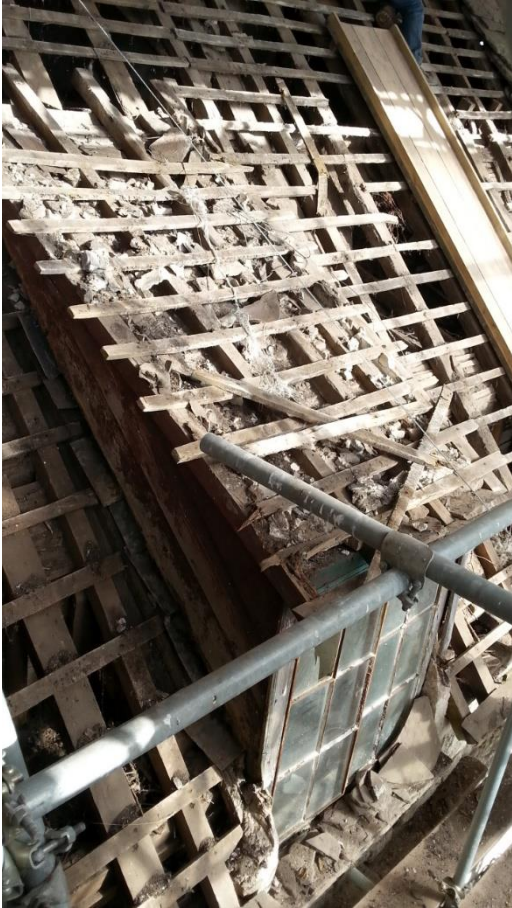
Autumn 2016. The front dormer stripped.

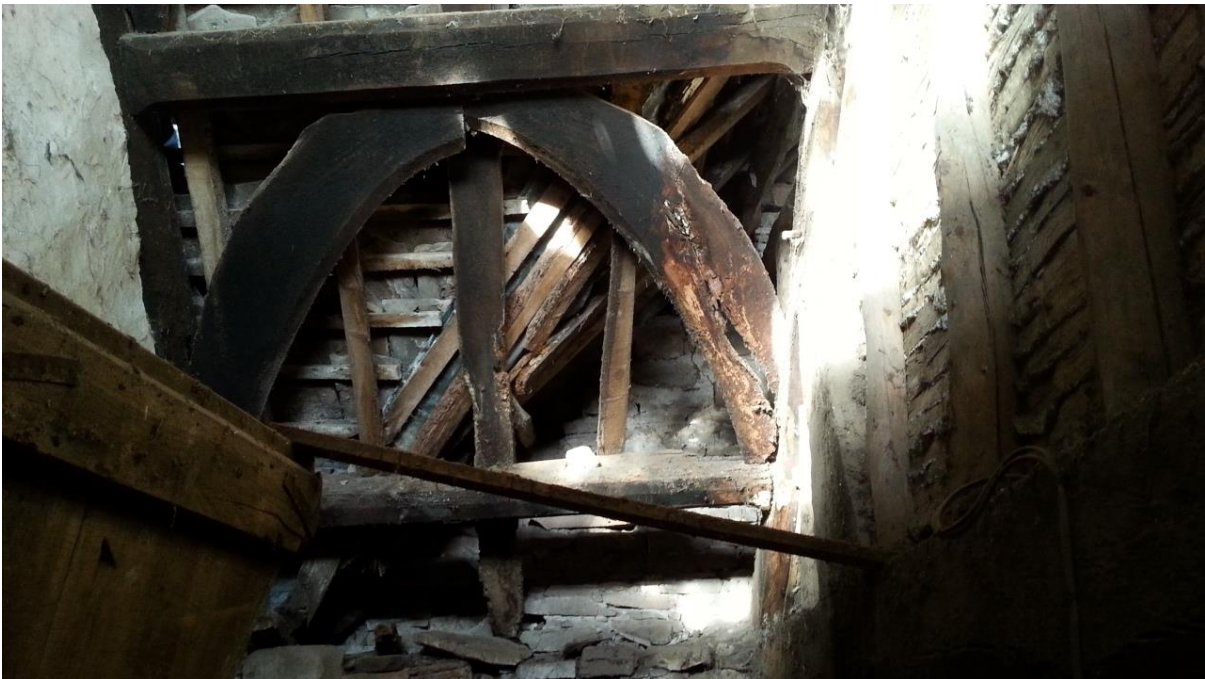
Looking north in the solar range roof space. Note the plastered partitions between the studwork, showing that this attic floor was also in domestic use.

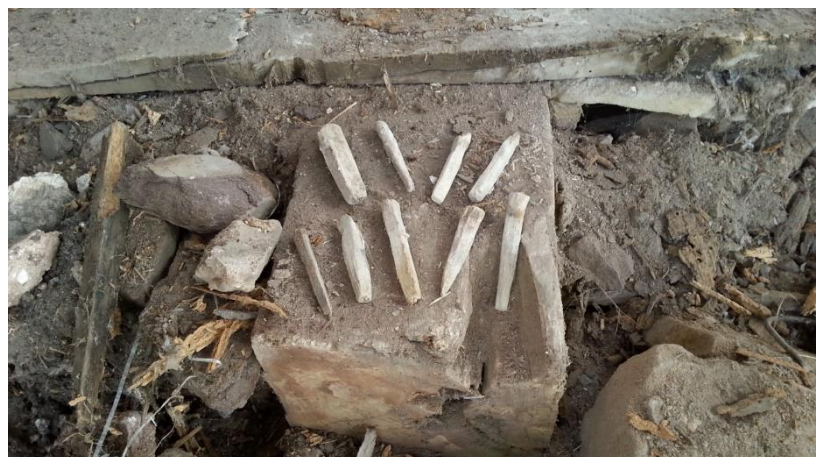
Below: As the roof was stripped, these little oak pegs came to litter the site, redolent of long evenings of fireside whittling. Today, stainless steel tingles are used to fix the roof tiles instead.

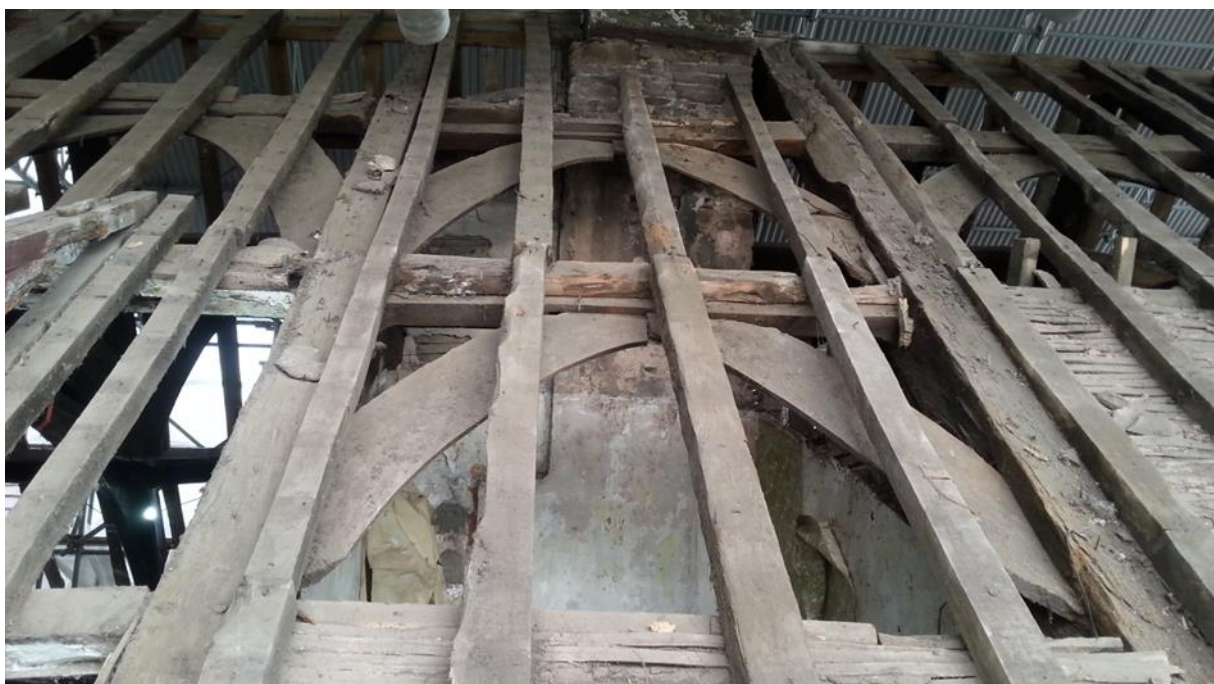
For a time during the project, when the roof was off and the first floor boards lifted, a sense could be caught of what the hall was like when open to its rafters. The curved brace above the high end shown here could possibly have been a support for the dais canopy. The medieval carpenters had trouble with join between the solar range and the hall range; it may even have been left as a jetty with the solar joists exposed.

Below: the massive chimney stack inserted in the 1690s burst through the carefully laid out progression of wind braces.

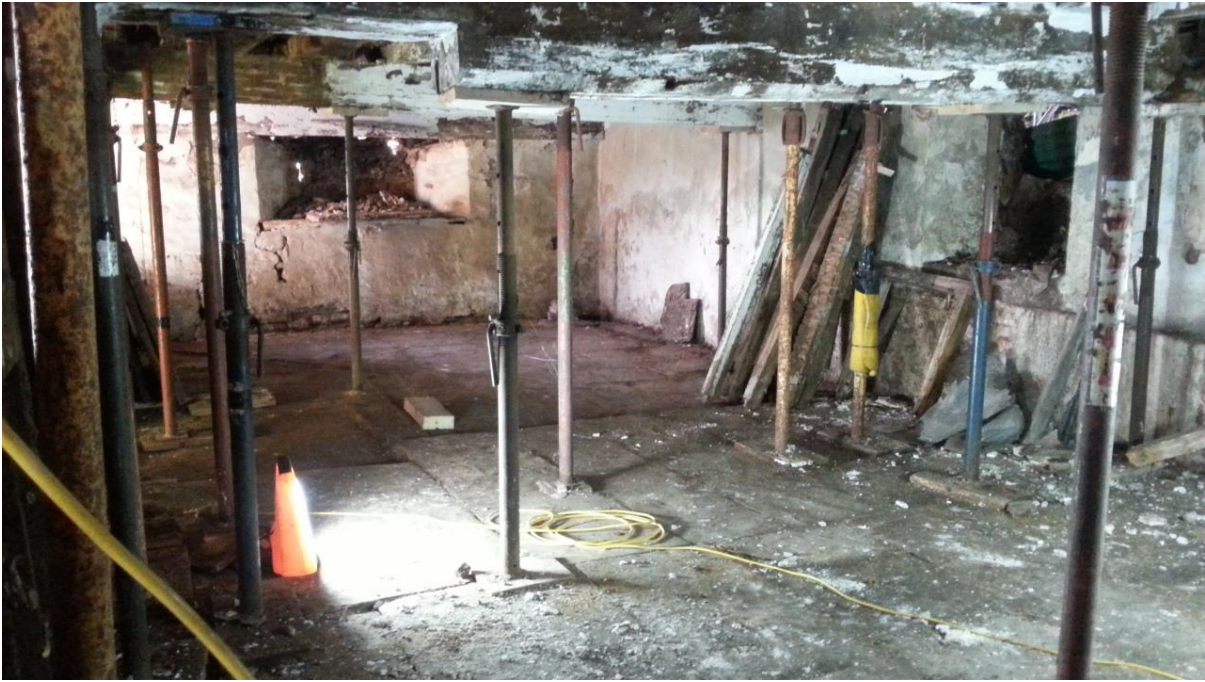
The ground floor of the solar range stripped out, looking south. The ceilings were so low that at some stage a doorhead had been hacked out of the crossbeam (top left). The thickness of the walls is apparent in the window embrasures.

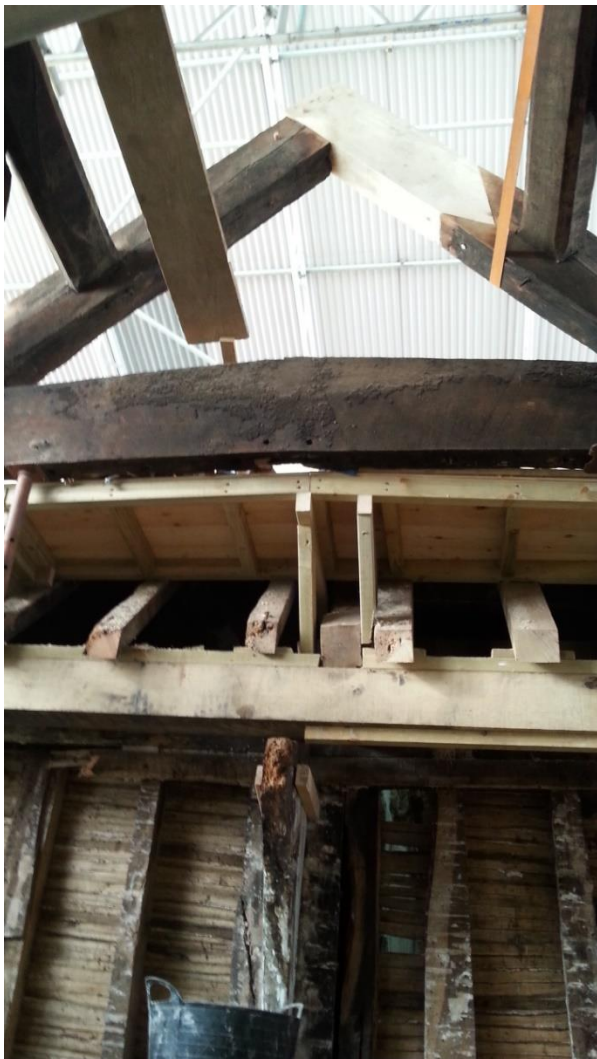
By January 2017, signs of reconstruction were emerging, rather than simply unpicking. Here, the original, rather bodedged joint between the solar range and hall range roofs has been improved. Note the lap joint repair at the apex, carefully scarfed in.

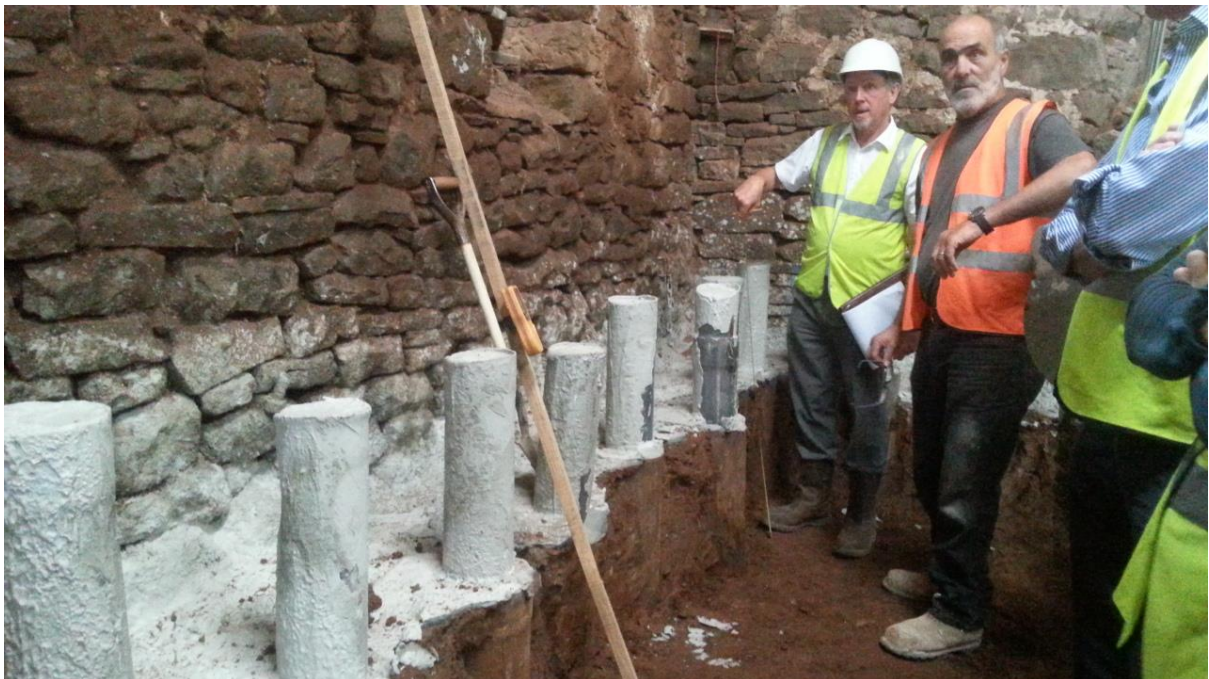
Major piling and underpinning underway in the Threshing Barn, today invisible beneath the concrete plinth that also helps stabilise its walls. The excavation of the floor also enabled the installation of underfloor heating.

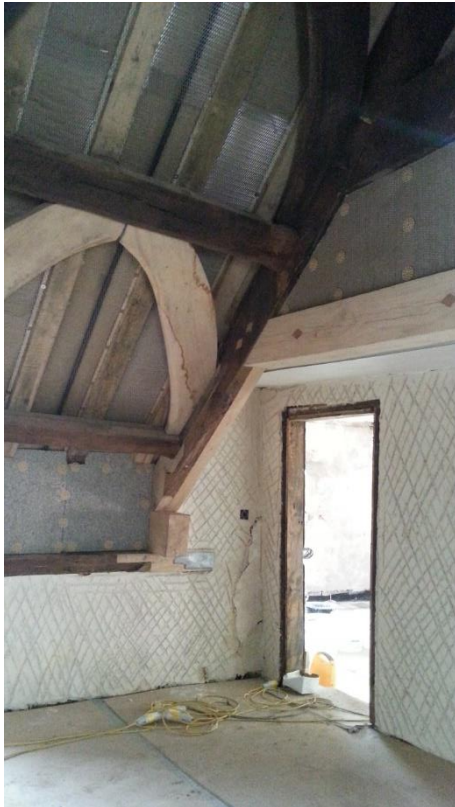
June 2017. Insulation of the underside of the hall roof going in, timber repairs and a first scratch coat of lime render on the walls. Through this door into the solar, plaster repairs are underway to the ceiling, using fibred lime plaster sheets across which the finger moulding can be dragged.

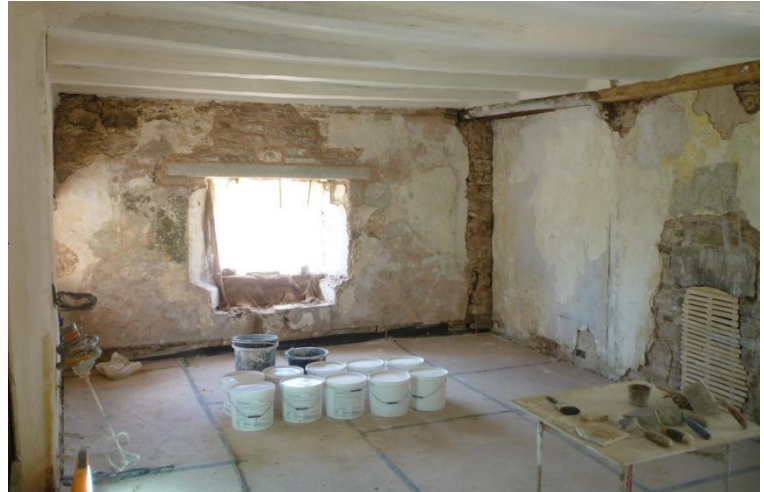
Trial samples of moulding ready for approval, and the plasterer's tools. The wooden mould will be dragged through the wet plaster to form the moulding.

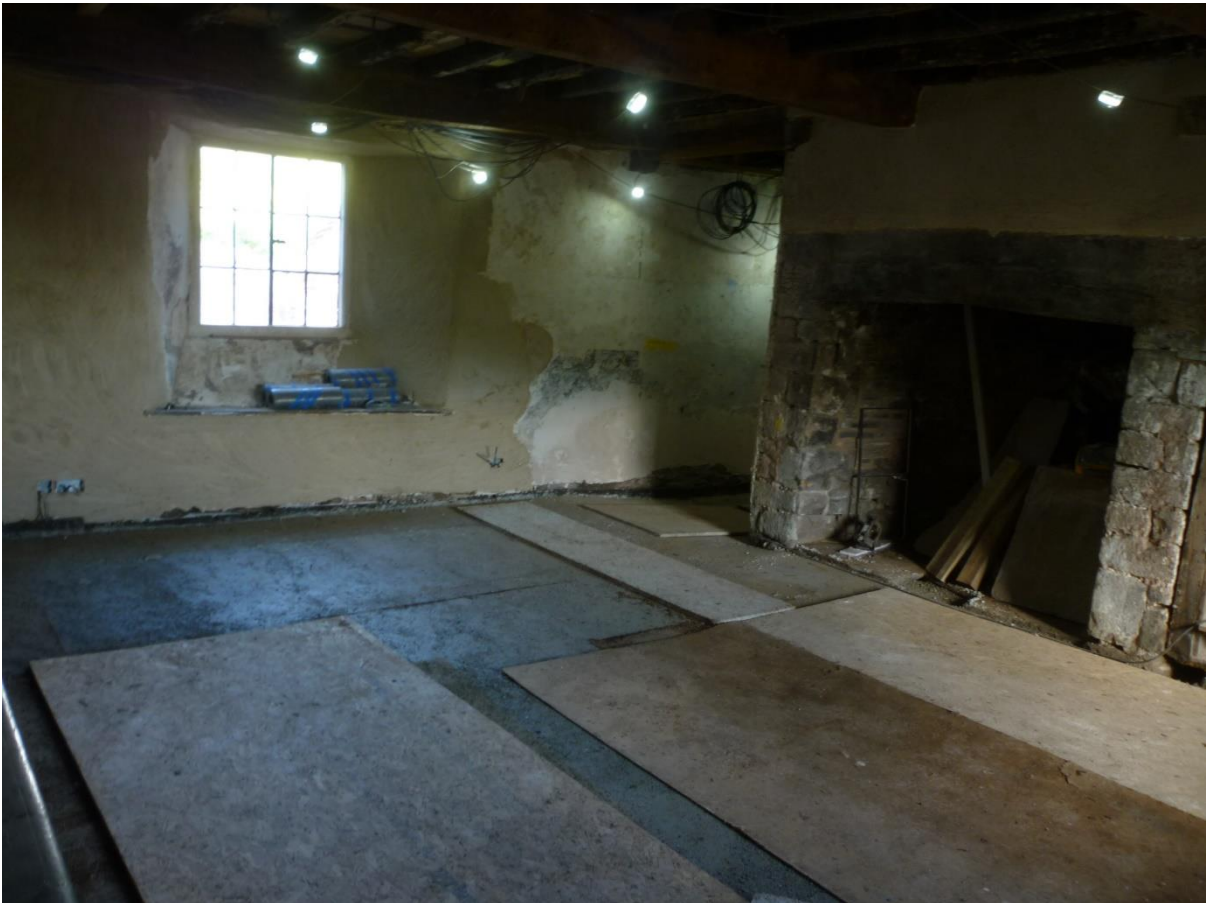
The 2017 SPAB Fellows visited the site in September, here with Susan McDonough, Landmark’s Head of Historic Estate. By now, the underfloor heating had been installed and limecrete floors were down in the house (below in the hall).

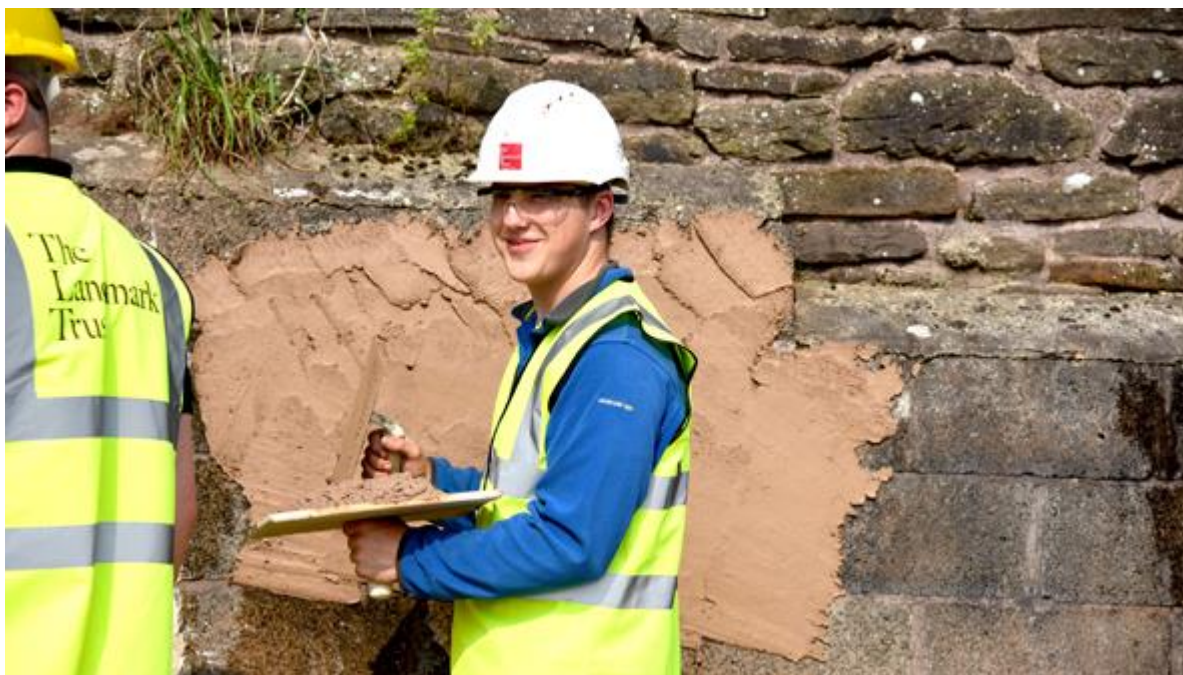
Nigel Jervis from Ty Mawr demonstrates the art of lime plastering.

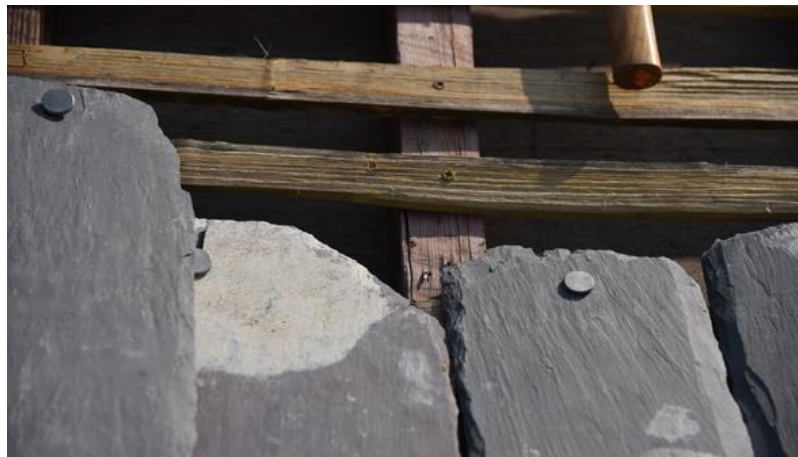
Prince's Foundation Young Heritage Apprentices puzzle over the roof tiles. They compared traditional and modern techniques.

Pegged slates hung over laths

'The Young Heritage Apprentices also had the opportunity to spend the day working with Richard Jordan of Jordan Heritage Roofing. A mock-up of a roof, mounted onto the back of a trailer allowed Richard to work with groups at ground level and on a compact scale. The YHA's worked with slates rather than the heavy stone tiles found on Llwyn Celyn's roof. Roofing is not as easy as it looks – enough maths is thrown into the process to baffle most people, before you even begin to think about diminishing courses, Welsh valleys (tiled as opposed to lead lined-valleys between two roof slopes) or decorative features. Richard made it tantalisingly clear that the possibilities are endless.
