The Landmark Trust

MANOR FARM History Album

Written by Charlotte Haslam, 1982
Updated 2000, 2015

Manor Farm

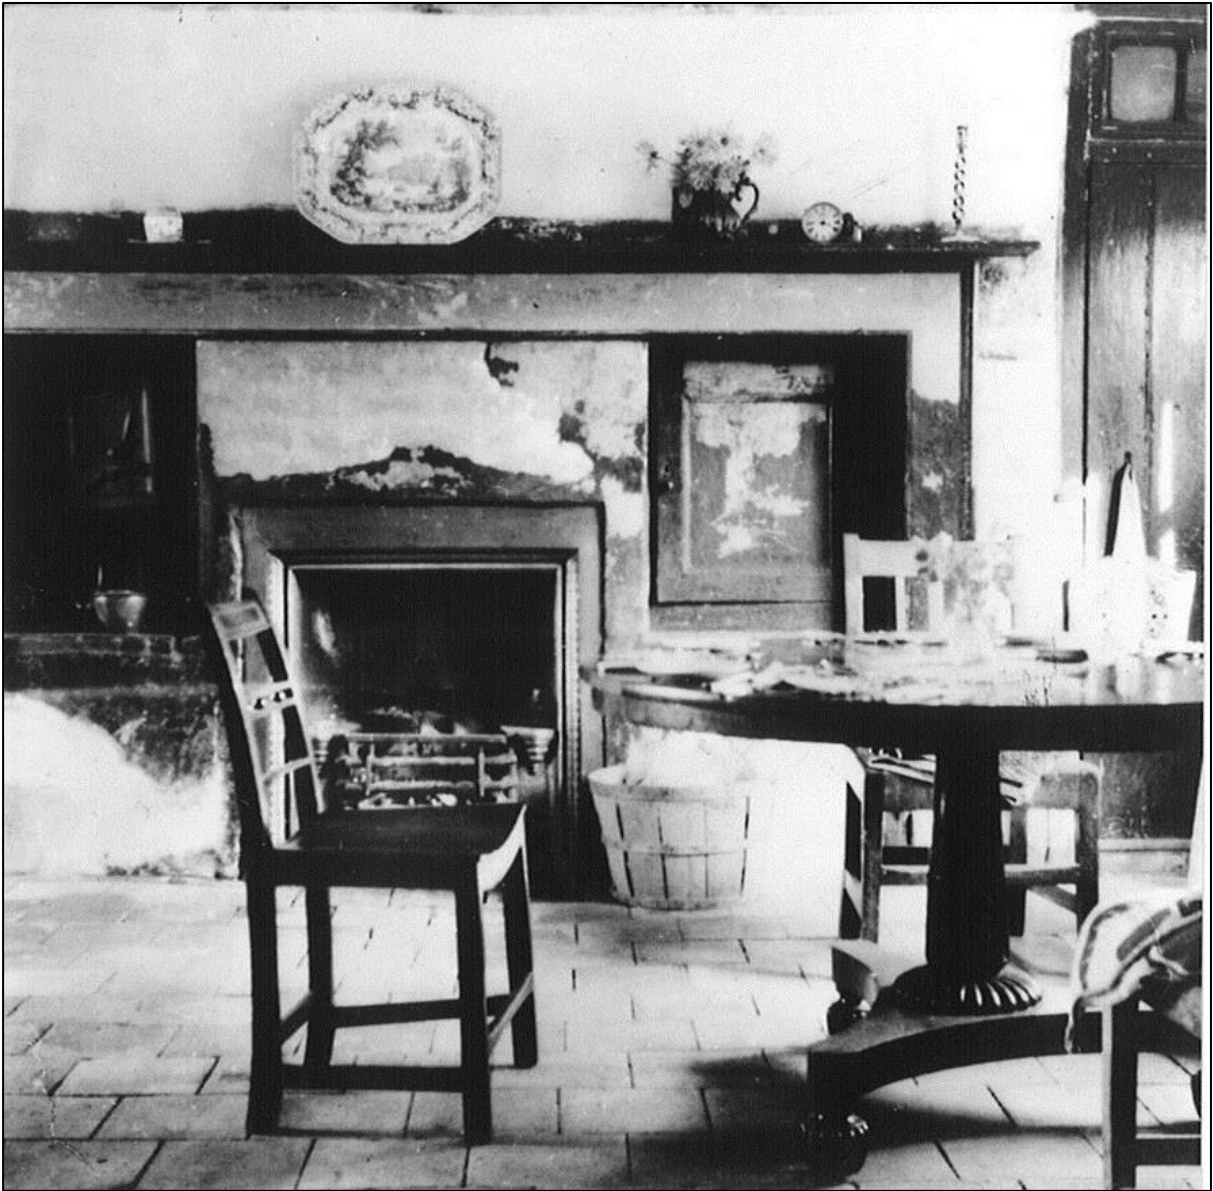
The hall fireplace before it was opened up by Mrs Dance.

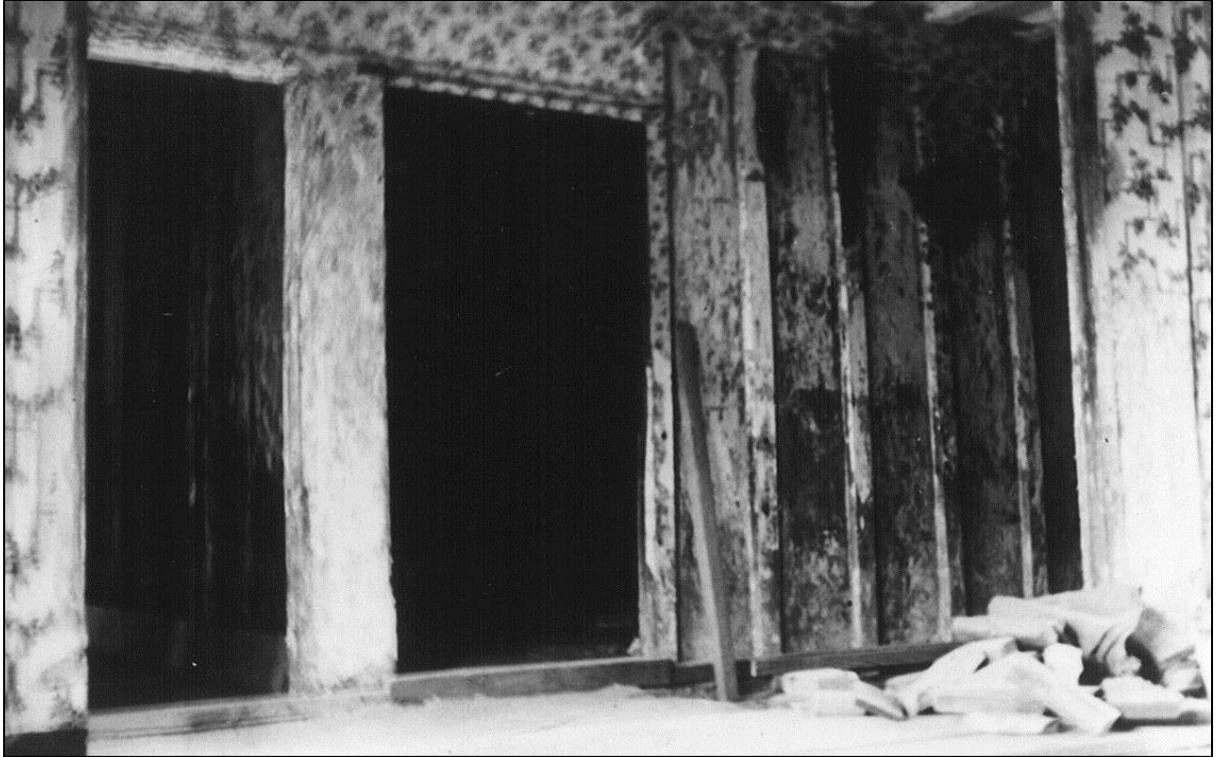
The screens passage in 1948

The most interesting and quite remarkable feature, apart from the actual existence of the screens passage, buttery and larder intact, is that all the original partitions forming the rooms are constructed of oak studs, chamfered and grooved, about 4½" x 3", set 11" apart with vertical oak boards ½" thick, about 12" wide and 8' high fitted into the groove and filling the spaces between the studs. The studs and boards are perfect and of a lovely light brown colour. The five or six doors are each of three oak planks, with wooden handle and latch and "country blacksmith" hinges. All the beams and joists are beautifully chamfered and stopped. The oak floors everywhere are in perfect condition.

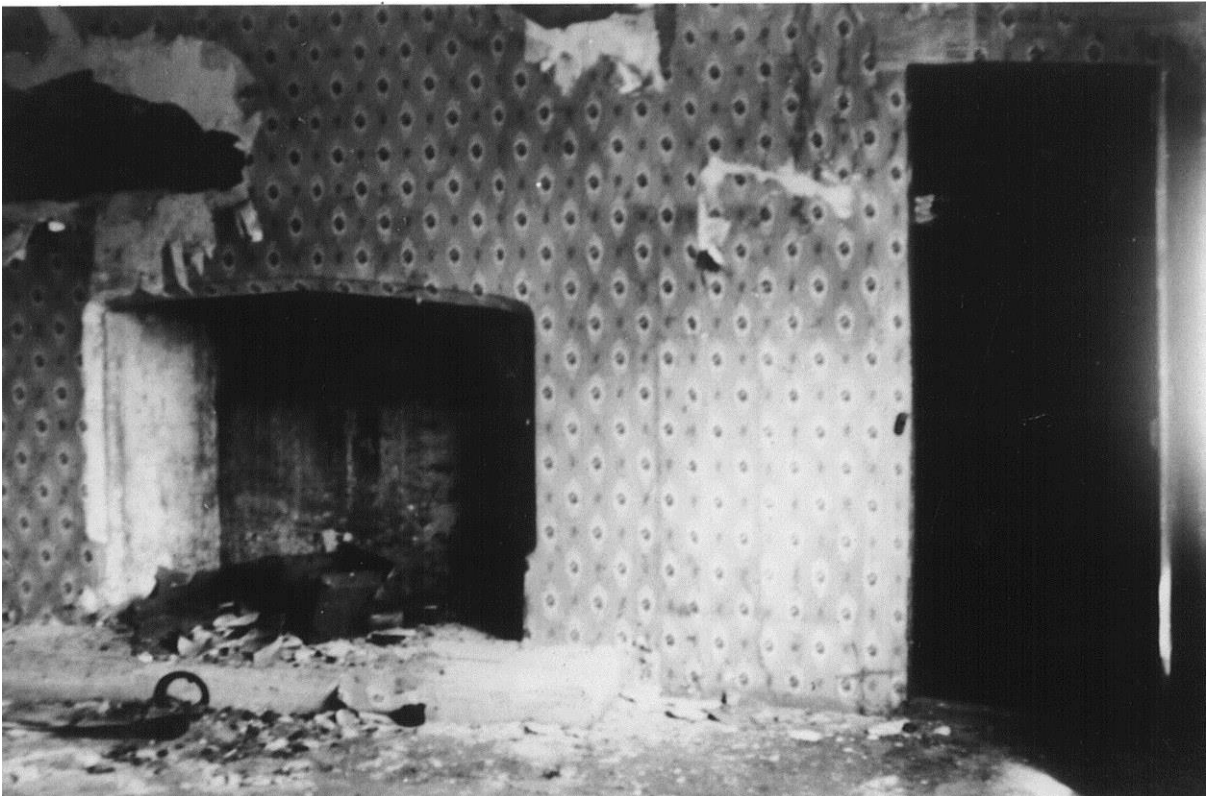
The fireplace in the central bedroom in 1948

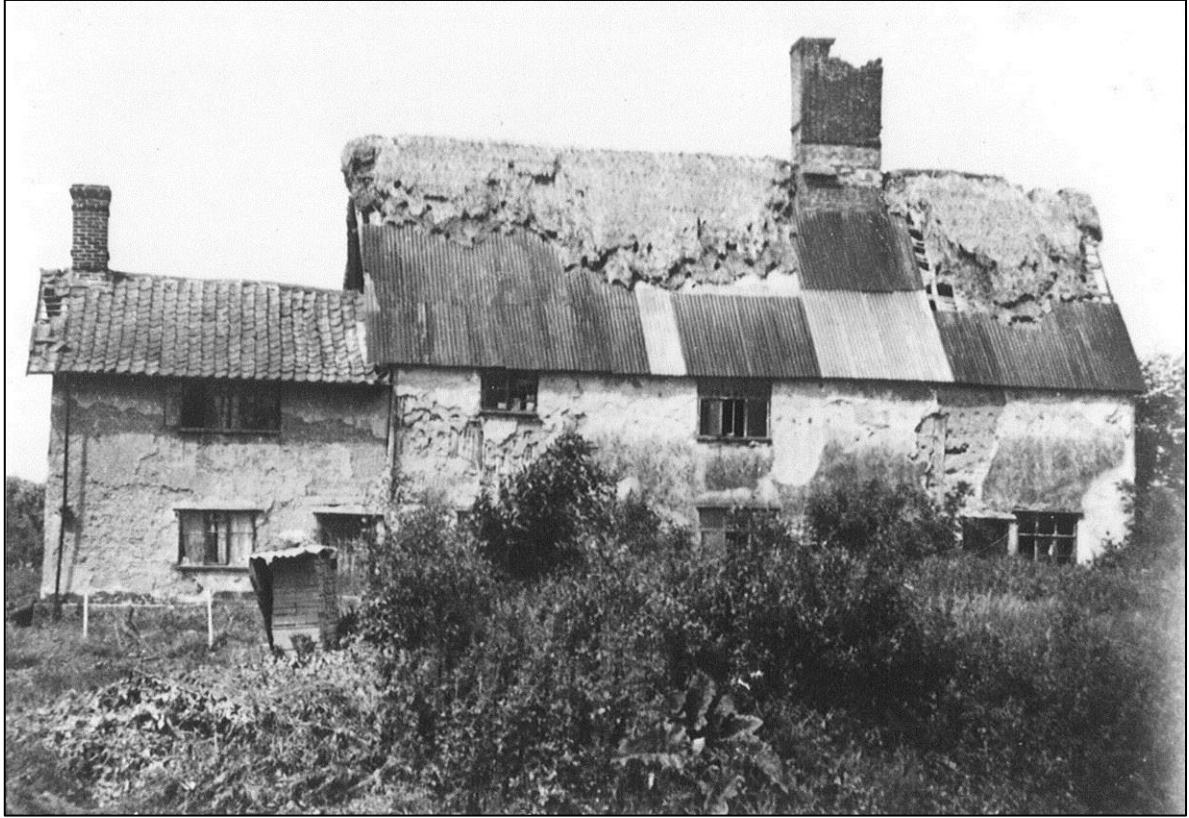
Manor Farm as it was in 1948 when bought by Mr and Mrs Dance.

The house, which had got into the last stages of disrepair during the war, had been empty for some years. The roof was partly covered with second-hand sheets of corrugated iron, and flapping sacks protected some of the holes in the walls. Water had been soaking into the shallow foundations, a settlement had taken place which had strained and drawn some of the mortice joints, and the roof framing showed signs of rocking over. The interior contained the mouldering rubbish of the last occupier.

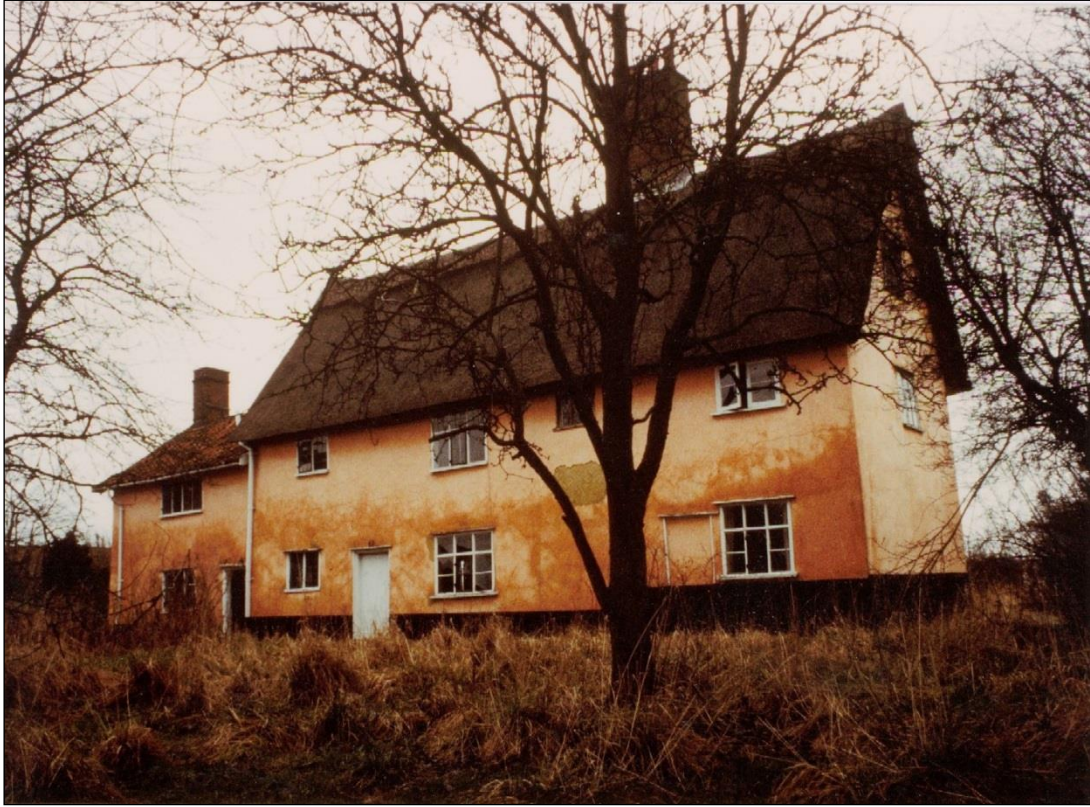
Manor Farm in 1979. The clay plaster had suffered from damp and was breaking up in a number of places.

Areas of the external lime plaster were again breaking up. The initial plan was just to repair these patches, but the sections needing attention turned out to be larger than had been expected, and so the more practical course in the long term was to replaster the whole of the building, especially since the work was then eligible for a grant from the local authority. A new coat of colour tinted lime wash was then applied. The interior was also given a new coat of white lime wash.

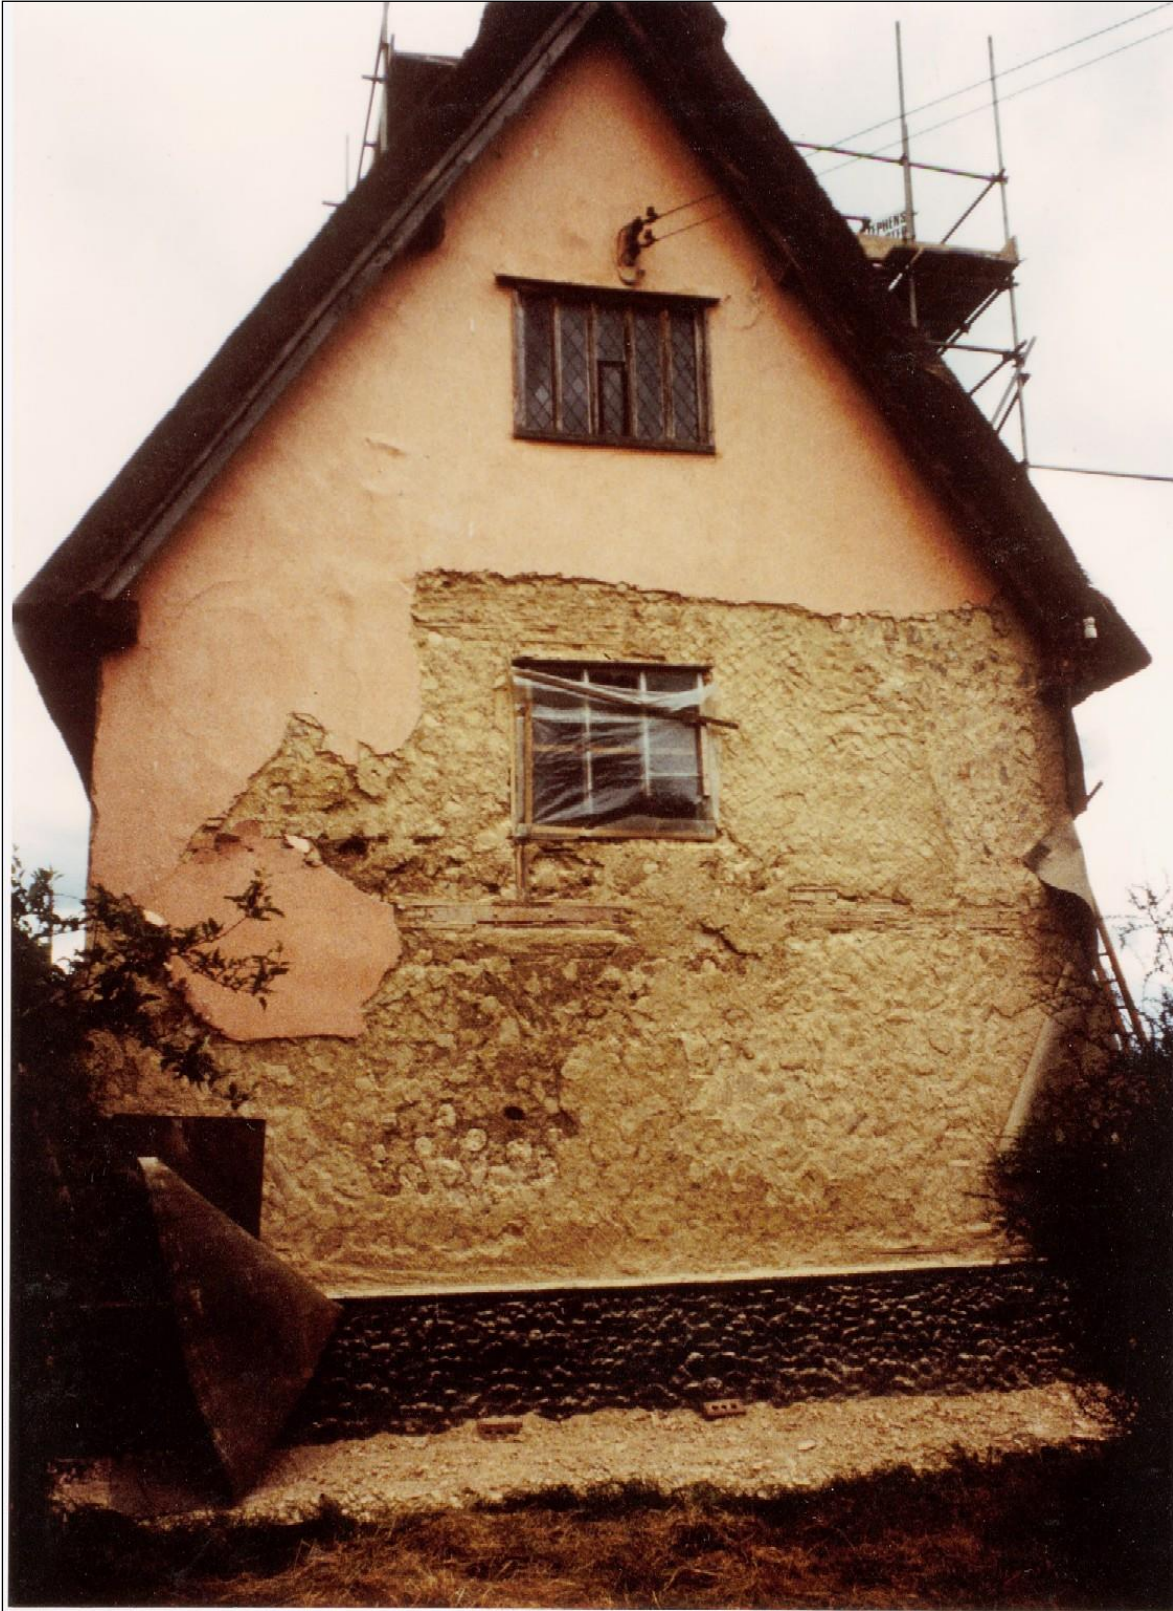
A bulge in the wall at the east end had caused the plaster to crack more than elsewhere so that it no longer formed a secure base for the coating of limewash.

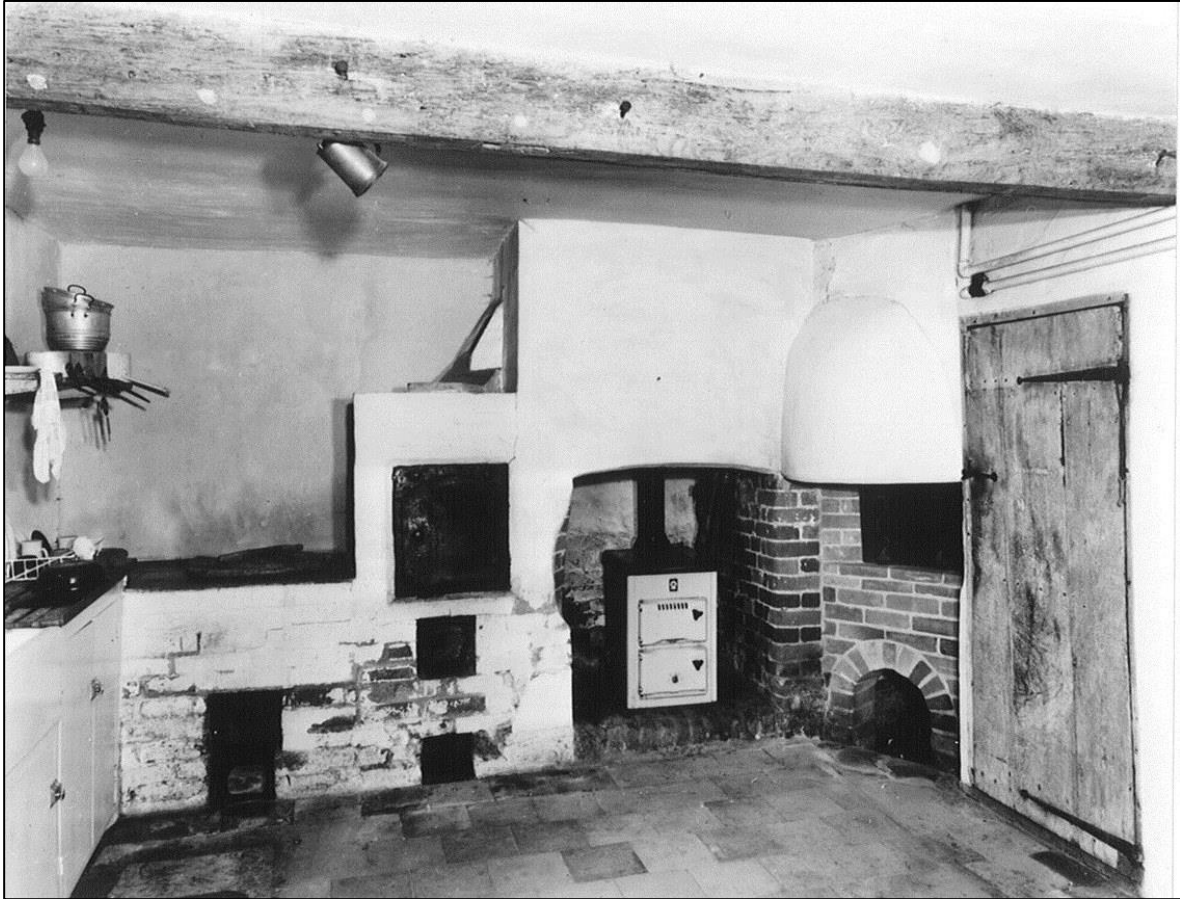
The kitchen as it was in 1979. A lot of damp was coming through the chimney wall.

the main alteration was the removal of the downstairs bathroom from the oak-panelled pantry in the older, central part of the house, to the larder or dairy in the later addition. A more efficient water heater was fitted into the airing cupboard upstairs. The previous boiler was in the kitchen, where the ventilated food cupboard has now been built.

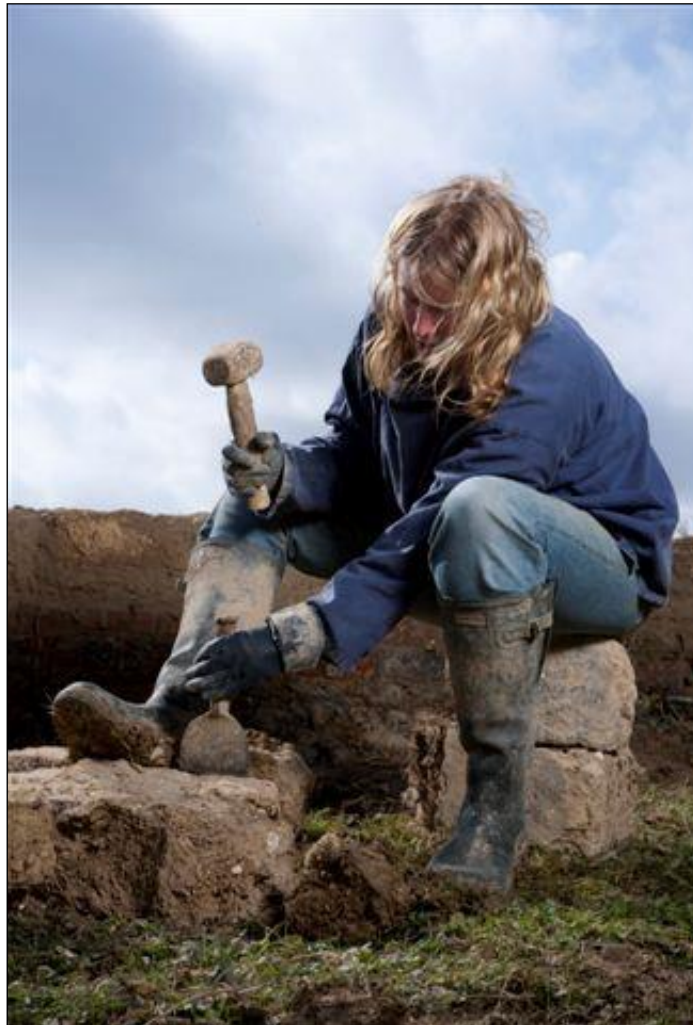
Charlotte Eve shaping the clay blocks

The moulds were made of wood, glued, wedged and soaked overnight so that the lump could be released. The mould was placed on a smooth, hard, flat surface and the clay mixture thrown in handfuls so that it was well compacted into the corners of the mould. The top was then levelled off. By lifting the mould carefully the block slid slowly out and was left to dry out of the sun, undercover for a month.

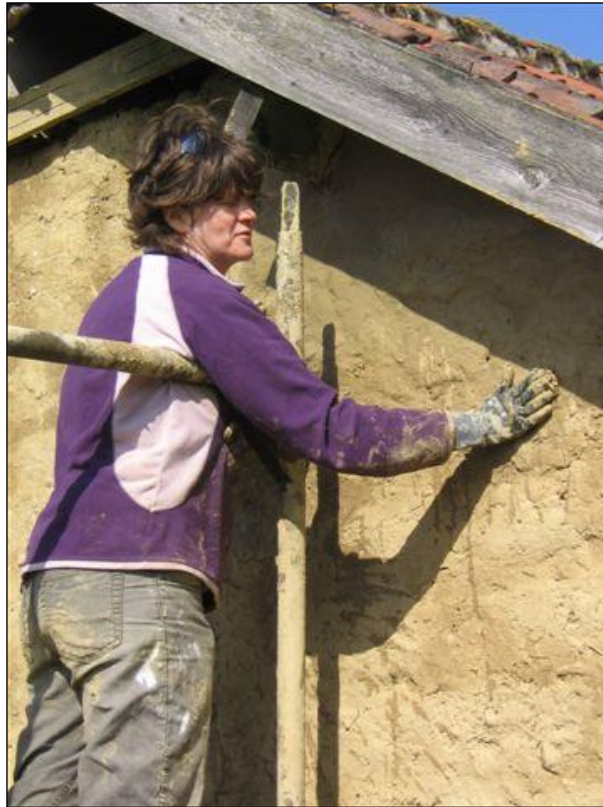
Kate Edwards daubing the gable and barn still to receive its tarred finish (below).

The clay lump barn is the greenest of materials, the local earth and requires regular maintenance to remain sound. When it crumbles, the material can often be gathered up and re-worked. In 2010 Kate Edwards and Charlotte Eve of Edwards Eco Building, practitioners of this reviving skill, carried out general repairs to the barns including building the gable end wall of the SE wing and forming new clay blocks from wooden moulds which were then plastered with more clay and sealed with tar. Meanwhile, the 'hat and boots' (or topping and foundations) of the clay block walls enclosing the yard were proving inadequate protection against the rain, causing the clay to sag, so the walls were given a good new 'hat', this time of clay tiles.

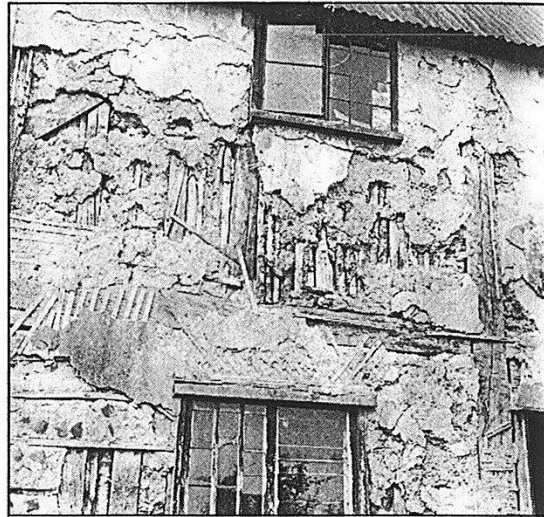
Exterior wall before repair.

every particle of the old infill being kept. Where wattle had to be renewed, hazel from the hedge was used. The daub was then thrown at the house, and although cracking badly in the first coating, further applications produced an excellent plastered surface which was then limewashed, the base being tarred.

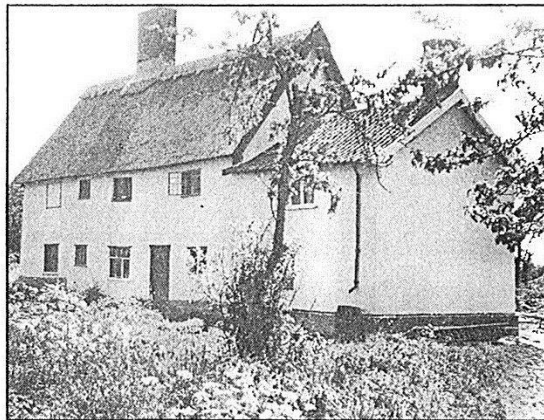
Manor Farm after the completion of repairs.

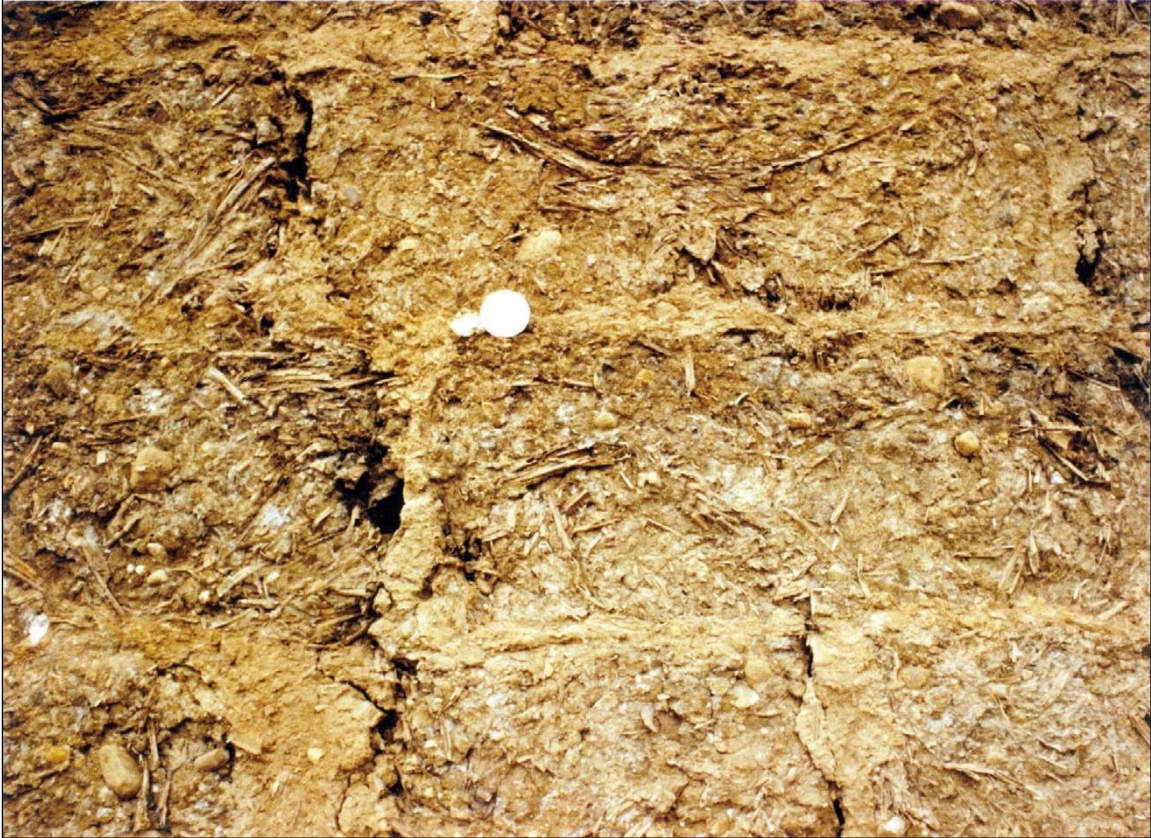
A detail of the clay daub on the east end of the farmhouse.
