## OLD CAMPDEN HOUSE SITE HISTORY ALBUM

### East Banqueting House & West Banqueting House

## Volume I – RESTORATION OF THE BUILDINGS

Written and researched by Caroline Stanford  
1999/2003

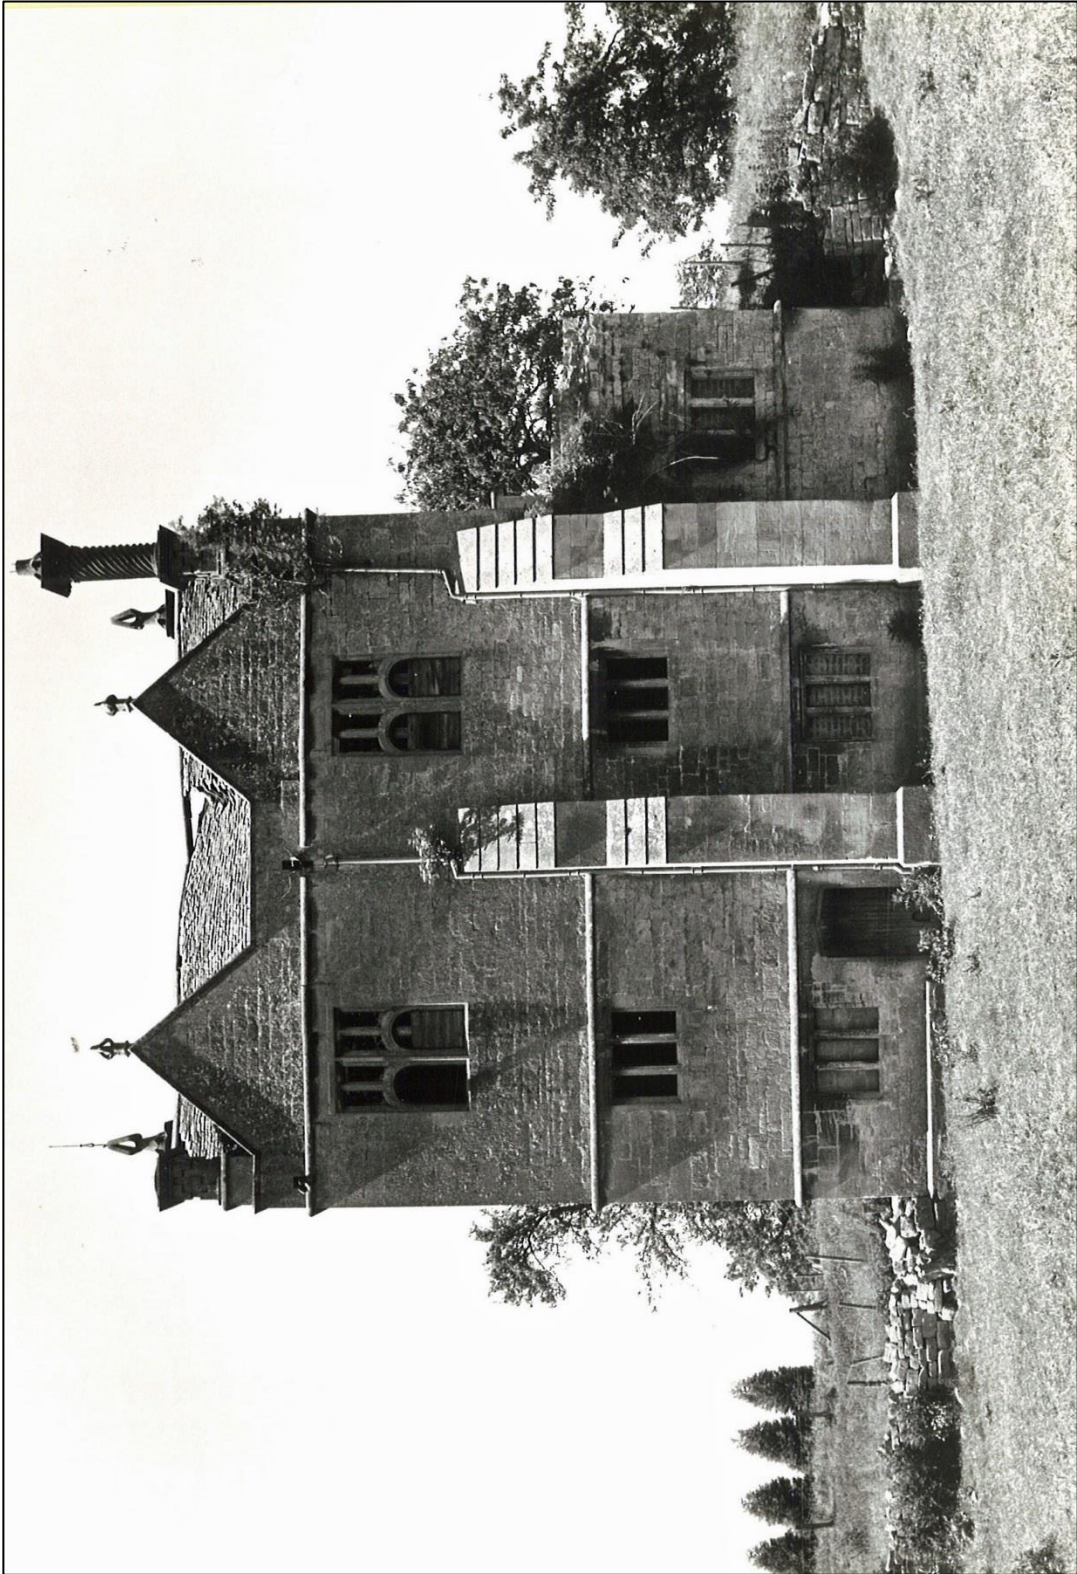
The East elevation before restoration.

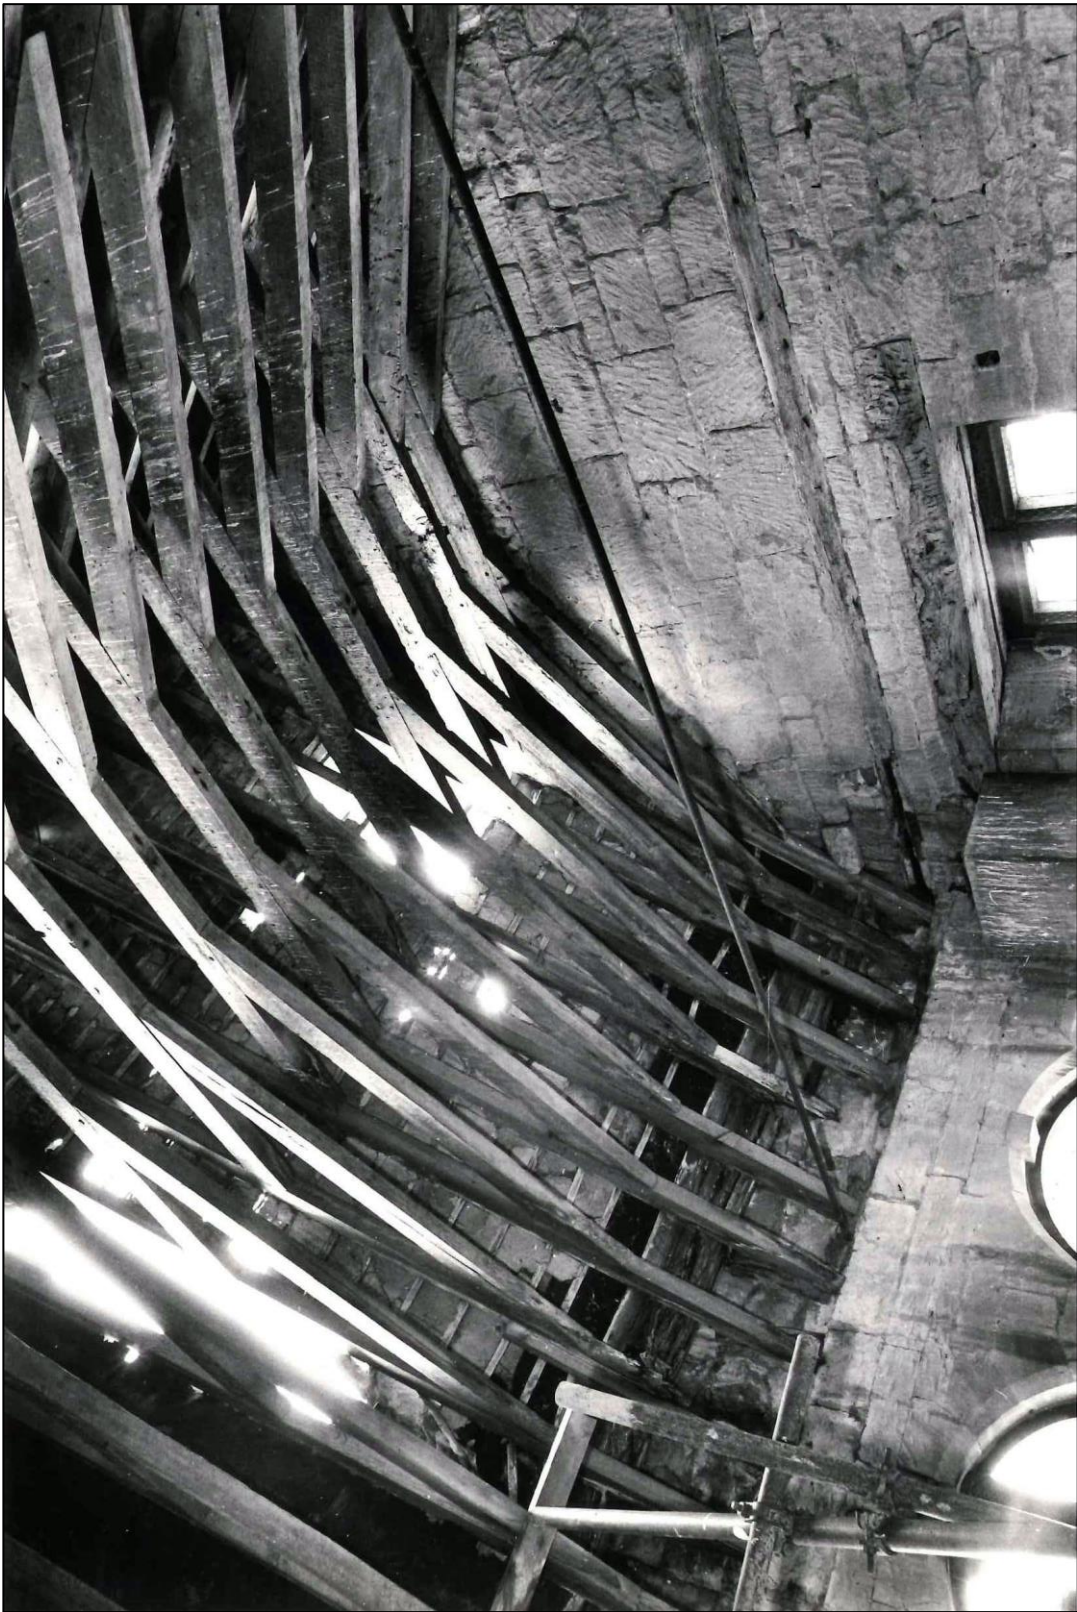
The roof had to be completely dismantled.

Once the roof had been secured and repaired, the covering of stone slates could go back. As many of the old slates were reused as possible, which in the end amounted to about half. These were made up with new from a quarry in the Cotswolds. Where the gables meet the main roof, there is no break in the slates, forming what is called a swept valley, a method traditional to stone-slate roofs.

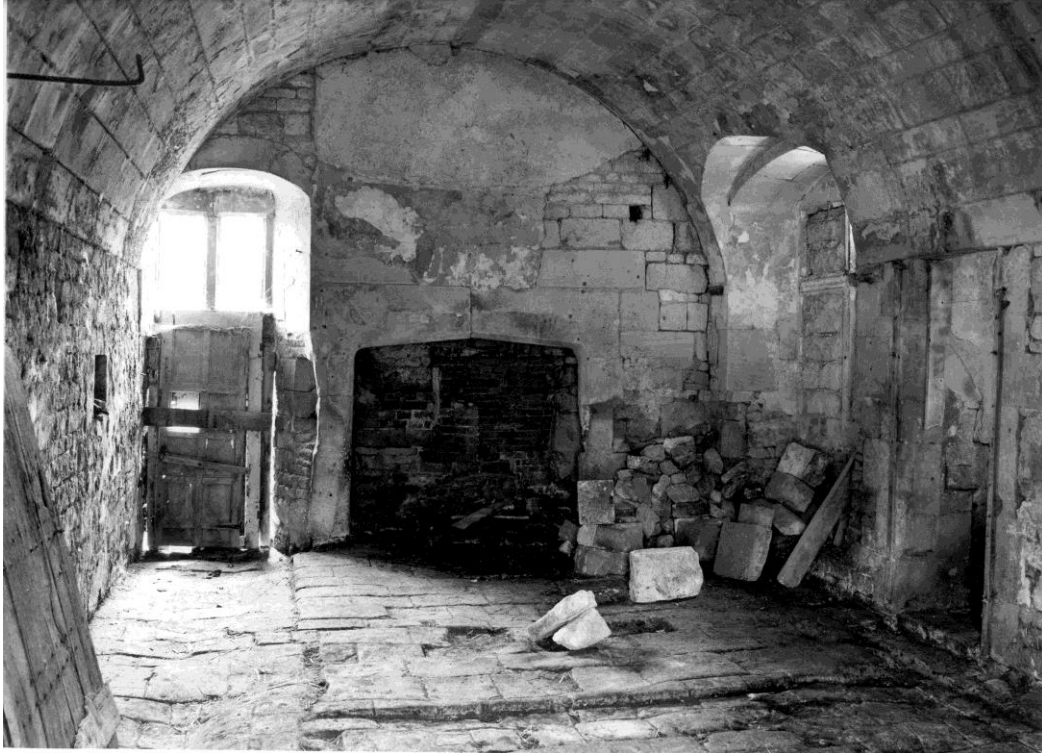
**The lower level showing the partially blocked west window (to the right) before restoration.**

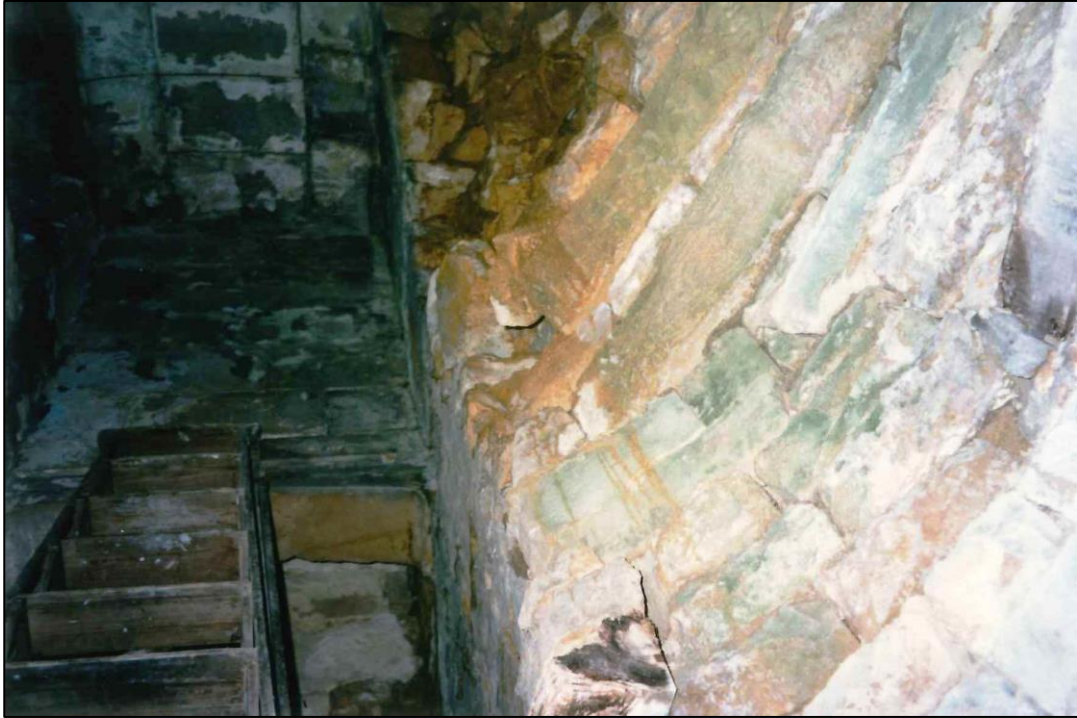
**The collapsed staircase caused by water ingress.**

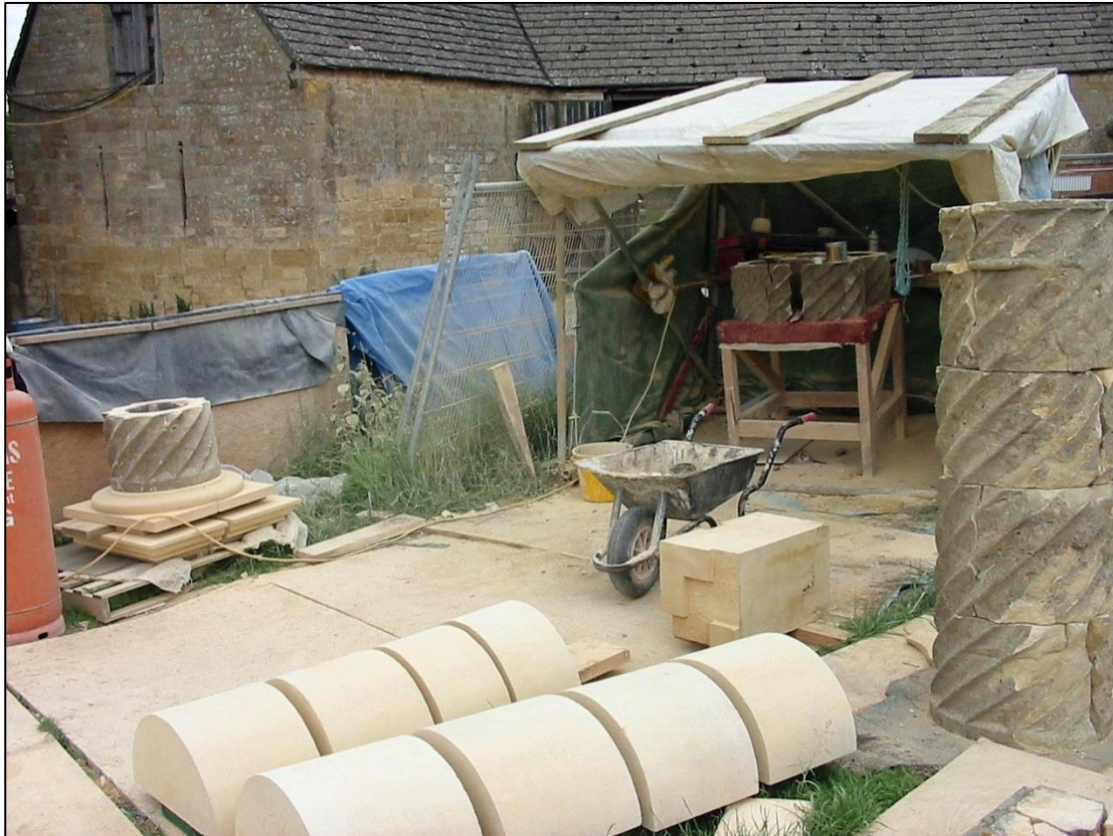
Two new chimneys were built on site in a traditional stonemason's bankers' shed, June 2002.

Also at roof level, two chimneys were found to be beyond repair and had to be replaced. The work was done on-site in a traditional stonemason's bankers' shed. The shafts were carved in two halves, each divided into several slices and the

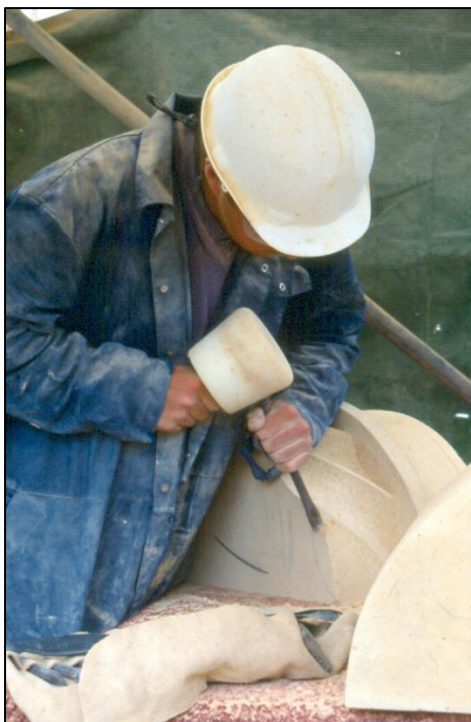
Chiselling the 'barley sugar' fluting on the new chimneys.

fluting lined-out and chiselled by hand – no machine can do the job. John Brown, a joiner for Landmark who has worked on many of our buildings, was seconded to Sapcotes' masons during the project to learn something of their craft. He became sufficiently proficient over the months to be allowed to carve the base of one of the new chimneys.

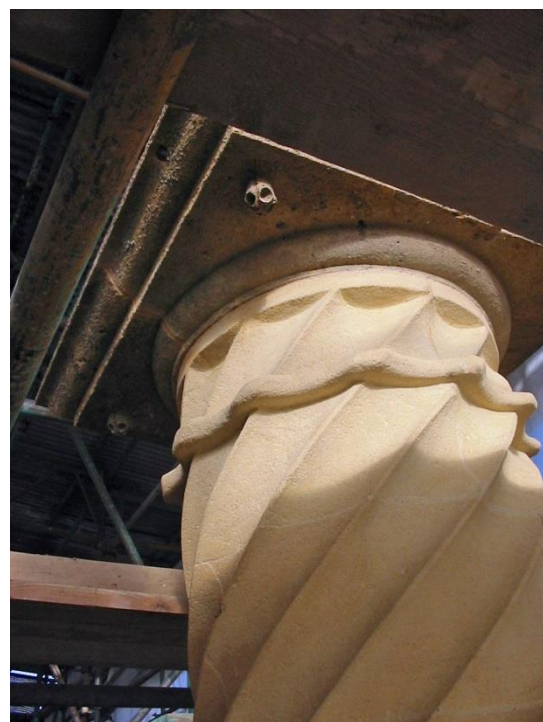
Original stone carving detail of the small *gotti* beneath the square plinths of the chimneys.

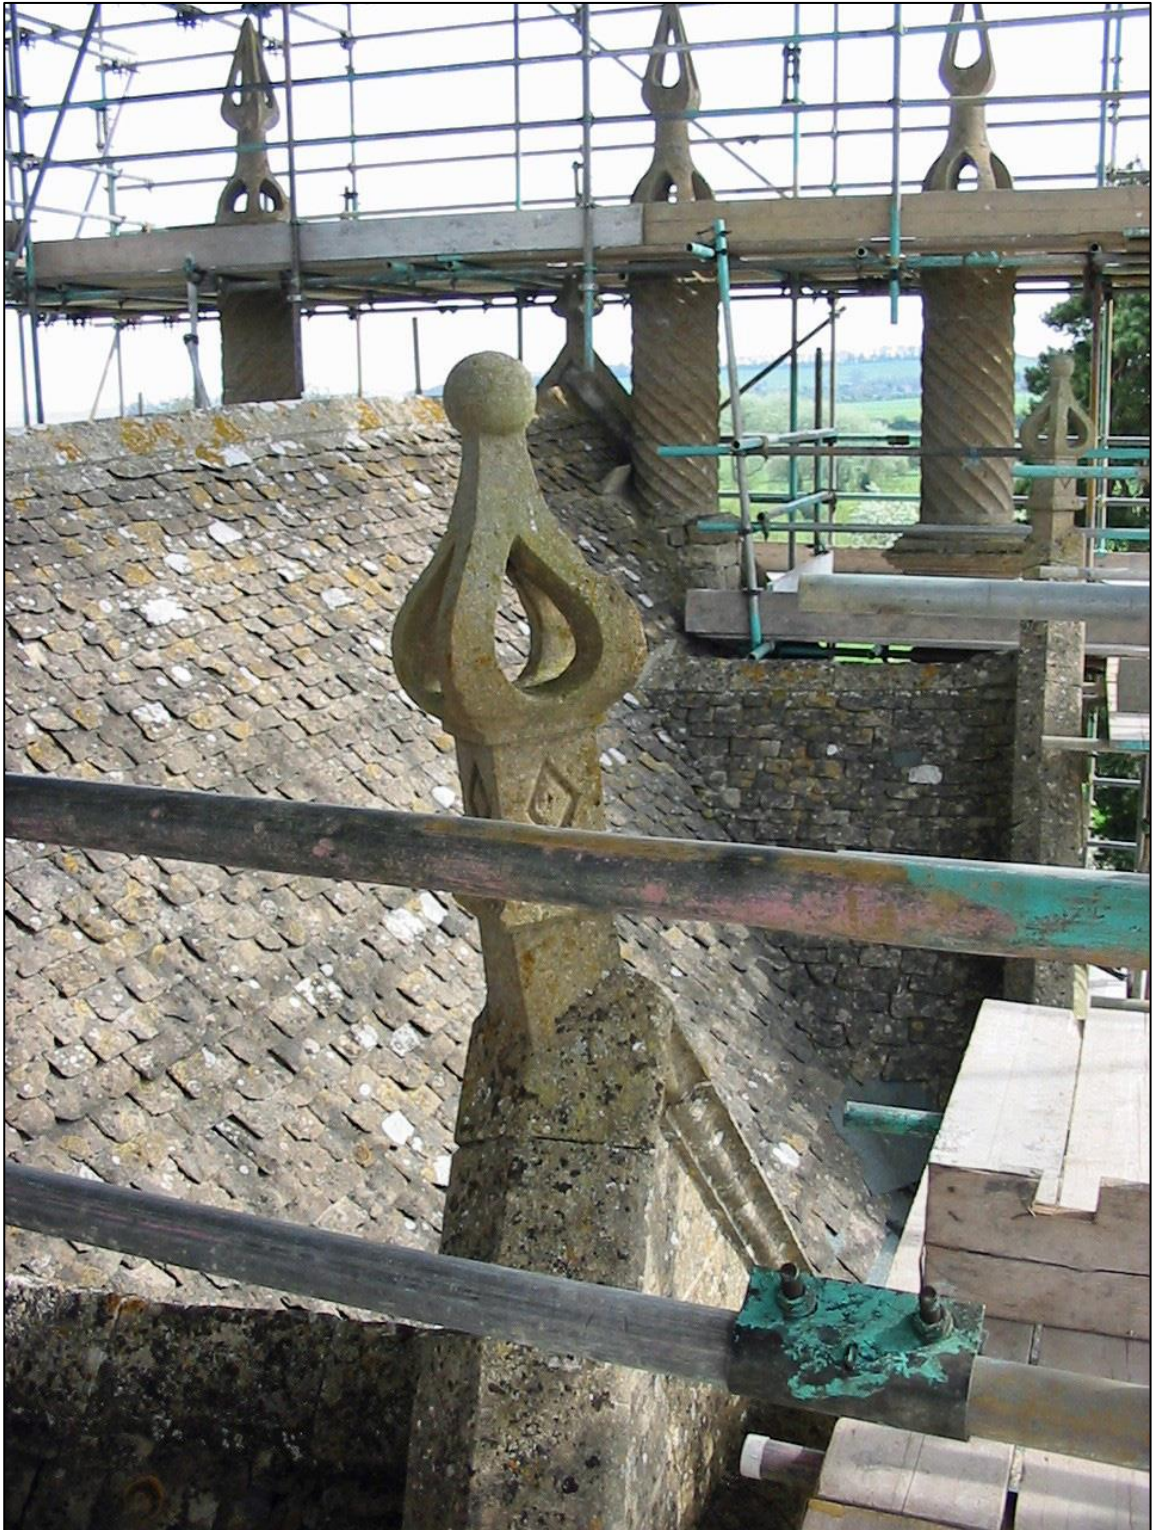
The roof undergoing repair.

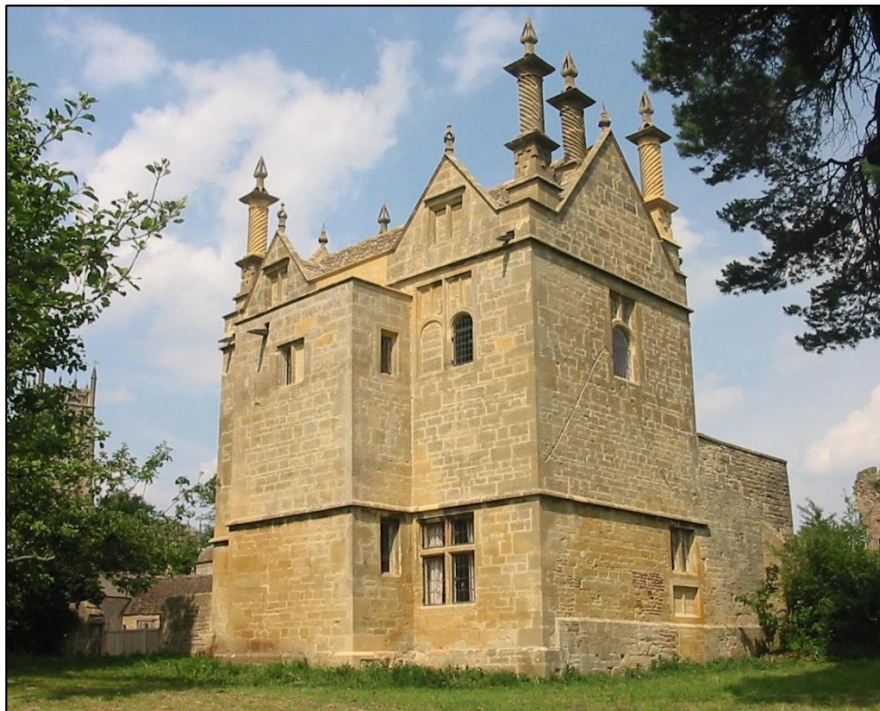
**The view of the south-west elevation after restoration showing the unblocked west window and the re-blocked lower half of the window on the south.**

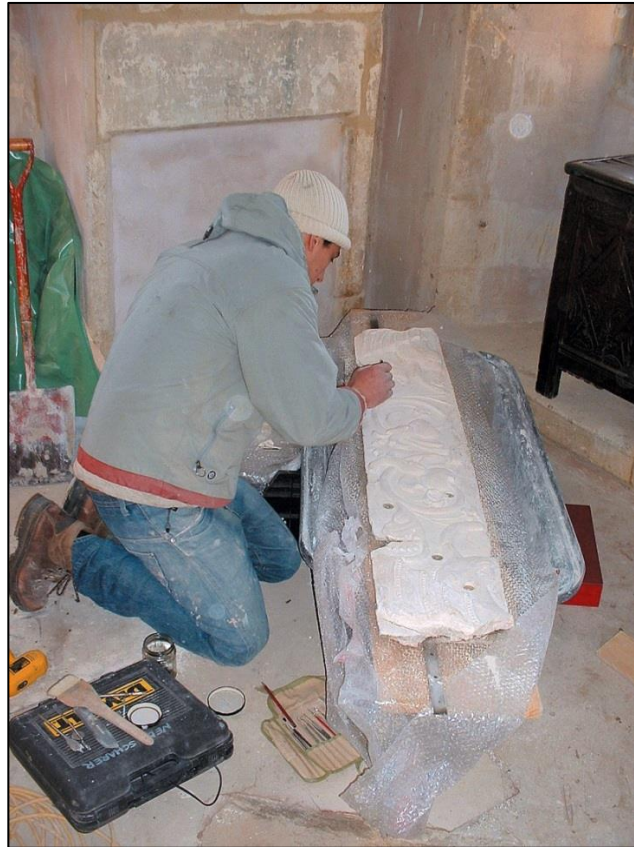
**Piecing together fragments of the decorative frieze below the cornice on the first floor.**

The ceiling on the first floor still had its original barrel vault (unlike the East Banqueting House where the Earl of Gainsborough had once again intervened). Unfortunately it was so decayed that it had to be replaced with new lathes and 3-coat lime plaster. The patchy plaster in the rest of the room is largely as we found it, limewashed over. The decorative frieze that runs around the cornice has been pieced together from pieces picked up off the floor or stored in boxes in the Fellowes' attic by conservator Ned Schaerer. The fashion of the day was for such plaster to be brightly painted, although the only evidence of colour that remained here was blackening of the winged grotesque's eyes, which we have reinstated. The cornice moulding is based on sections found on the floor.

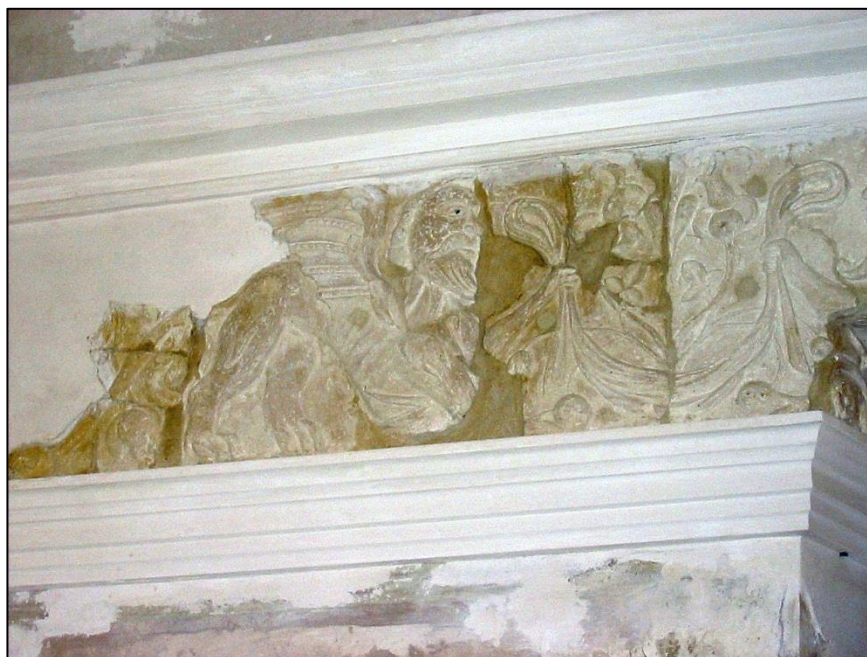
**The blackened eye of the winged grotesque was the only evidence of colour that remained and which we have reinstated.**

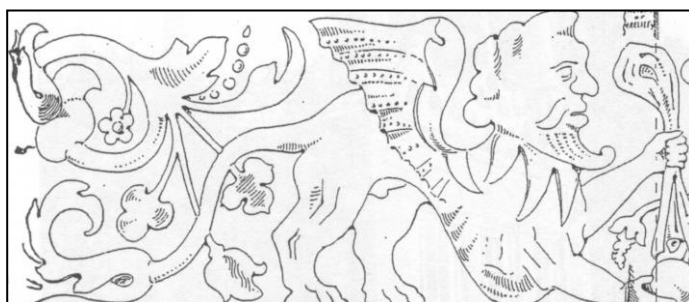
**Drawing of the complete grotesque**

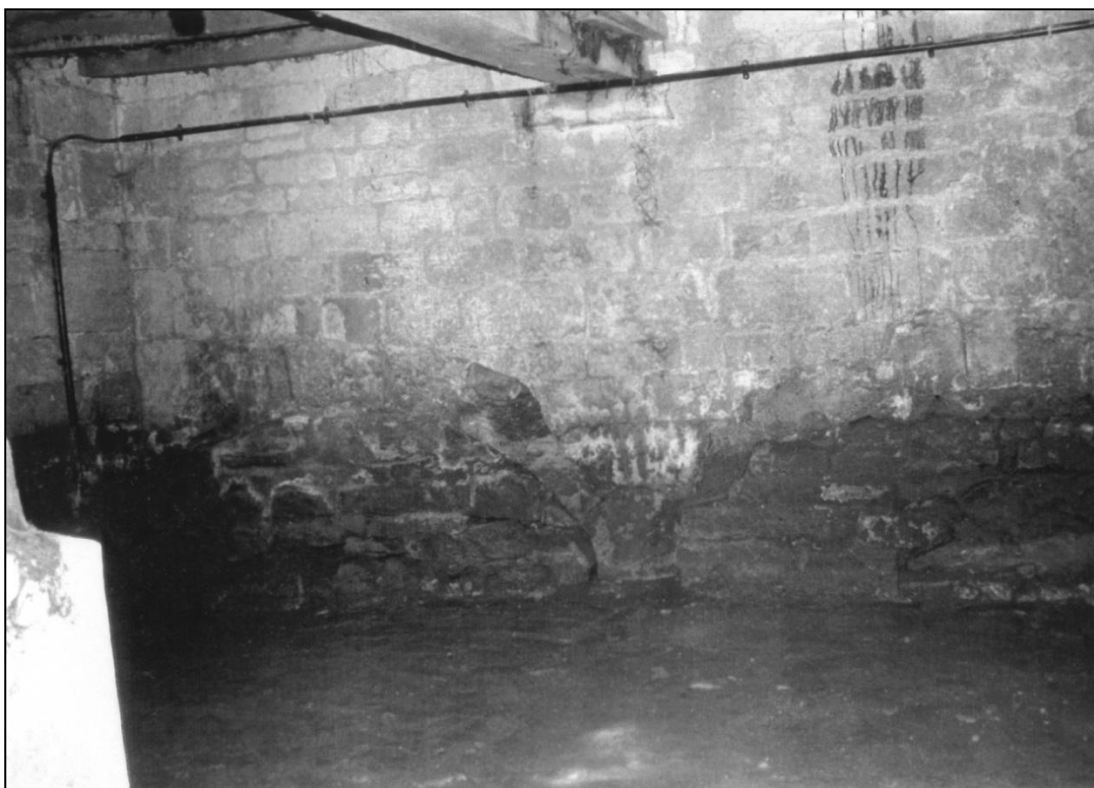
**The cellar of the Almonry, showing the possible conduit arches built into the wall (now blocked) and drainage channel down the centre.**

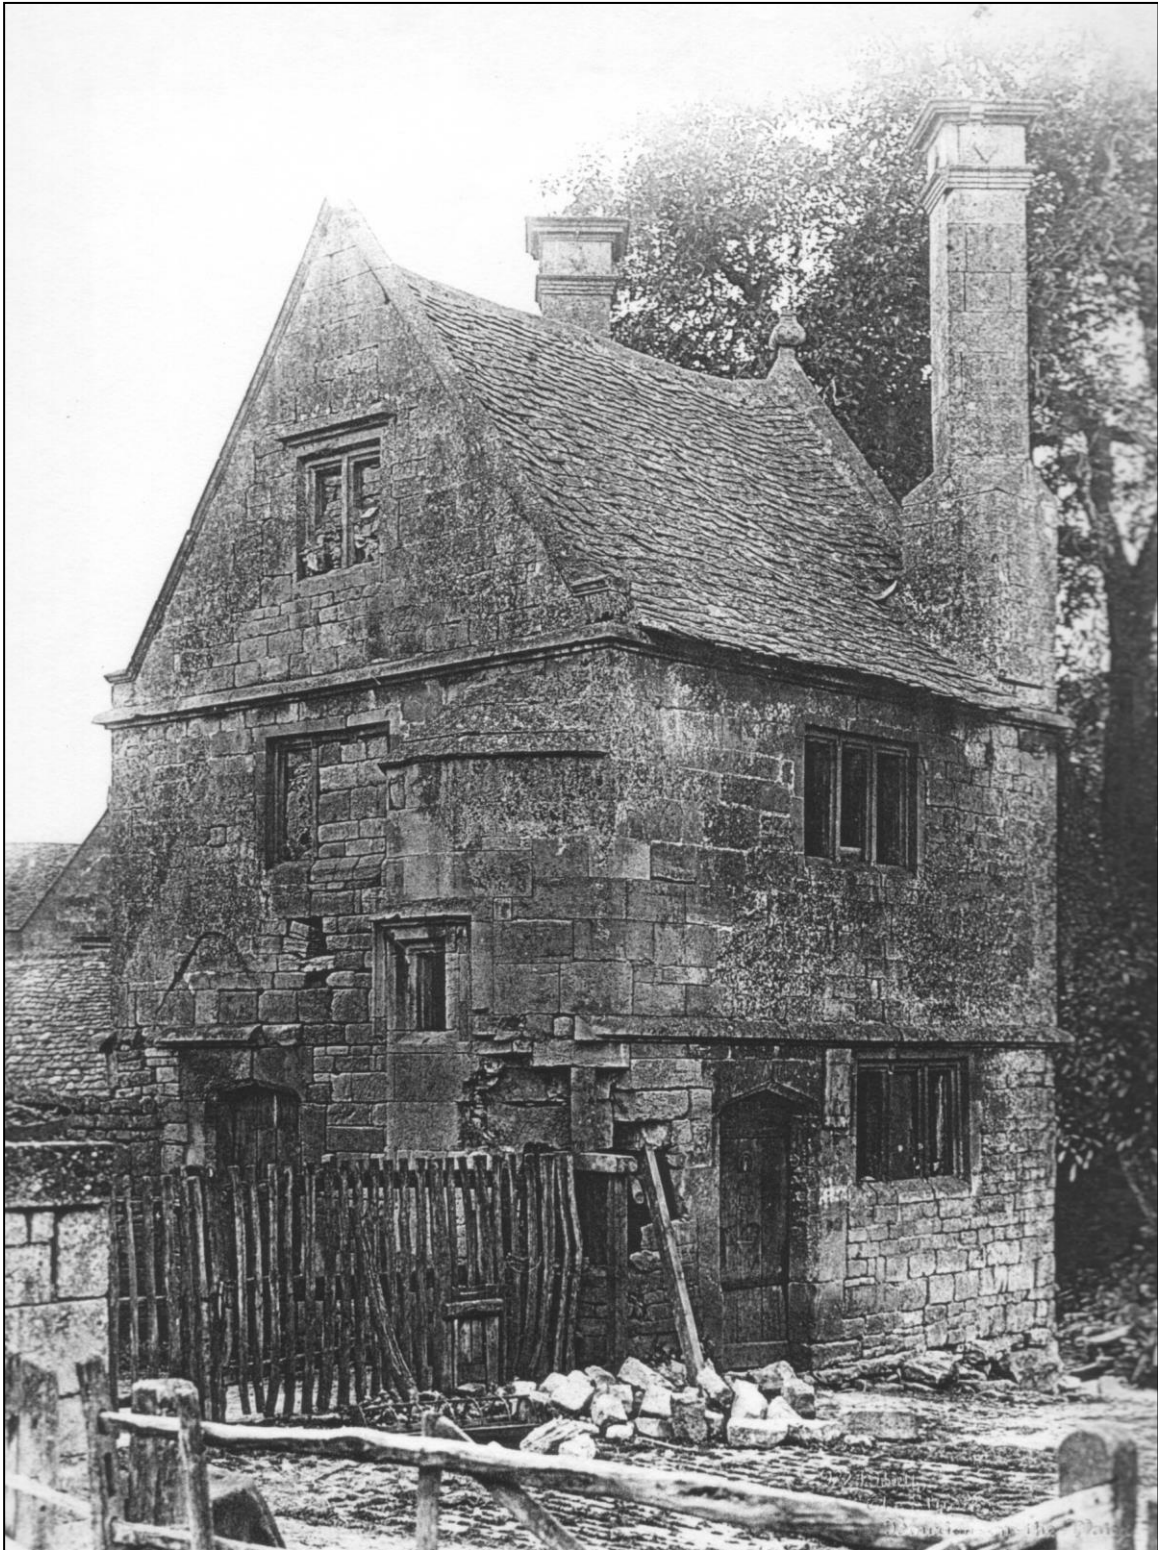
**The Almonry before its repair in 1929. The removal of the lean-to (see Fig 29) has made the dangerous state of the stair turret alarmingly clear.**

Under Griggs' instructions, in 1930 local builders Pymment and Sons undertook repairs to the stair turret. Pymment & Sons were the firm founded by the same Mr Pymment, builder and joiner, who had taken on the Silk Mill. (His firm is still in business today, under the same name although now in different ownership). According to sound SPAB principles, photos were taken before and after the repairs at Griggs' instigation.

The photos show that the stair turret at ground level was almost completely rebuilt and the first floor window on the south elevation was reinstated. The shadow of recently removed accreted buildings is also apparent, a removal that may have accounted for the dangerous state of the stair turret. The first floor window in the south elevation also appears to have been almost completely replaced. Griggs was correct that the stone would tone down naturally, though his repairs can still be identified today on the stair turret.
