# The Landmark Trust

## **SHELWICK COURT**

### **History Album**

**KEY FACTS**

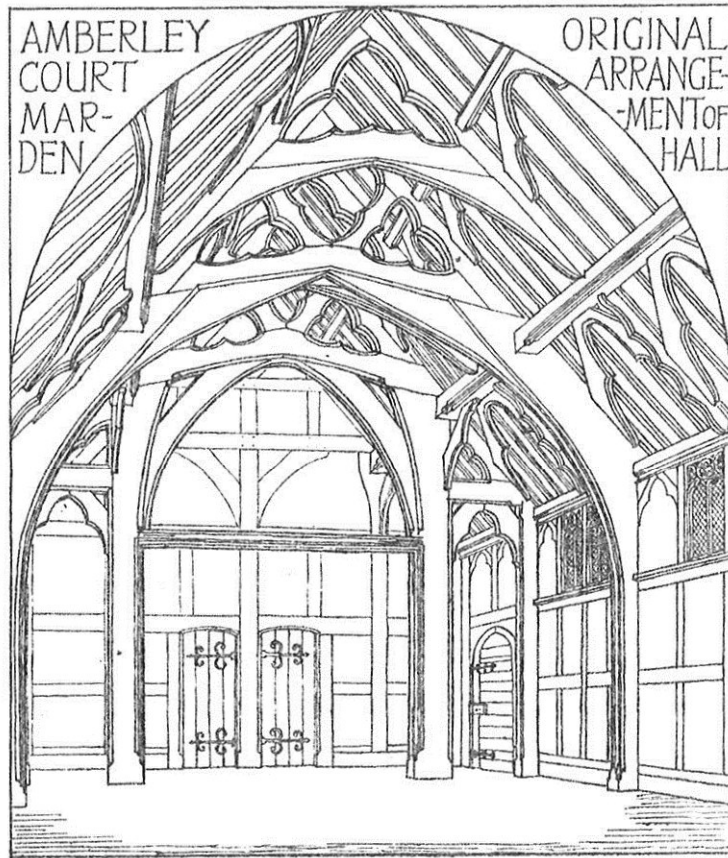
**The medieval Shelwick might have looked something like this, with a hall between storeyed cross wings. Amberley Court has the same system of main and secondary trusses in its roof, both in the hall and the wings.  
From the Royal Commission on Historical Monuments: Herefordshire vol 3**

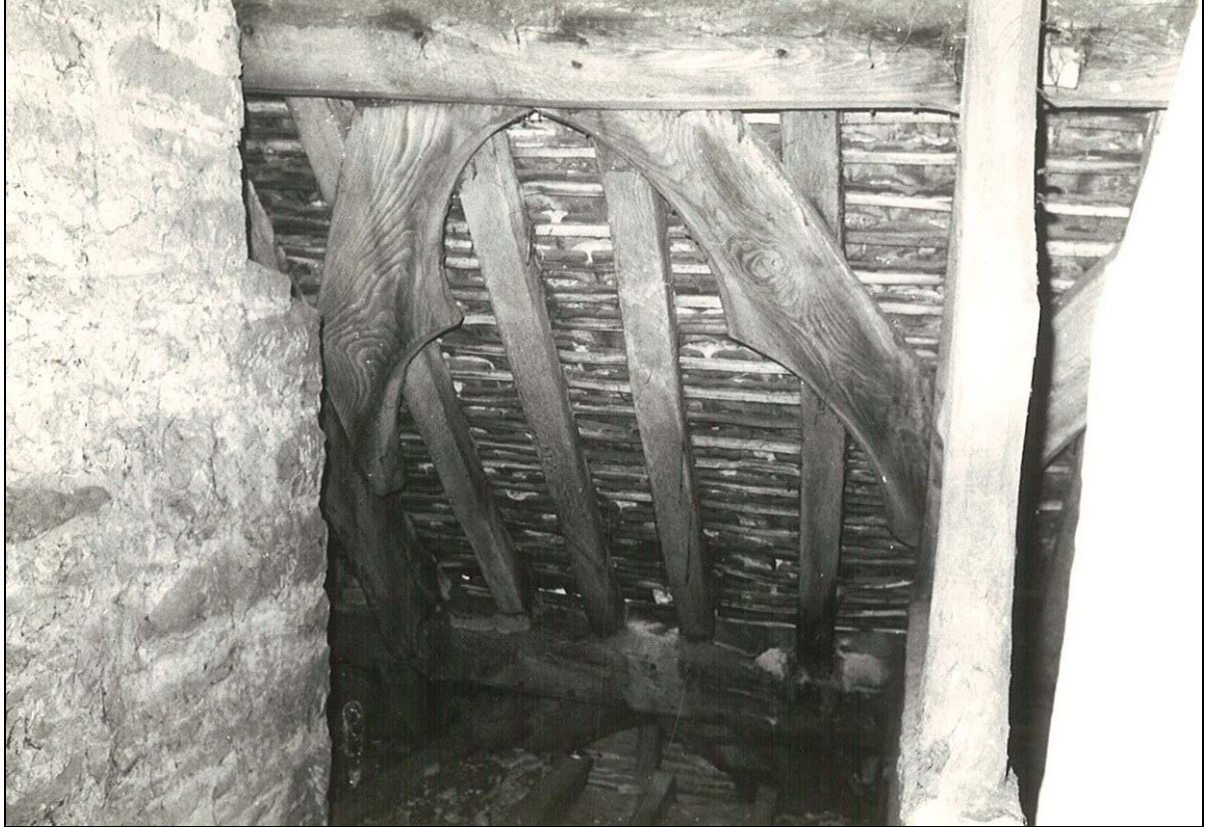
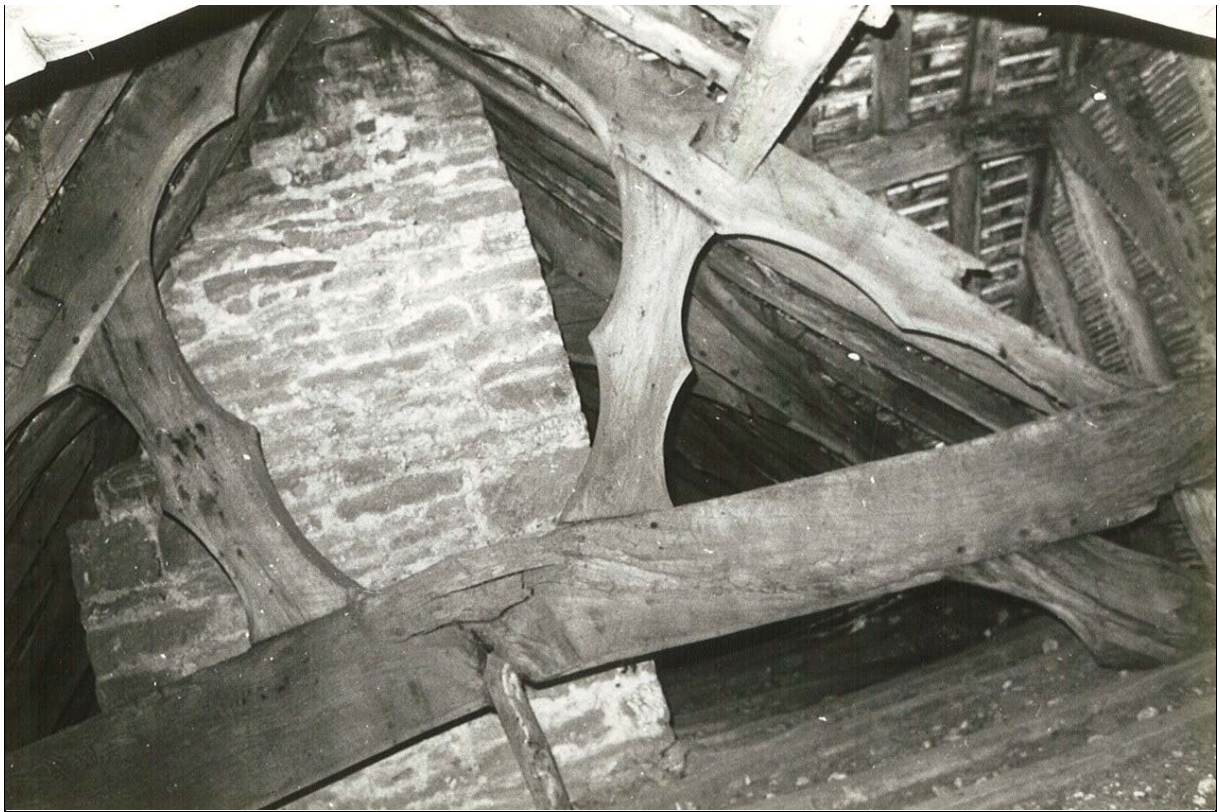
**Medieval roof**

In the roof, repairs were also kept to a minimum. Where a section of collar-beam in the central secondary truss had been cut away for the 17th century chimney, and where part of the northern tie beam had rotted, new oak was let in. Rotted ends of purlins and wall-plates were renewed too, but missing wind-braces were not replaced. In two cases where joints had failed, steel plates were inserted to hold the truss, rather than opt for wholesale renewal. In this way, just about everything you see is medieval workmanship, and there is no need to question what is new and what is old.

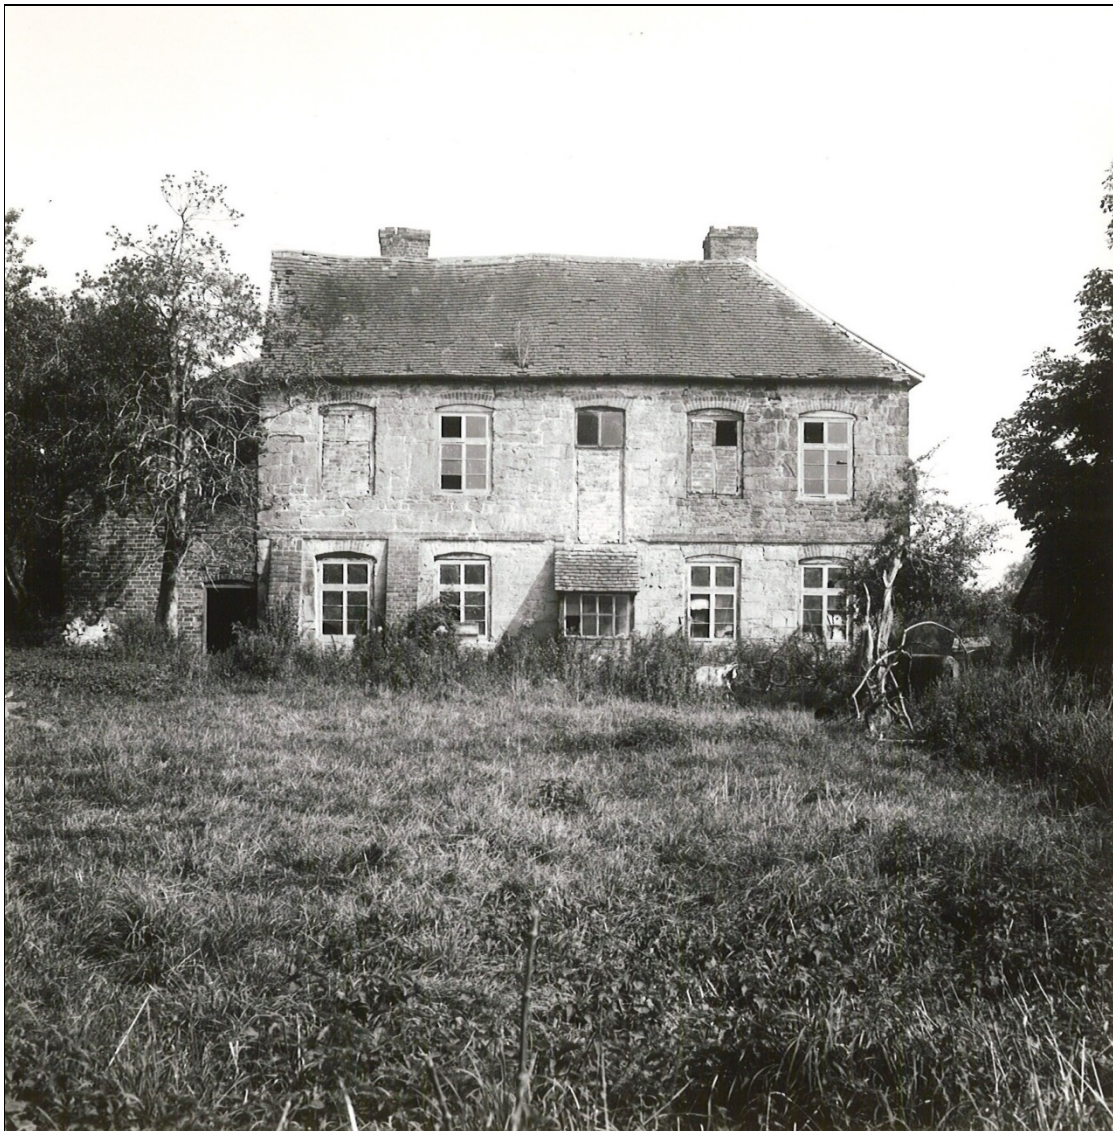
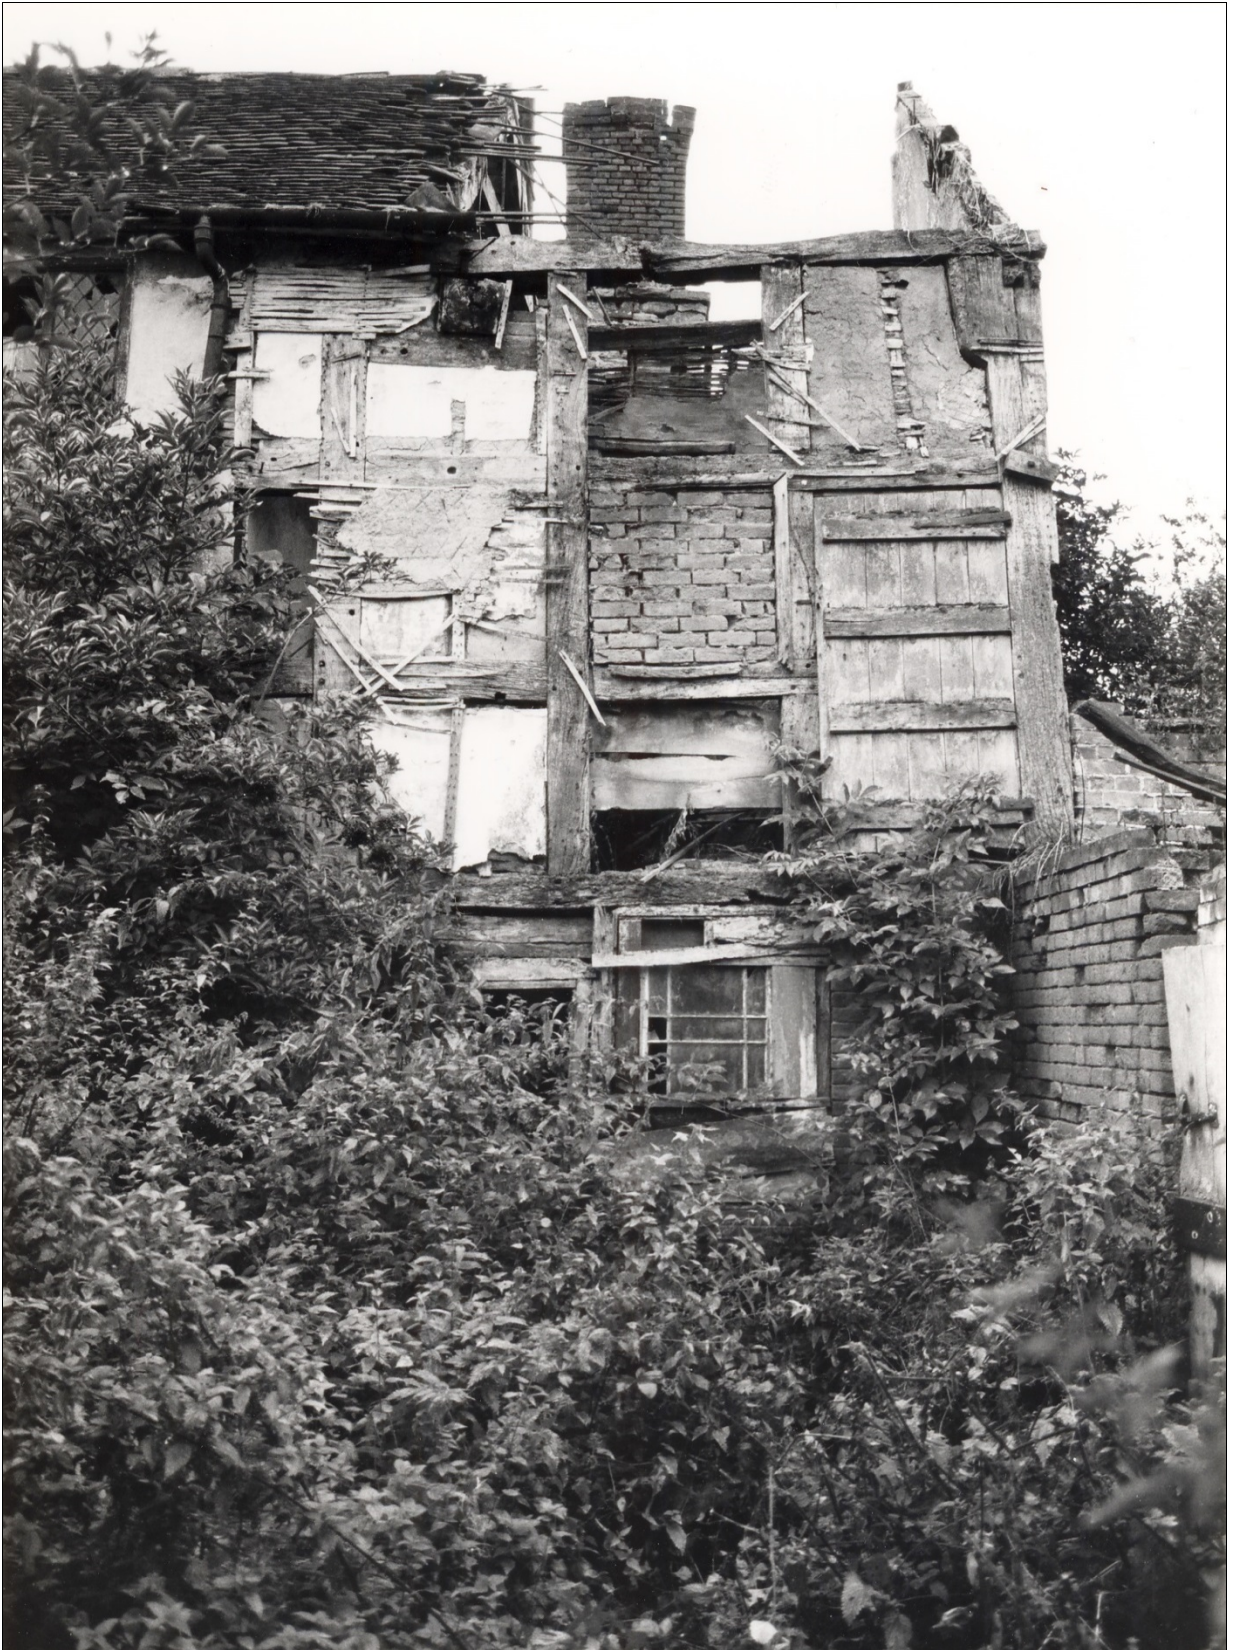
**Shelwick Court circa 1981**

It is hard now to imagine the state of Shelwick Court as it was in 1981. The gable on the north west corner was standing (just), but the roof behind it had collapsed. The south front was bulging ominously, plaster was falling off the walls inside and out, and structural timbers were sagging where their ends had rotted. Neither floors nor stairs were safe to walk on. Collapsing brick walls and lean-to sheds disguised parts of the house, and a caravan stood against the north-east corner, into which Mr Orgee had moved when a Closing Order was enforced on his home in 1960. The finest part of the building, the medieval roof, could only be seen after a perilous scramble through the attics.

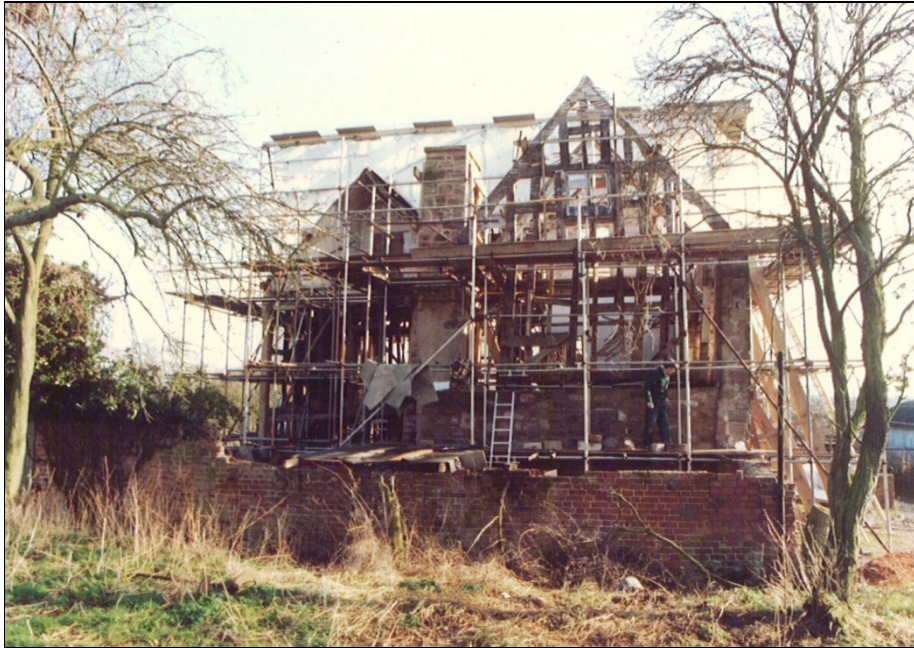
**The medieval wing was protected by a temporary roof while work was carried out**

Such policy decisions over, the most imperative need was to get on and prop up the building before any more of it fell down. Scaffolding was constructed, bracing the medieval roof, and the whole of the south front was shored up with timber buttresses. Then the unpicking could begin - always requiring great caution in a timber building, since it is possible to find yourself with almost no building left at all.

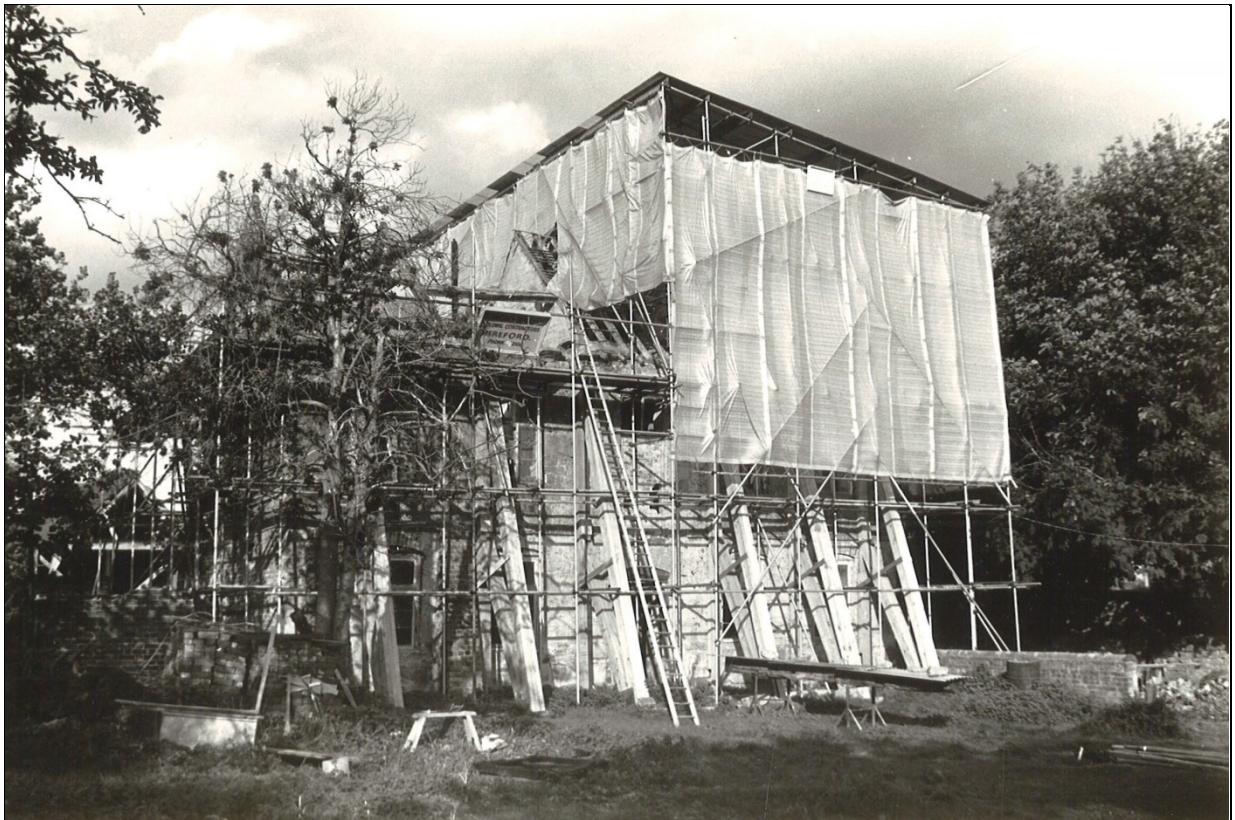
**Shelwick Court with temporary shoring in 1982**

The discovery that the medieval wing had originally contained a first floor chamber or solar, and had not been open from the ground, meant that the chimney need only be taken down to that level. The ground floor stage, with its fireplace on one side and ovens on the other, could be kept. It would also support a ring-beam of reinforced concrete which the engineers advised forming around the front half of the building, to provide stability. On the front this would anchor the steel ties which were to run through the wall to the plates on the outside, holding the two skins of stone together.

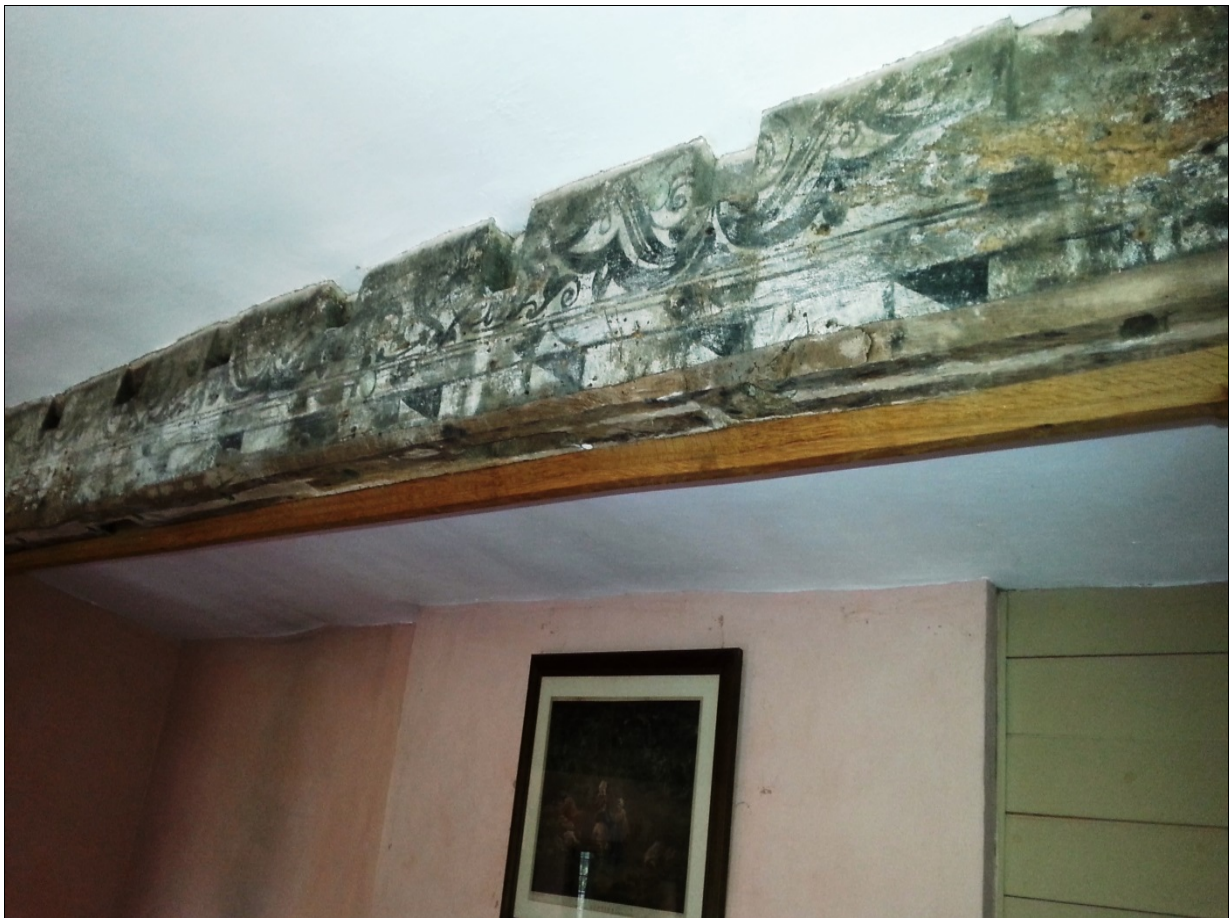
**Exposed 16<sup>th</sup> C beam**

In the rooms below the solar, the medieval framing was exposed. Apart from this they have kept their 17th century appearance. In the southern room a beam with painted decoration was discovered, apparently of late 16th century date. The beam was in poor condition, so the painted surface was cut off and applied to a composite beam made to support the new ceiling. The decoration itself was cleaned and consolidated by John Dives. New windows were fitted in the northern room, and new softwood floors in both.

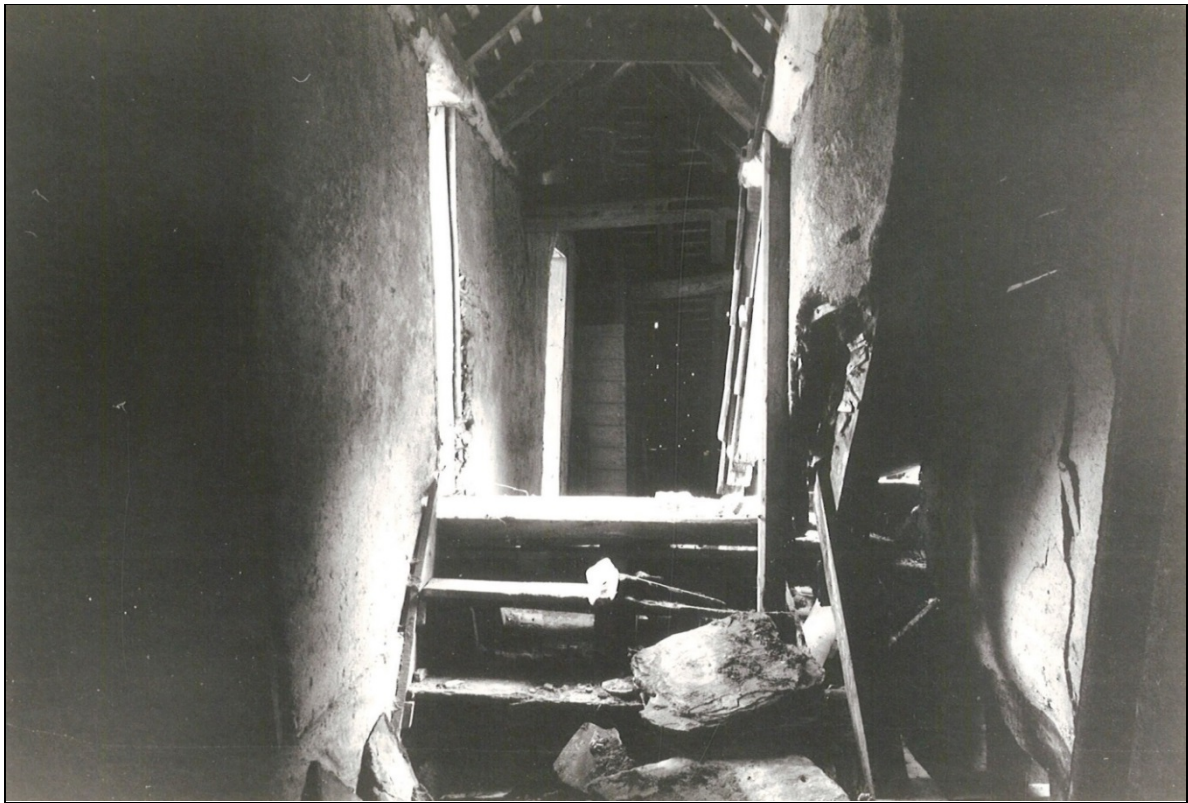
In the south-west and staircase wings the repair was fairly straightforward. Round the staircase the frame was repaired on the same principles as the east wing, and then the weather-boarding carried on round. Two 17th-century windows survived intact, the small top one still with its original glass and lead. The staircase itself had new oak put in where steps or other sections were missing or badly rotted. 19th-century softwood balusters were replaced with new oak ones set diagonally, as they had been originally, but otherwise it was reconstructed as before.
