The Landmark Trust

WARDEN ABBEY History Album

Researched and written by J.M. Wilson 1978
Expanded and revised by Charlotte Haslam, 1994
Re-presented in 2015

Warden Abbey founded	1135
Converted into house	1550s
Listed	Grade I within Scheduled Ancient Monument
Restoration Architect	John Phillips
Restoration Contractors	Bernard Ward Ltd of Bedford
Opened as a Landmark	1976

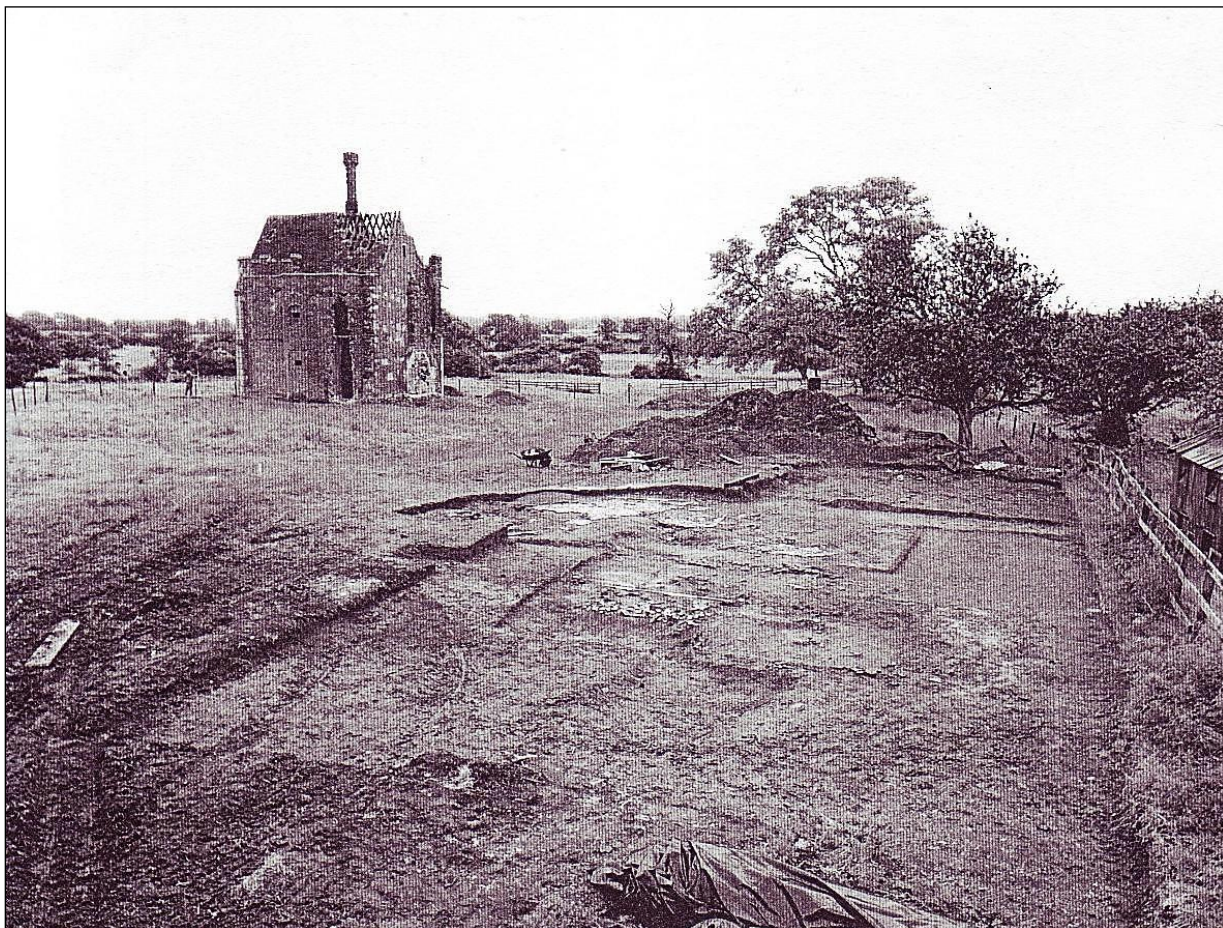
The first excavation of the abbey church in 1961. The roof was damaged by a fire in the late 1950s. The corner of the garderobe tower had collapsed (BCC)

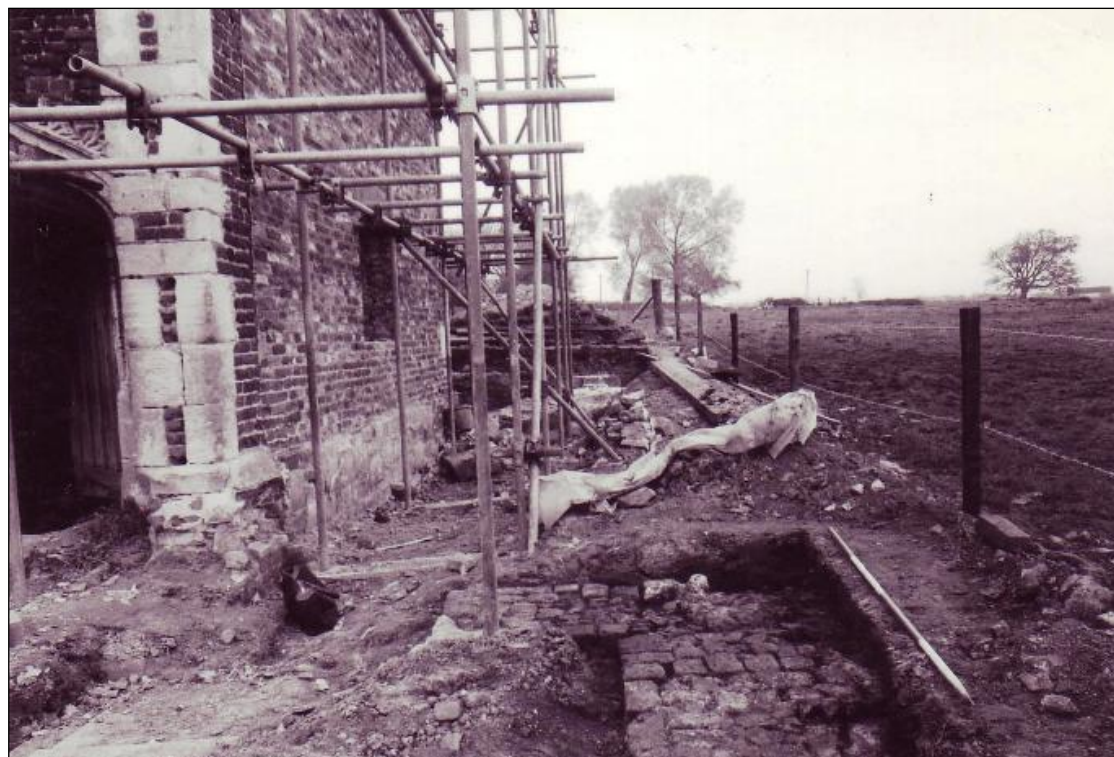
The foreground shows a brick footing for the demolished wing of the mansion, partly re-using Abbey stone.

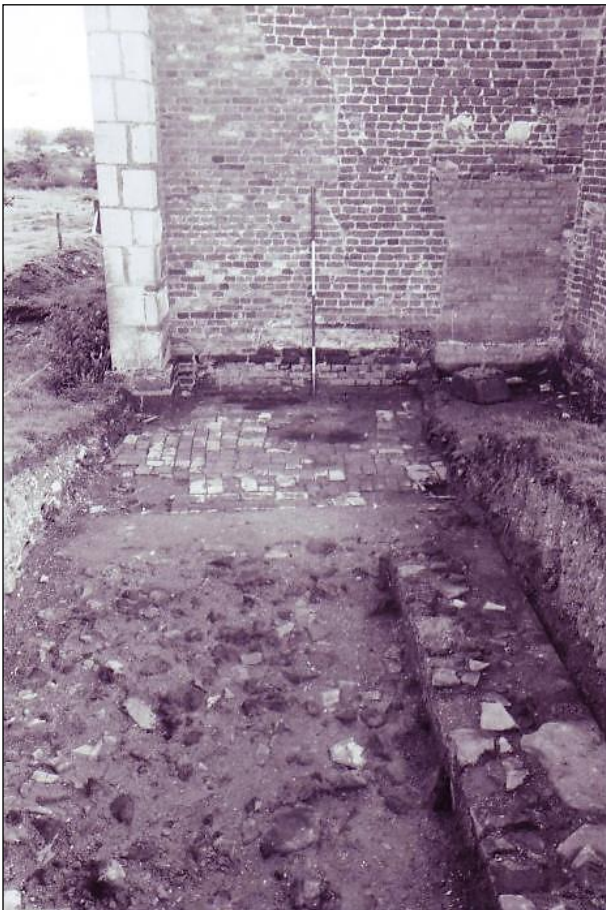
The present building showing the blocked doorway, now opened, with the 17th century floor of the attached building in front. In the foreground is a medieval wall and room fill which was over the top of the second pavement.

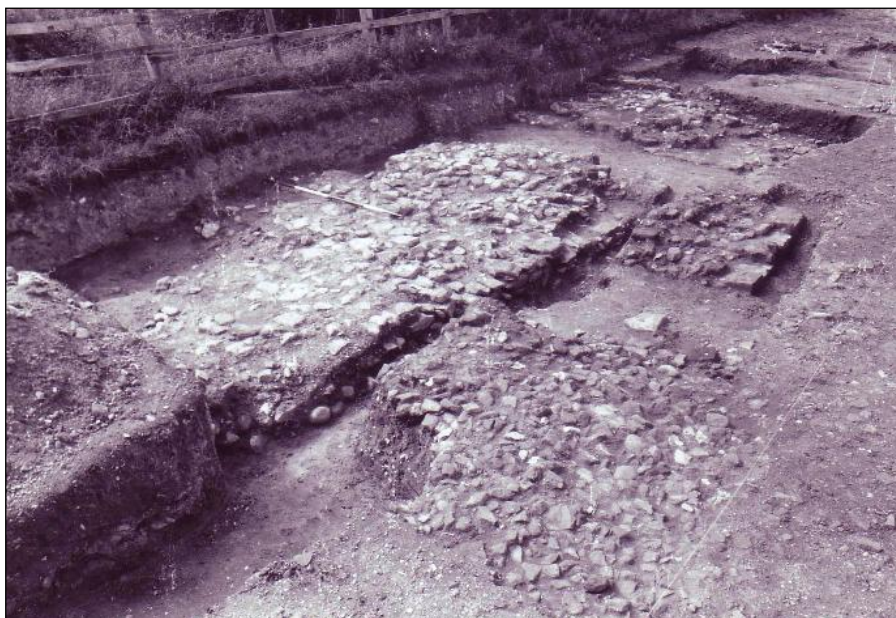
Some of the robbed footings of the walls in the nave of the church.

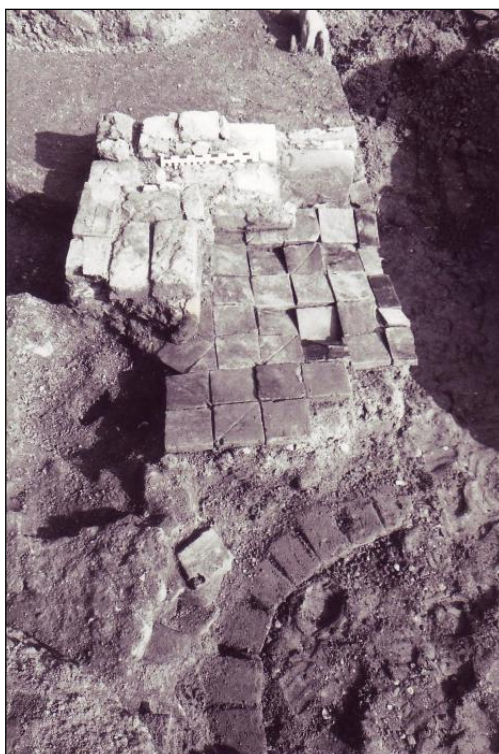
**The remains of the medieval floor outside the present kitchen and sitting room. It survived only because a stone hearth had been built on top of it at a later period.
In the foreground it's a post medieval well.
Some of these bricks were used to repair the house.**

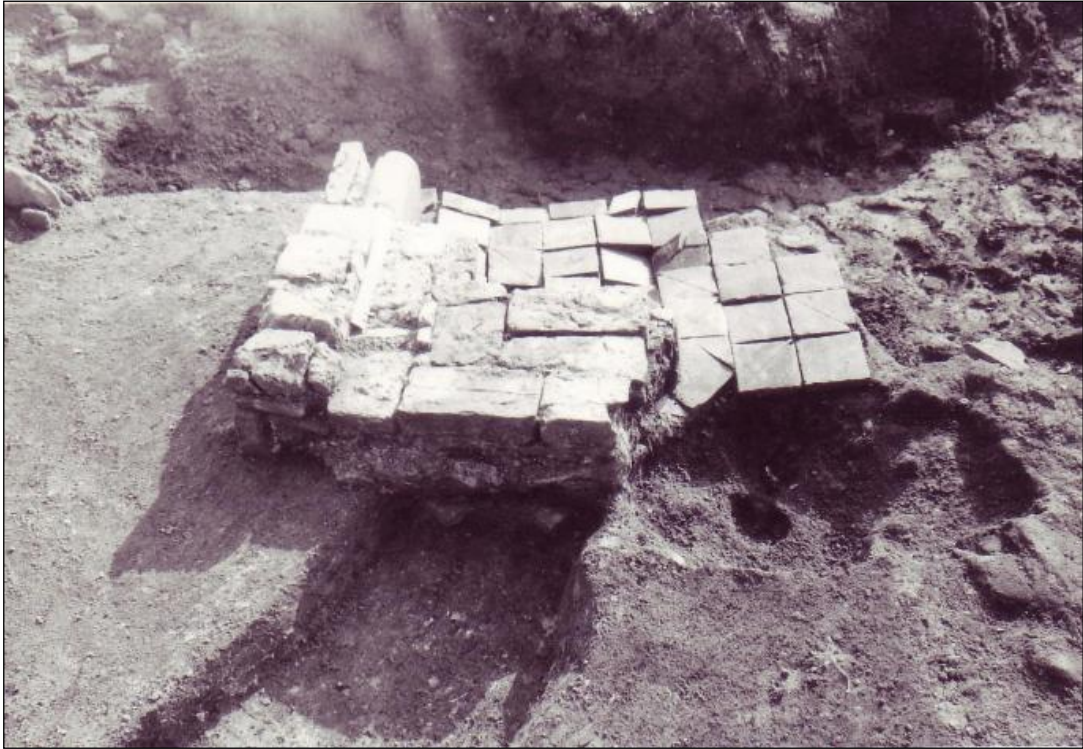
A further view of the floor with the hearth. The circular depression with a round hole in the middle is archaeological evidence of the pump which serviced the well.
