The Landmark Trust

OBRISS FARMHOUSE History Album

Written by Alastair Dick-Cleland, 1997

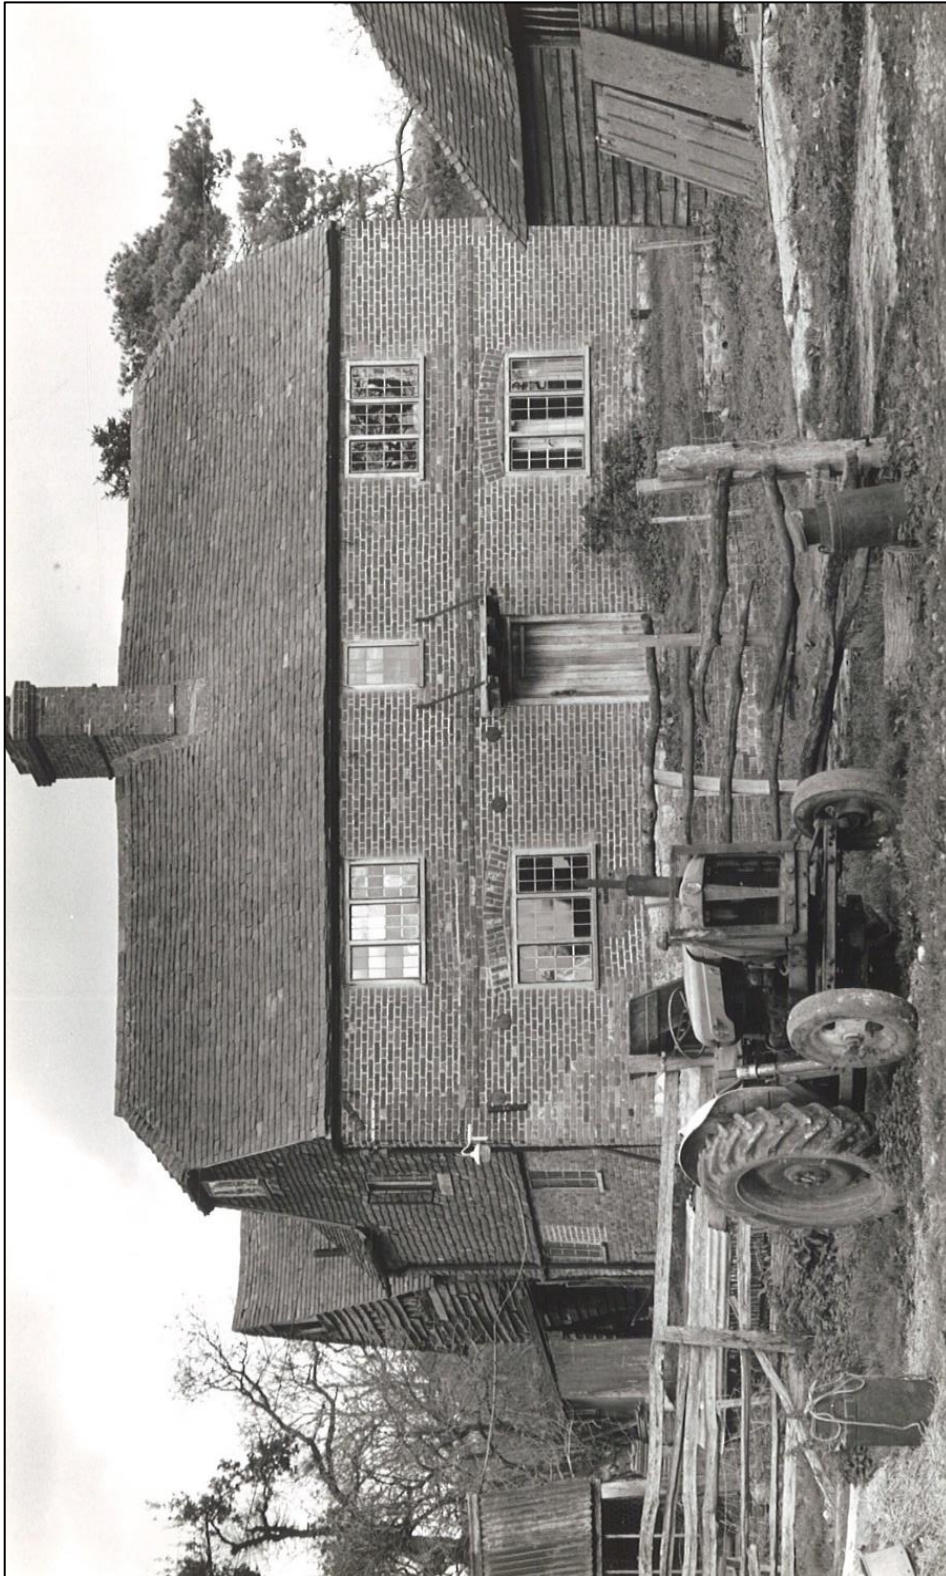
Obriss Farmhouse prior to renovation, 1991.

Unlike many Landmarks, the farmhouse itself required relatively little work. The house needed some structural work, where the sole plate or bottom horizontal beam to which vertical posts were attached, had rotted at the east end and along the front. The roof was retiled on new battens and insulation. Replacement sprockets were fitted – these project beyond the face of the wall which allow the lower courses of tiles to lay at a shallower pitch, enhancing the traditional look. Tilehanging on the back and sides of the house renewed, using a mixture of old and new handmade tiles. The underlying timber frame was found to be in good condition. The walls were repointed using a lime and sand mortar to match some areas of old mortar that survived. The 1920s windows were replaced with ones of a more sympathetic design of 3 x 5 leaded lights in oak frames. Pieces of tile were carefully cut to fill the space between the top of the window and the underside of the brick arch. A new sewage treatment plant was installed in the old orchard and an underground gas tank was put down below the barns.

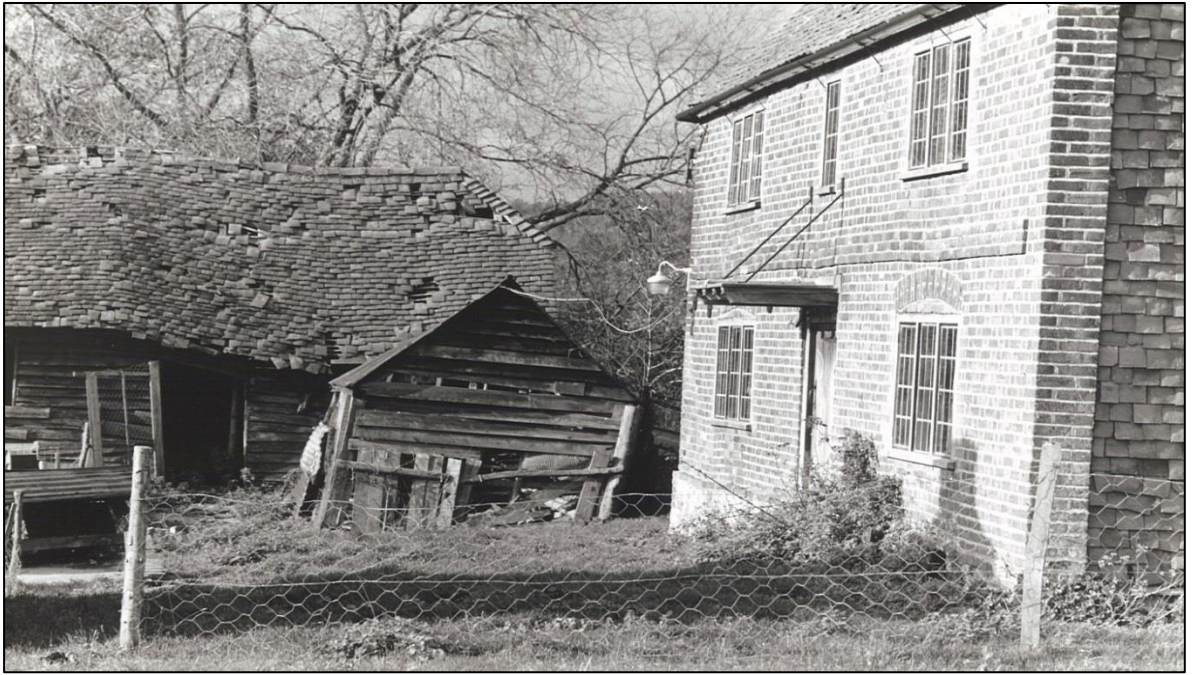
The cow-byre with attached shed prior to renovation, 1991.

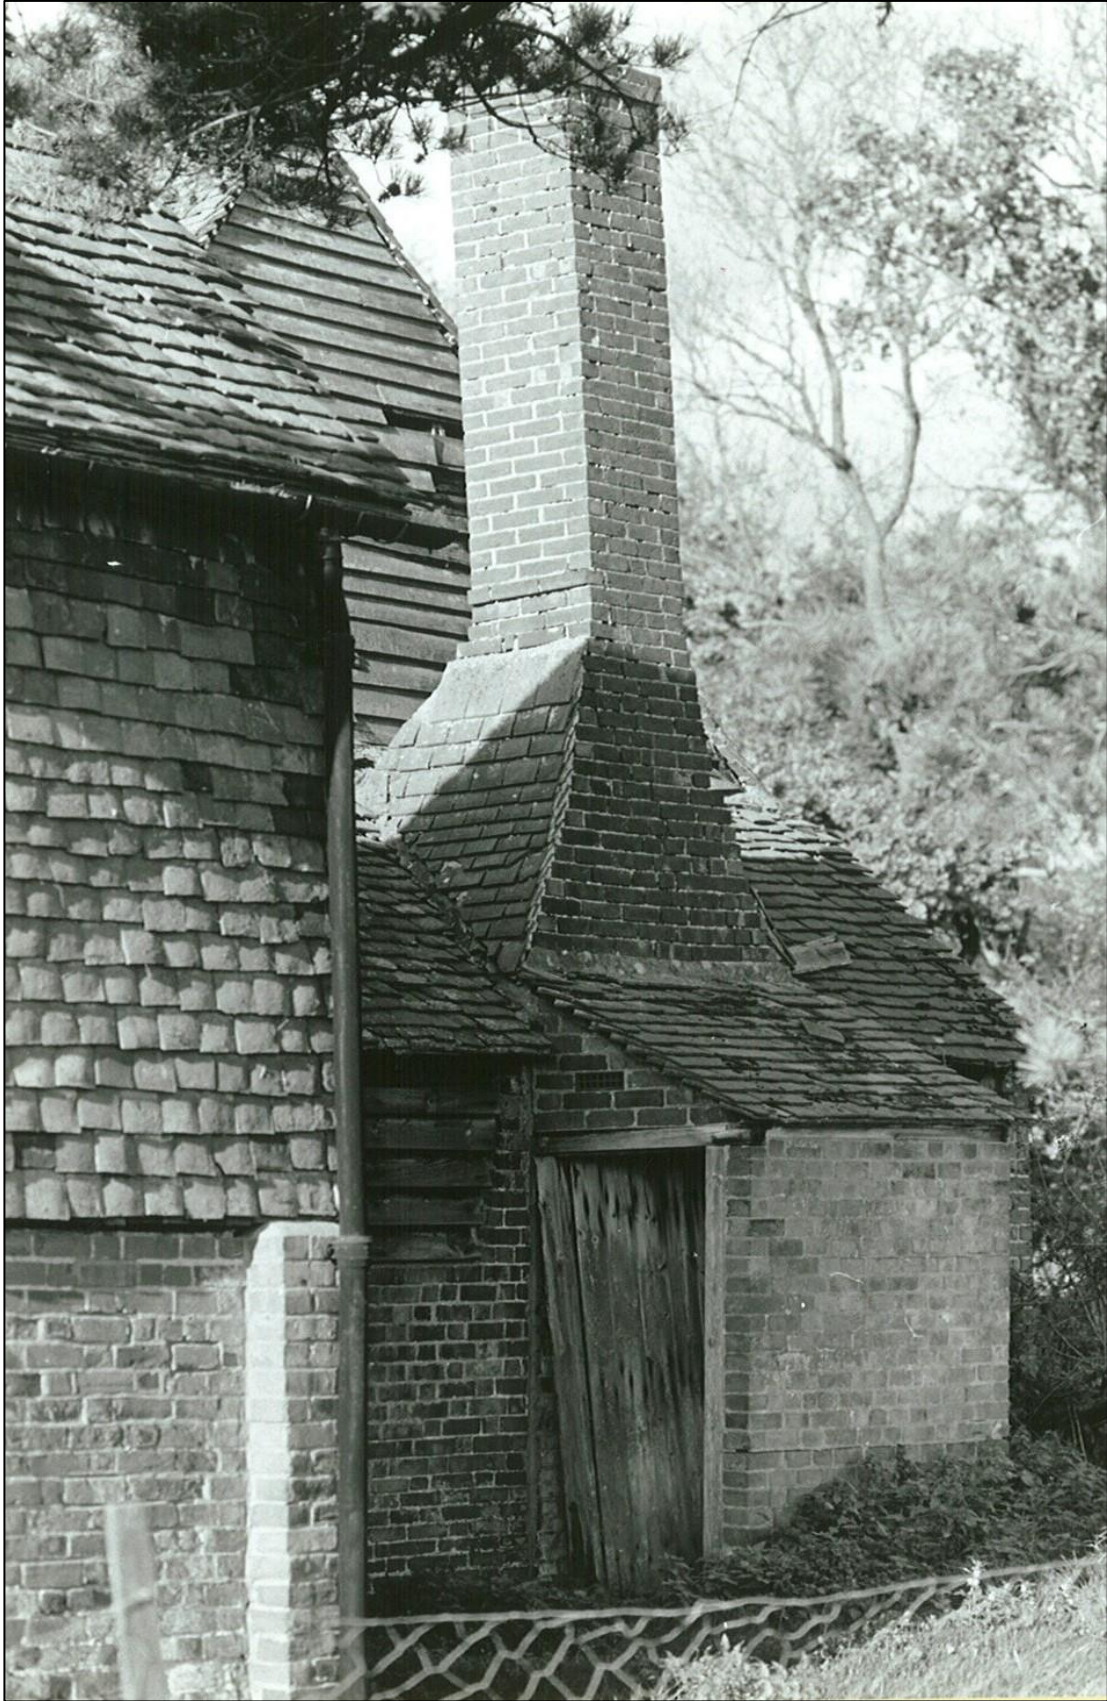
The chimney of the bakehouse (now reduced) and the demolished privy.

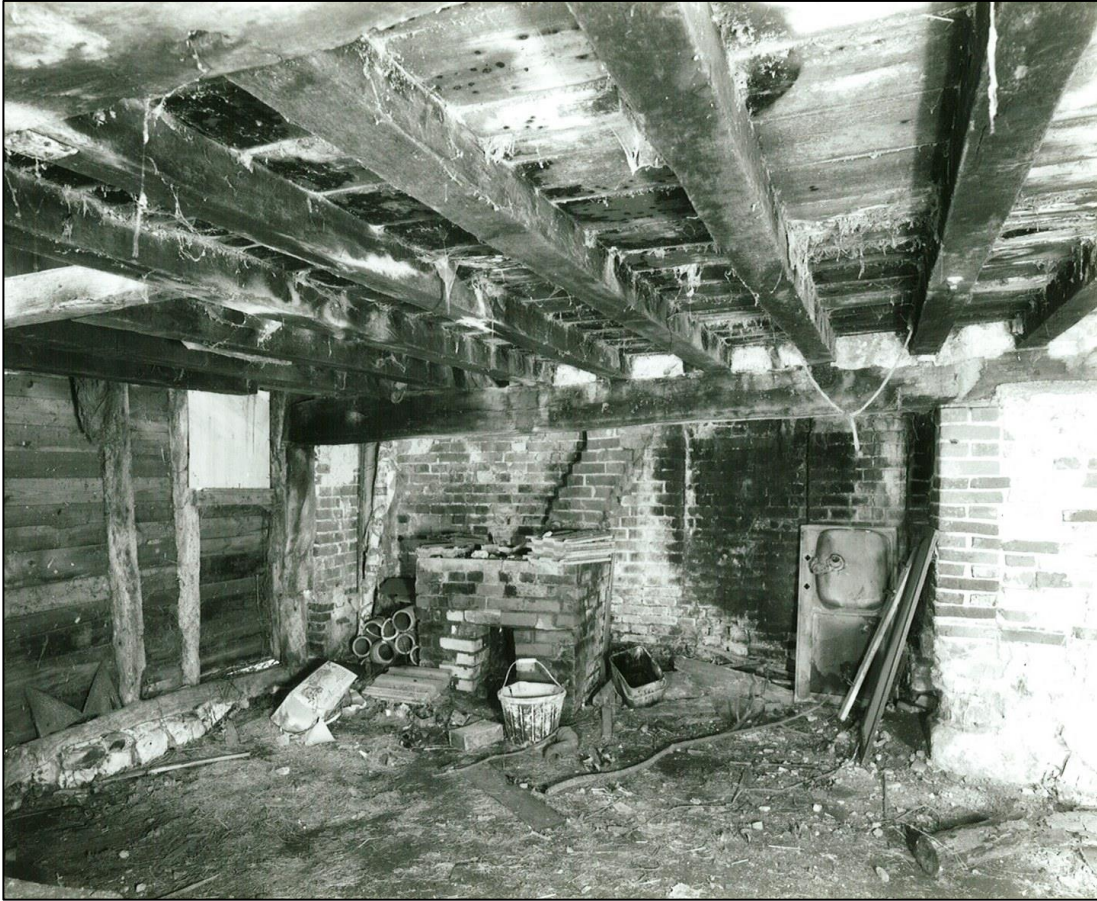
The bakehouse interior.

The building is situated across a narrow open yard or passage immediately to the rear of the farmhouse, to which it is set parallel. It is a two-bay, two-storeyed structure served at the eastern end by a single-flue fireplace located within a 19th century lean-to. A large bread oven is incorporated into the southern jamb of the fireplace, whilst towards the northern side is a built-in water-boiling furnace or 'copper'. A small room is divided off from the north-western corner by a 19th century partition, but otherwise the ground floor area is occupied by a single space, as too is the upper chamber, which remains open to the roof. The building is fully timber-framed. The furnace and oven incorporated into the fireplace show the 19th century use of the building to have been that of a combined wash-house/brewhouse and bakehouse. Soot staining on the timbers of the upper chamber (including the 19th century timbers) may indicate that smoking was also carried on within the building.

The origin of the structure is much earlier than the 19th century, for the main frame, roof and most of the first floor joisting belong to the 16th century. Furthermore, mortices in the outer faces of the end frame, together with stave holes in the soffite of the cut off ends of the plate indicate that the structure has lost at least one bay from either end and, when built, was of four or more bays in length. Some timbers within the western wall have been replaced, as too have some of the joists, but otherwise the frame of the surviving section is very complete. The timberwork was originally exposed to view within the external walls, the framing of which was infilled with large daub panels divided from one another by studs. At the upper level the walls are stiffened by headbraces, inset slightly so as to be masked from view on the principal face of the wall. The bracing in the side wall is in one direction - being sited at the western end of each bay - so as to prevent the frame from racking towards the west. That no bracing was incorporated to prevent eastward raking implies that a chimney on the site of the existing stack was always intended and was utilized to give the frame stability. Although the present chimney is largely of 19th century date, the base of the oven is clearly of antiquity.

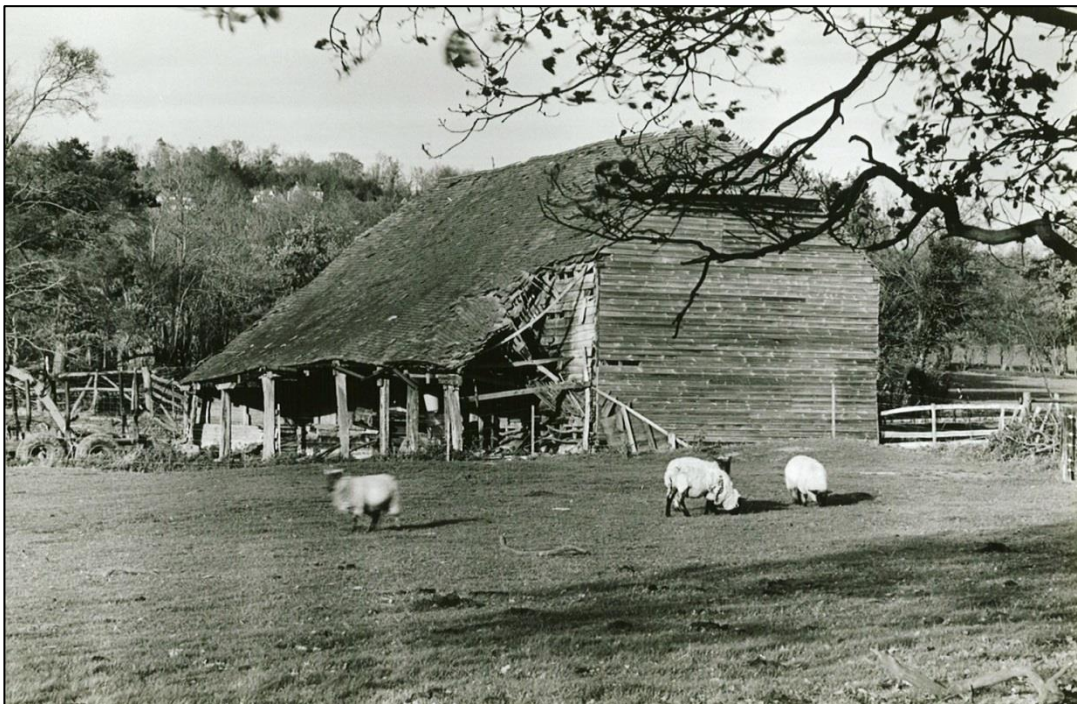
The 17th-century threshing barn in 1991.

The most urgent task in 1992 was the repair of the great threshing barn, which was near to collapse. This, and some work carried out on the other farm buildings, exhausted the funds available at that time. It was not until 1995 that Landmark was able to start work on the house itself, and to complete the repair of the bakehouse behind the house, and the buildings round the yard.

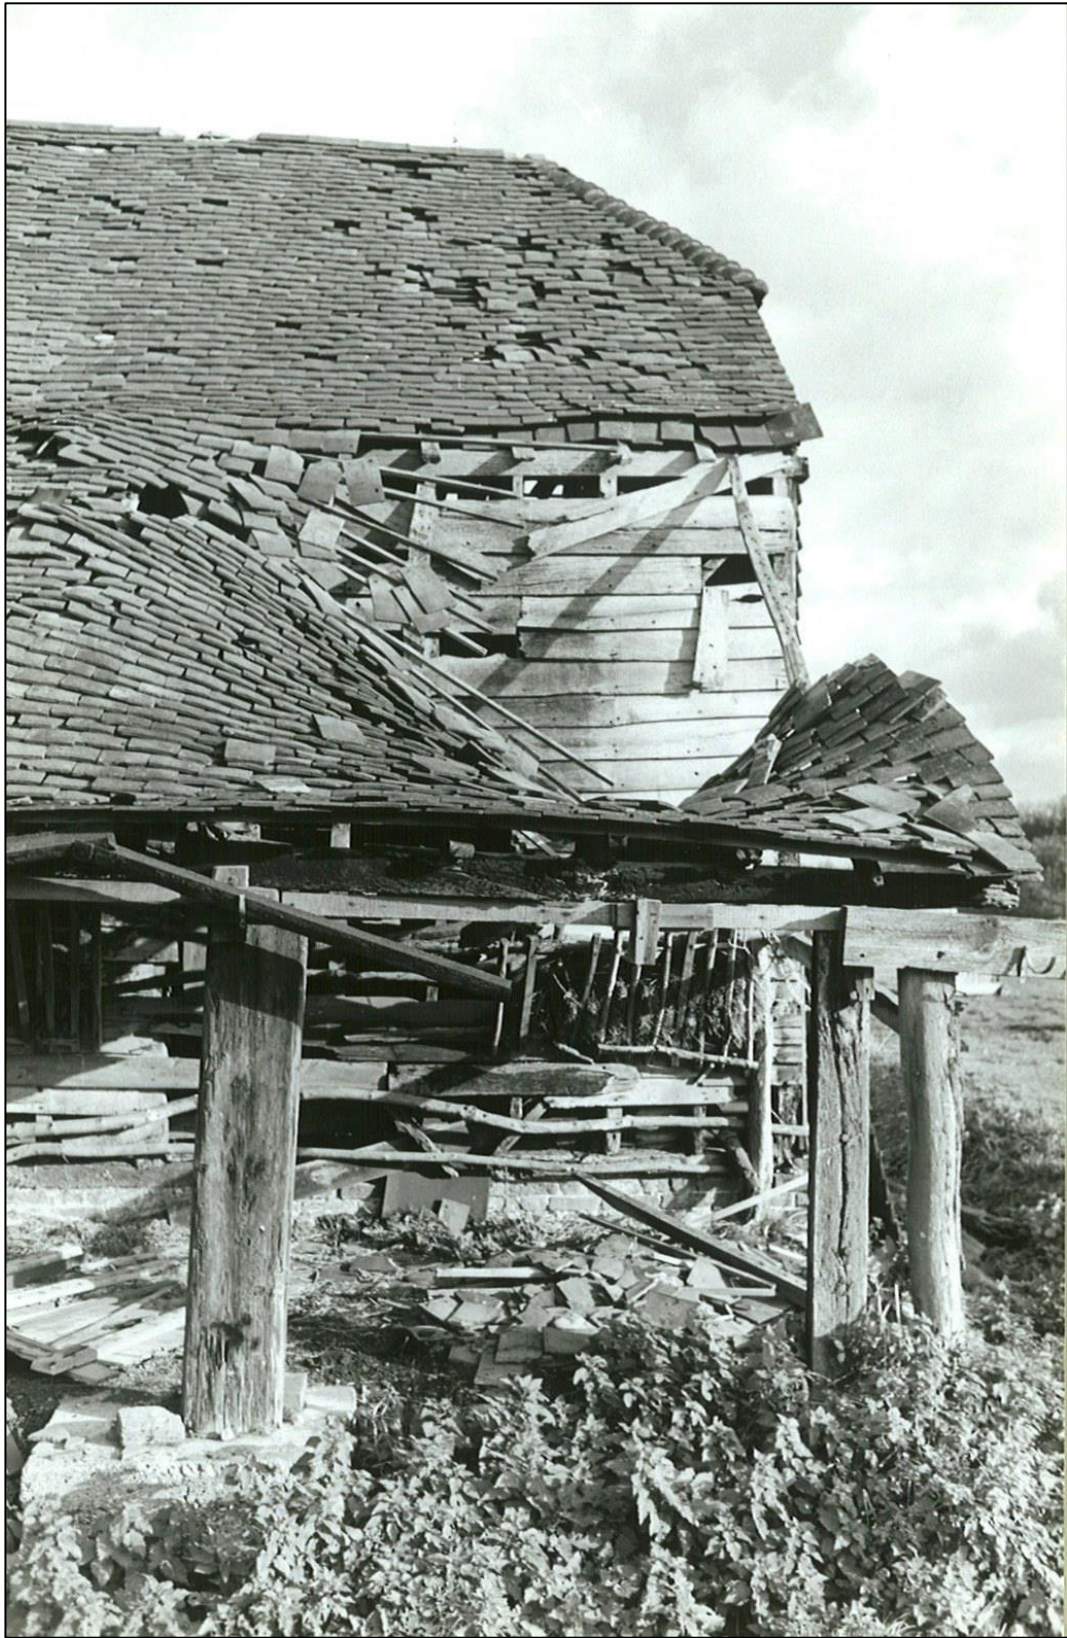
The 17th-century threshing barn.

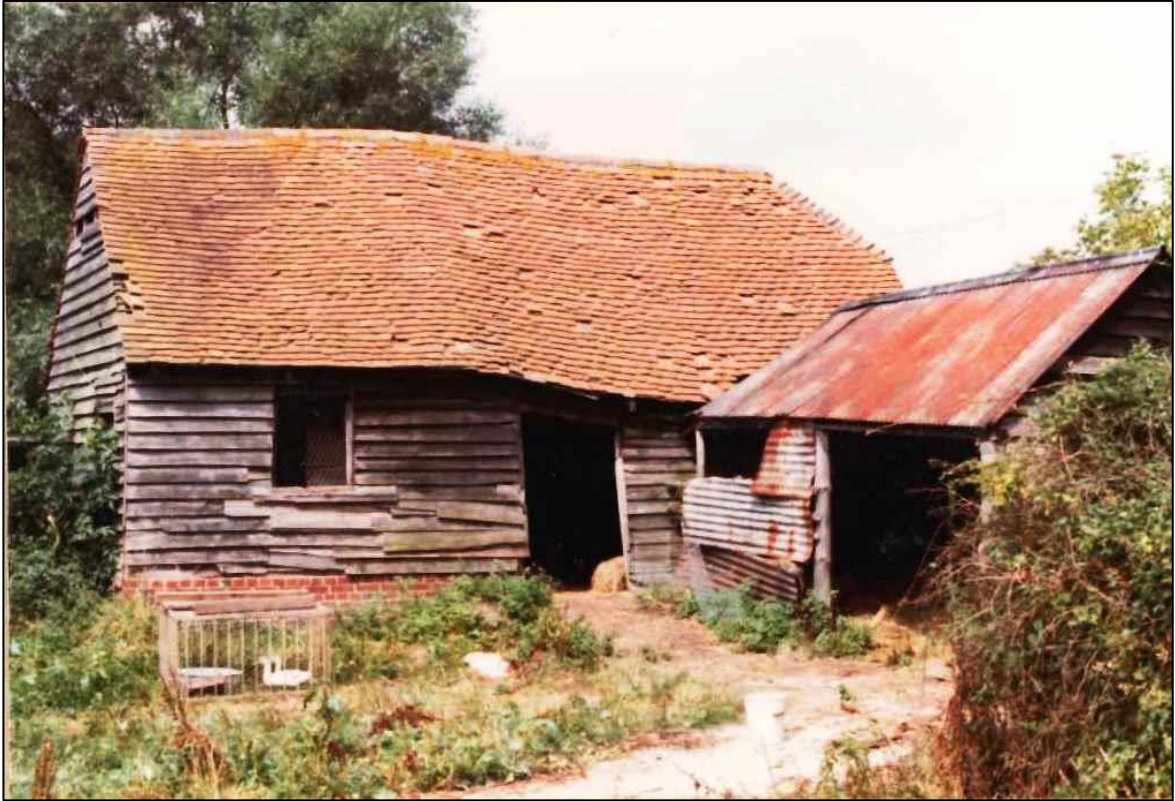
The cow byre with attached shed.

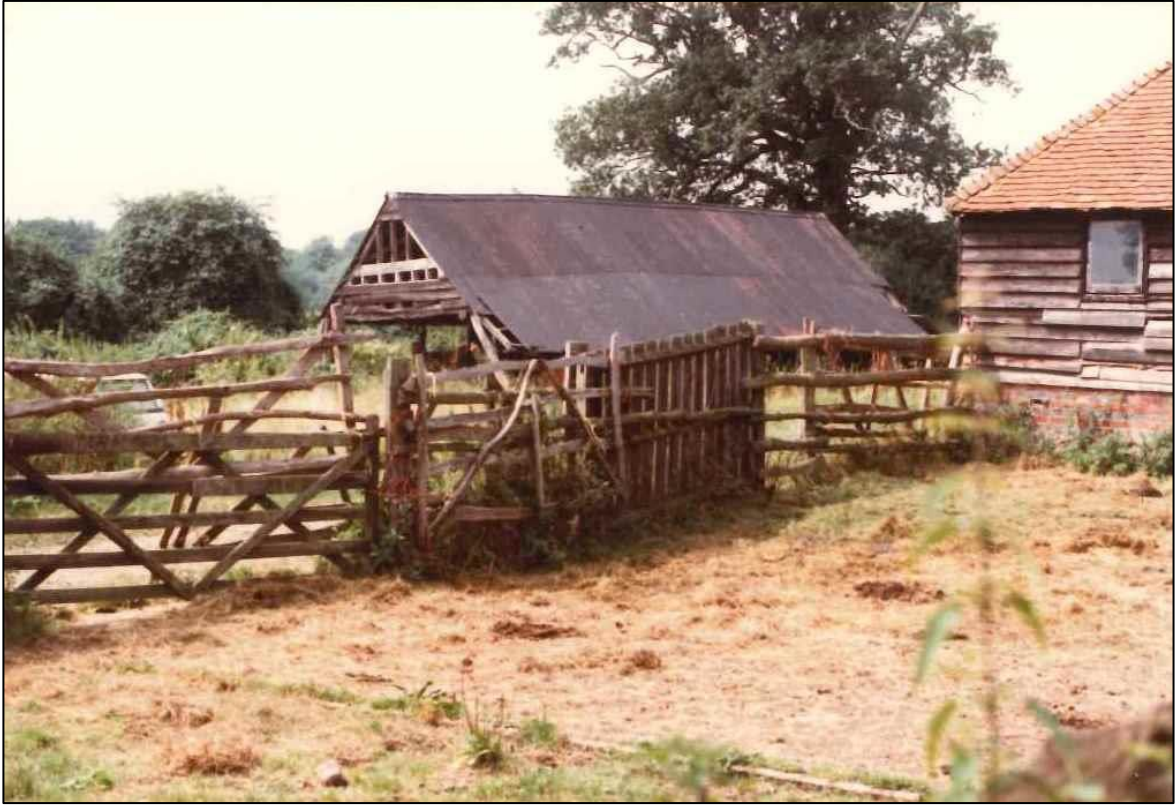
The demolished cartshed.

All the barns and the bakehouse were retiled and had their weatherboarding renewed or repaired, and then coated in black bitumastic paint. Below the west barn, a wagon shed that was in very poor condition was demolished. The northwest barn had to be taken down and rebuilt, reusing as much of the old timber as possible. The chimney and hearth of the smokehouse were structurally unsound, and so the lean-to privy was demolished, and the stack reduced in height. Steel ties have been inserted to add strength. A lean-to shed at the west end was also removed, as were several other corrugated iron sheds.

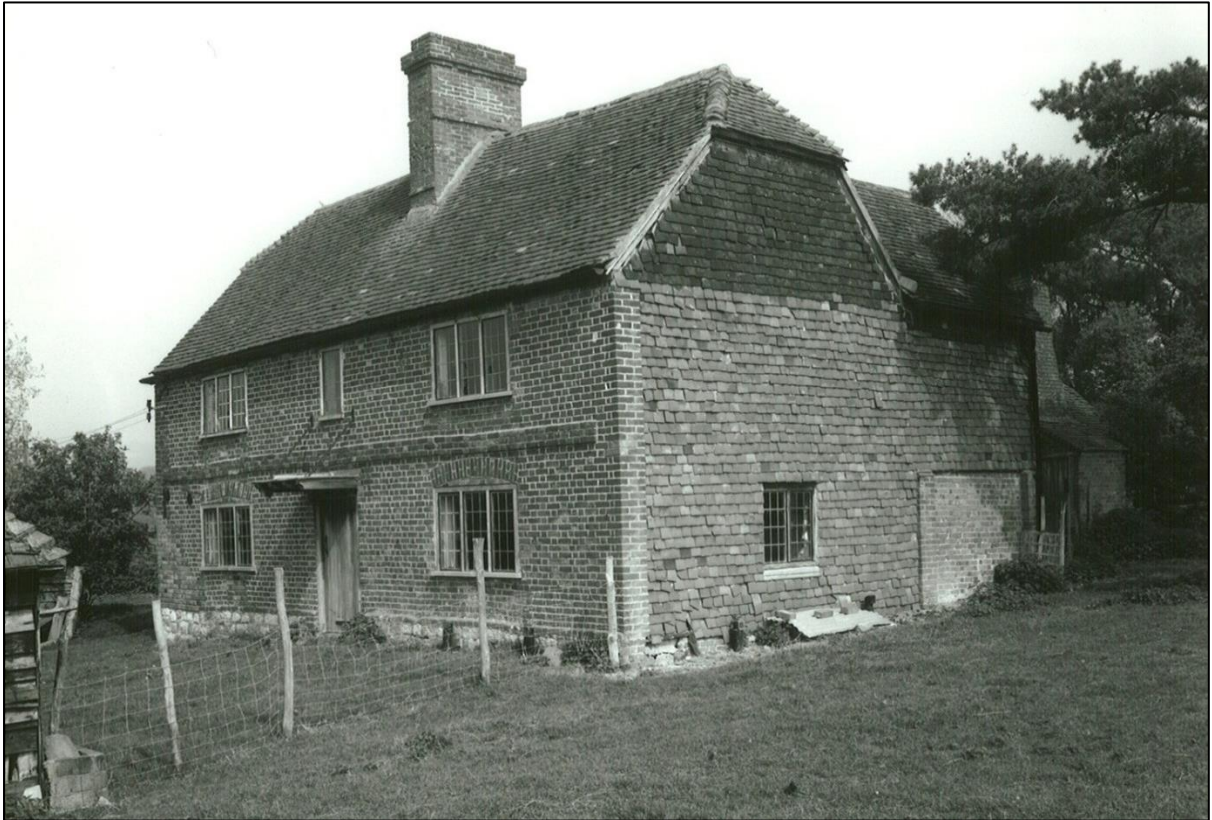
The east elevation before the first floor window was reinstated.

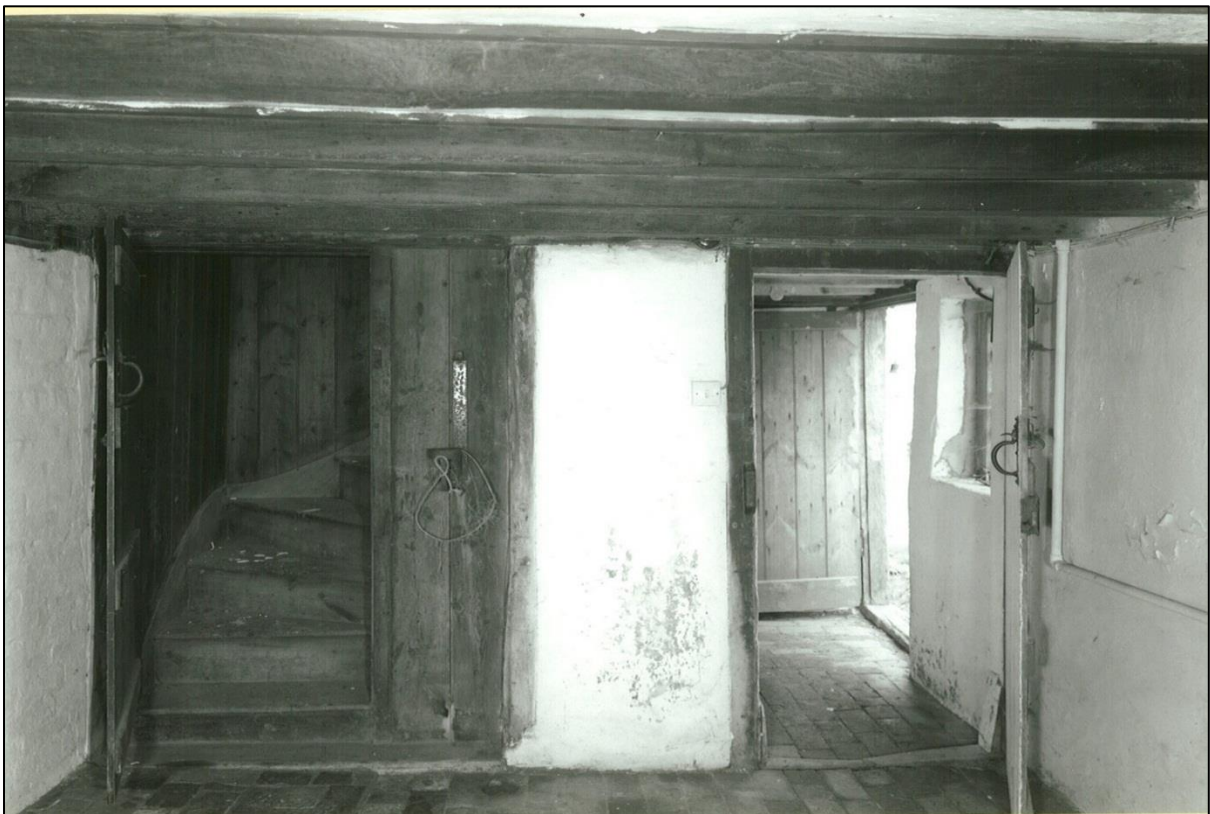
The back hall with the second staircase now removed.

Inside, restoration was kept to a minimum. Some re-plastering, using haired lime plaster on chestnut laths, was needed, and the creation of two new bathrooms and a new kitchen. A second stair, inserted in what is now the rear lobby, at a time when the house was divided into two cottages, was removed and the floor made up with new oak boards. The sitting room and bedroom above were painted in colours of which traces were found on the walls, using traditional distempers. The dado panelling was added to the dining room.

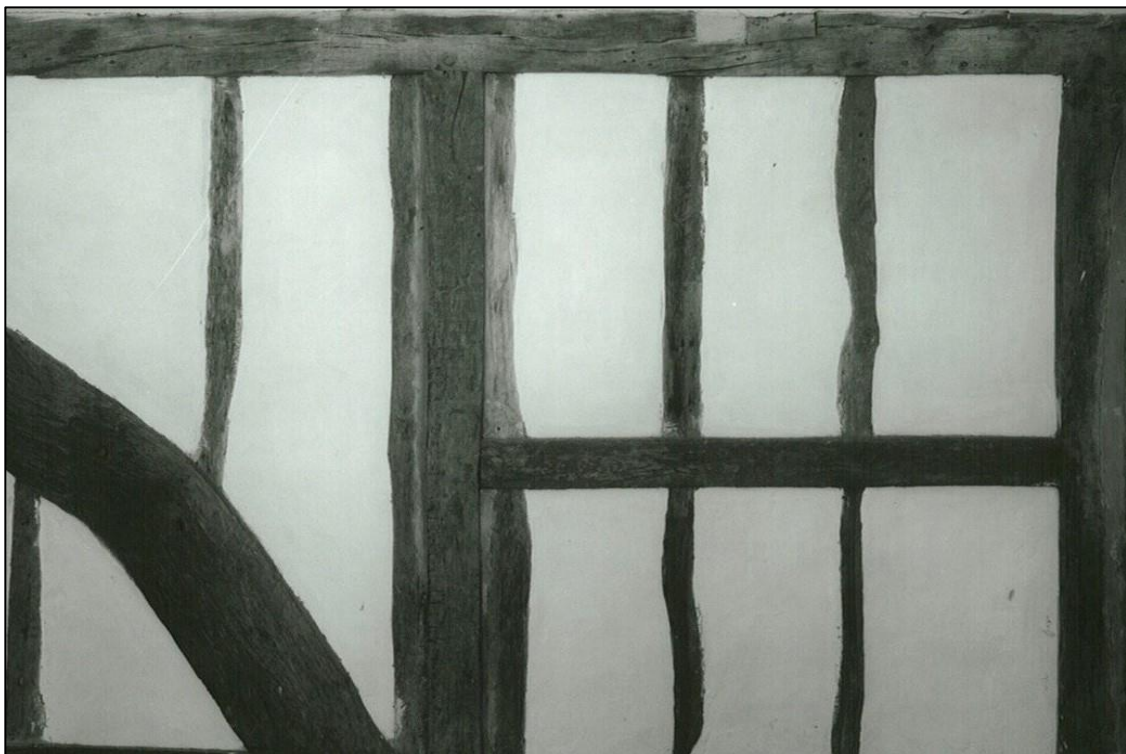
The south wall of the single bedroom was originally an outside wall. The framing shows the position of the earlier window. (RCHME)

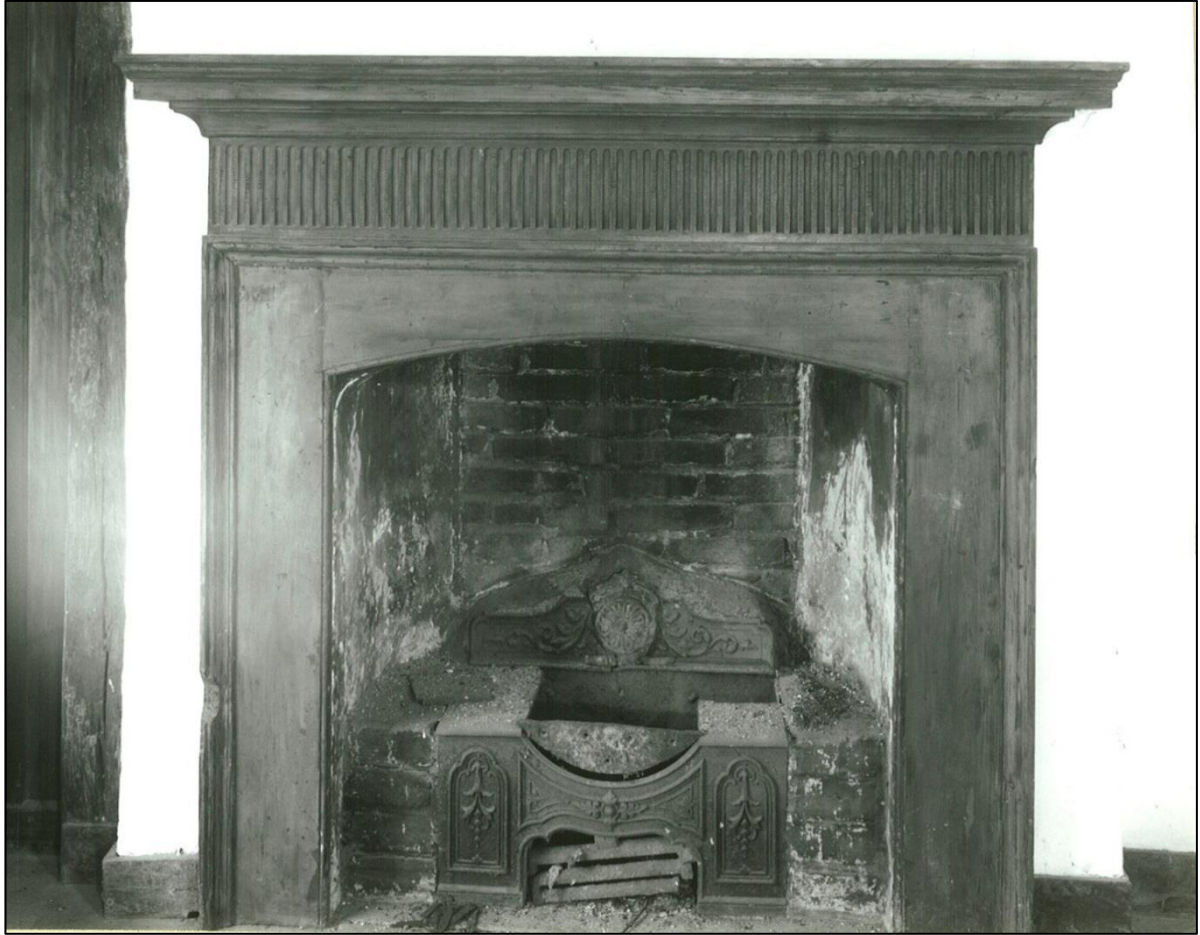
The fireplace in the south-east bedroom.
