IONA II DIVE TRAIL

Wreck Investigations & Monitoring

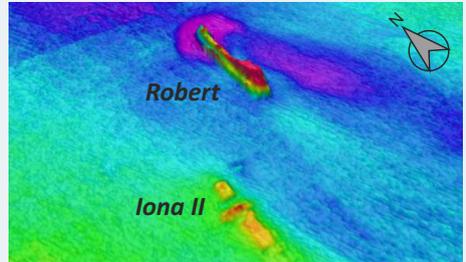
Bathymetric survey (Courtesy of UKHO 2008)

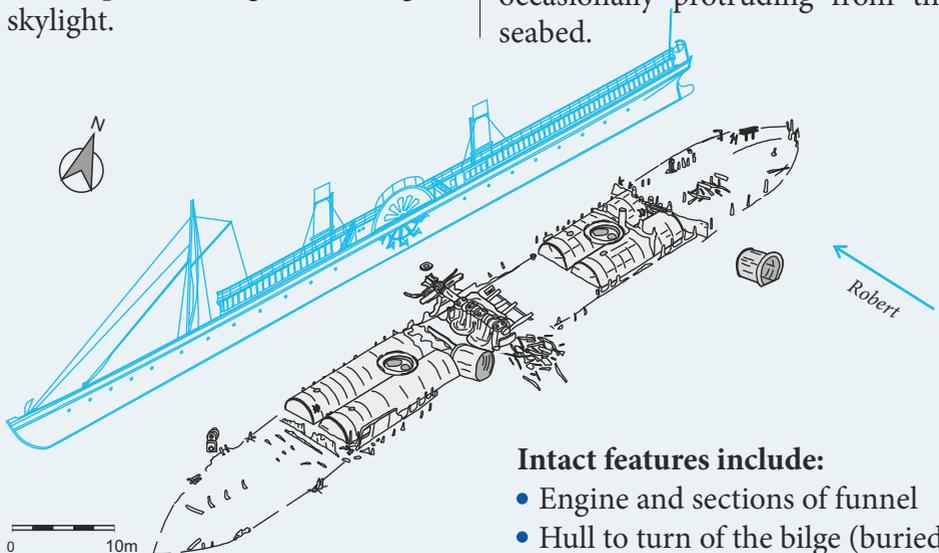
Missing features include:
masts, deckhouses and the majority of funnels

Intact features include:

- Engine and sections of funnel
- Hull to turn of the bilge (buried) and a 2m x 4m section of hull
- Pairs of forward and aft boilers
- Port paddle wheel and parts of starboard paddle wheel

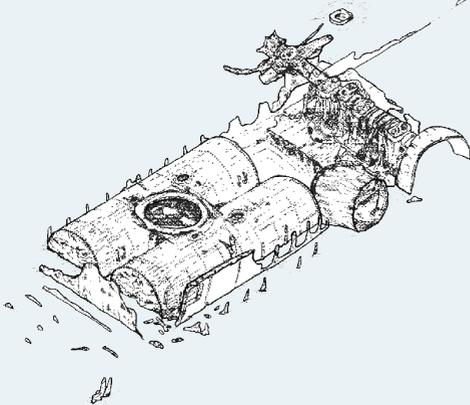
Isometric drawing of the *Iona II* (C. Rule)

Using this data in conjunction with some information from the ADU, one of their members, Carol Rule, was able to create an isometric sketch of the *Iona II*. This was the first visualisation of the wreck remains and has been the basis of all subsequent illustrations.

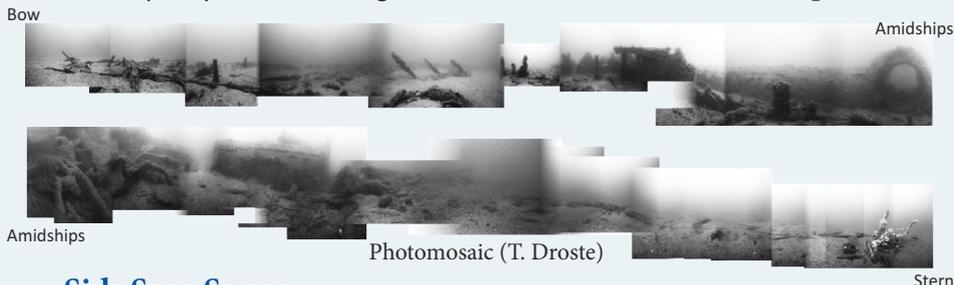
In 2001, a group of German divers completed several licenced dives on the wreck. One of them was Thomas Droste, who produced a photomosaic of port side elevation of the *Iona II*. This gave an unprecedented view of the entire length of the wreck showing how the majority of archaeological remains are clustered amidships.

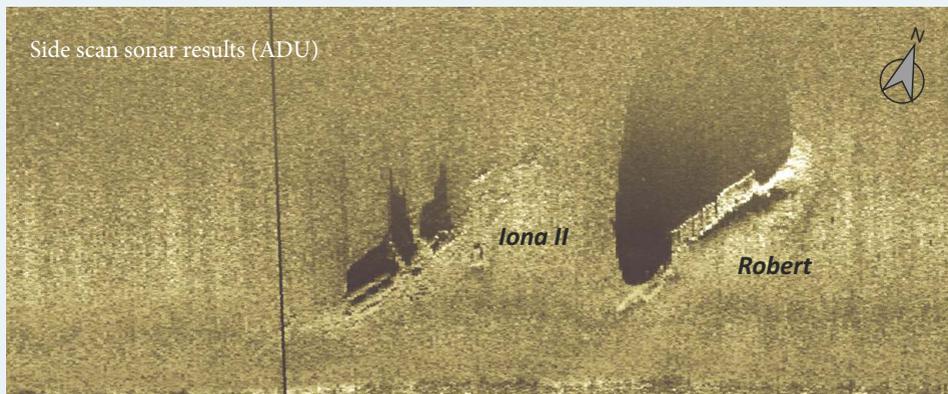
In 2002 the ADU completed a comprehensive side scan sonar (SSS) survey of the site. The sonar results were mapped and then used to direct divers over the site. The results of the SSS showed that the *Iona II* and *Robert* were only 30m apart which was why divers were finding it so easy to access the designated wreck from the undesignated *Robert*. The survey also identified a flaw in the designated area which meant that not all of the wreck was in the protected area. The 50m radius of the area had been calculated using inadequate equipment in an unstable inflatable boat which had led to the inaccurate positioning.

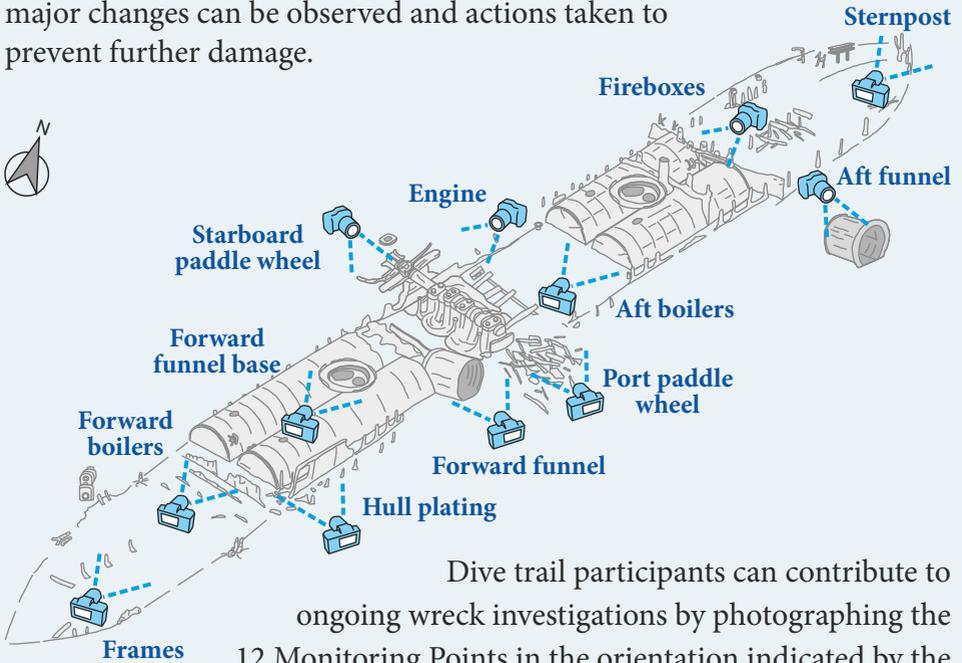
Dive trail participants can contribute to ongoing wreck investigations by photographing the 12 Monitoring Points in the orientation indicated by the camera icons. These photos can then be shared through www.flickr.com and compared with earlier images. Search in 'Groups' for 'Iona II' and upload your photos to one of the appropriate 12 Iona II Groups.
