LANGLEY GATEHOUSE

History Album

BASIC DETAILS

Built	c1610, adding to an early 14th-century building
Listed	Grade II*
Owner	Langley Estate
Landmark tenure	Long lease
Let for first holiday	1993
Repaired	1992-1993
Architect	Andrew Thomas
Builders	Treasure & Son
Site Foreman	Mervyn Higgins
Quantity Surveyors	Bare, Leaning and Bare

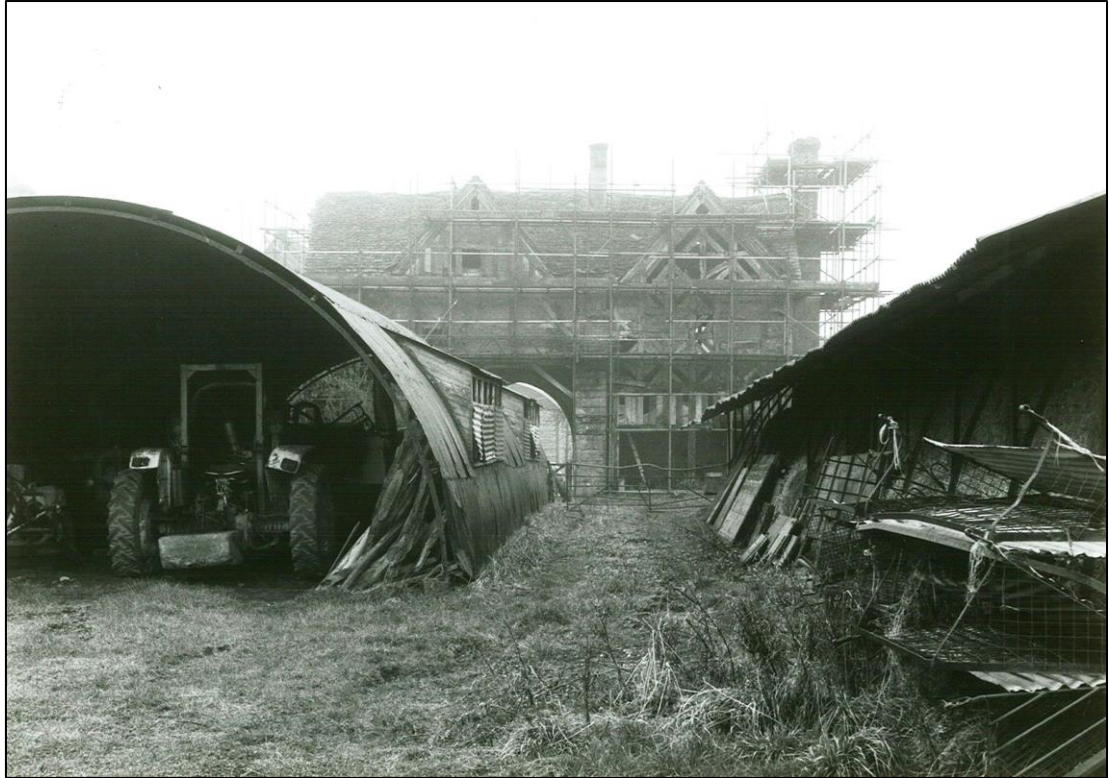
View from the east before repair

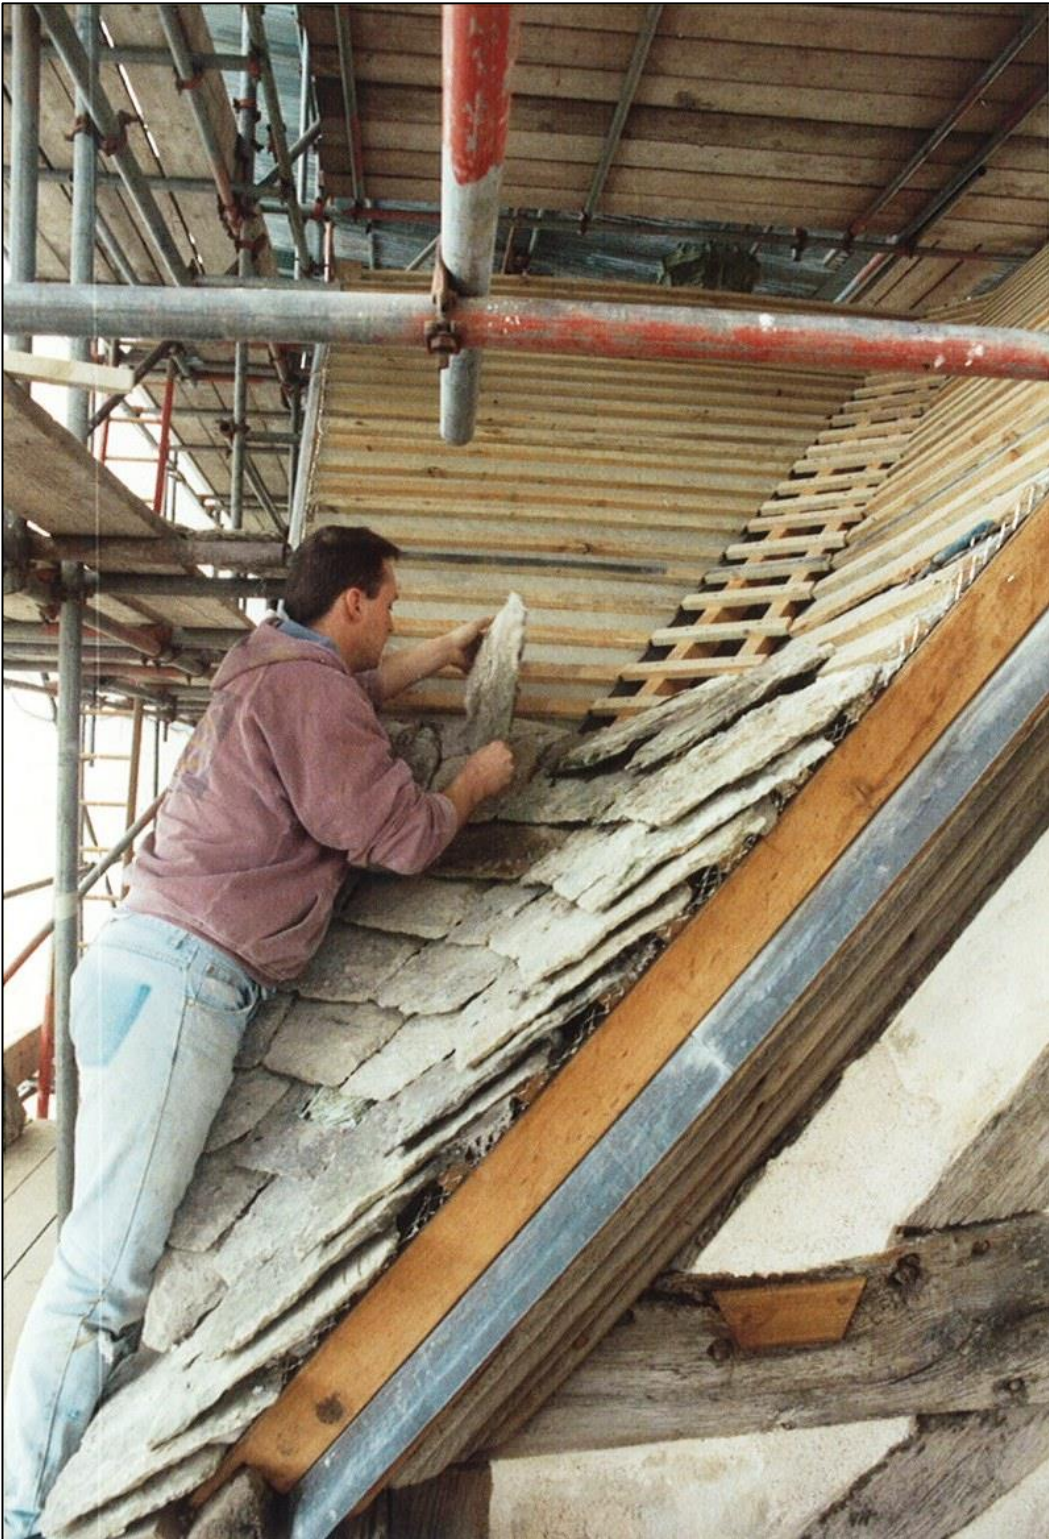
Positioning the re-laid Harnage stone slates for a roof valley

Once the slates had been stripped, the roof structure itself was patched and repaired. Softwood boarding was then laid on top of this, and the slates re-fixed onto new battens with new pegs. Some were bedded in mortar to prevent water seeping in. The slates were graded by size, with the largest ones for the lower courses, and the smaller ones higher up, in so-called diminishing courses. Many of them still have a good growth of moss and lichen on them.

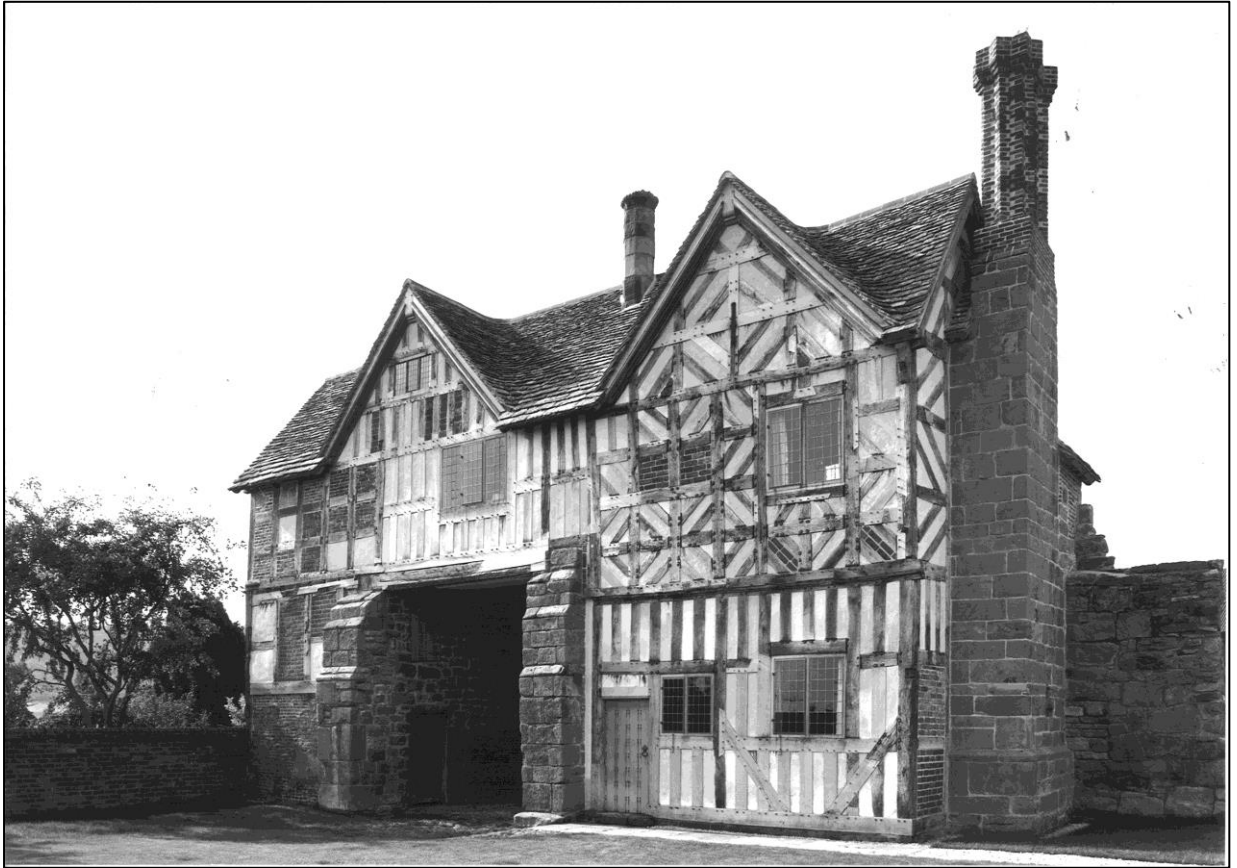
The repairs completed

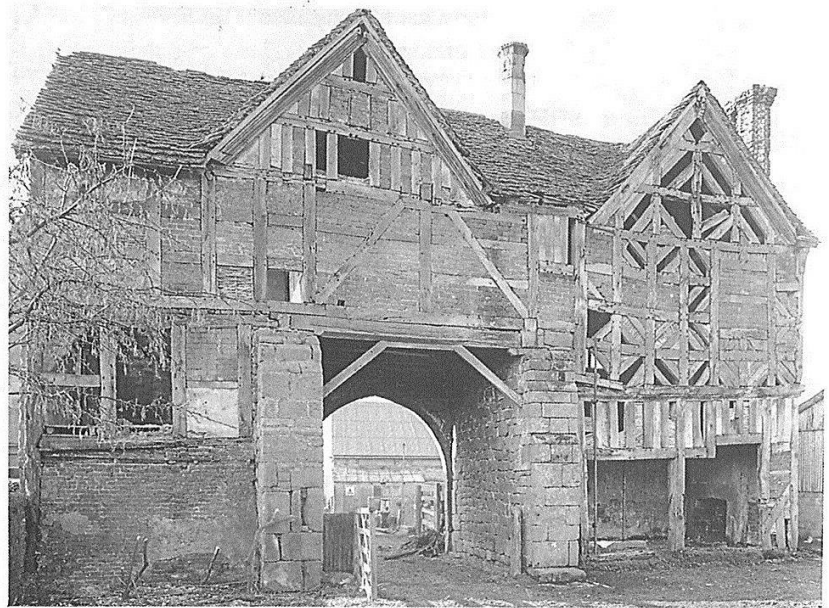
The east elevation before work began

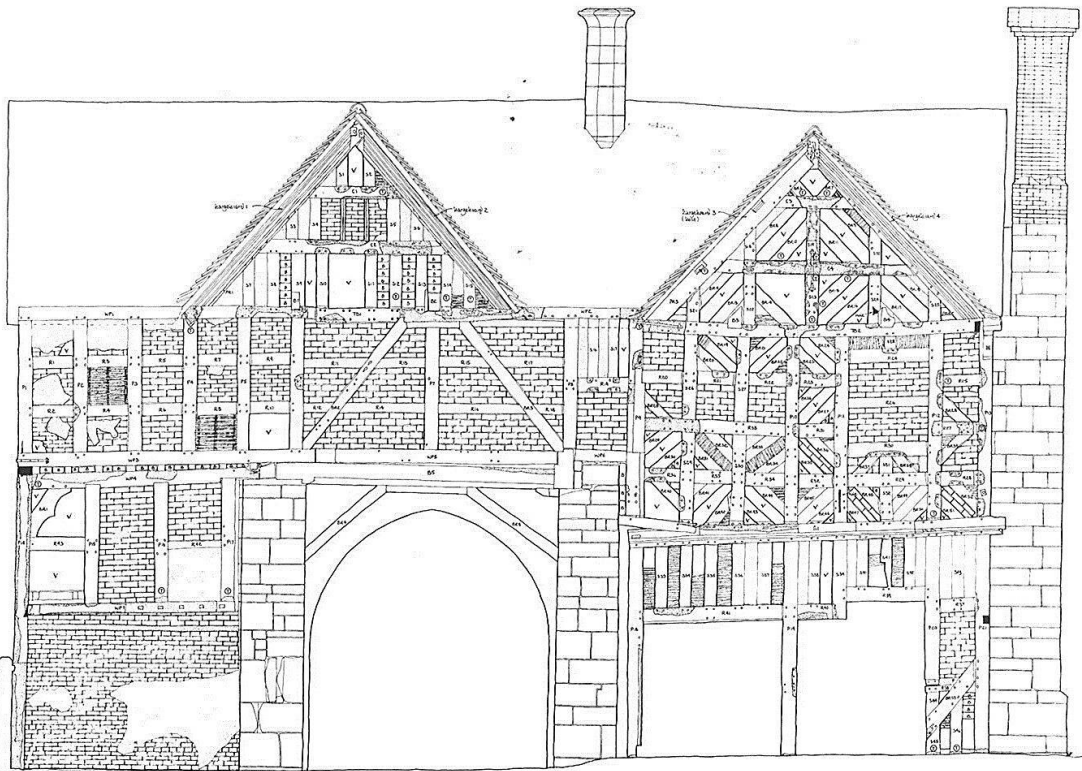
The east elevation after repairs were complete

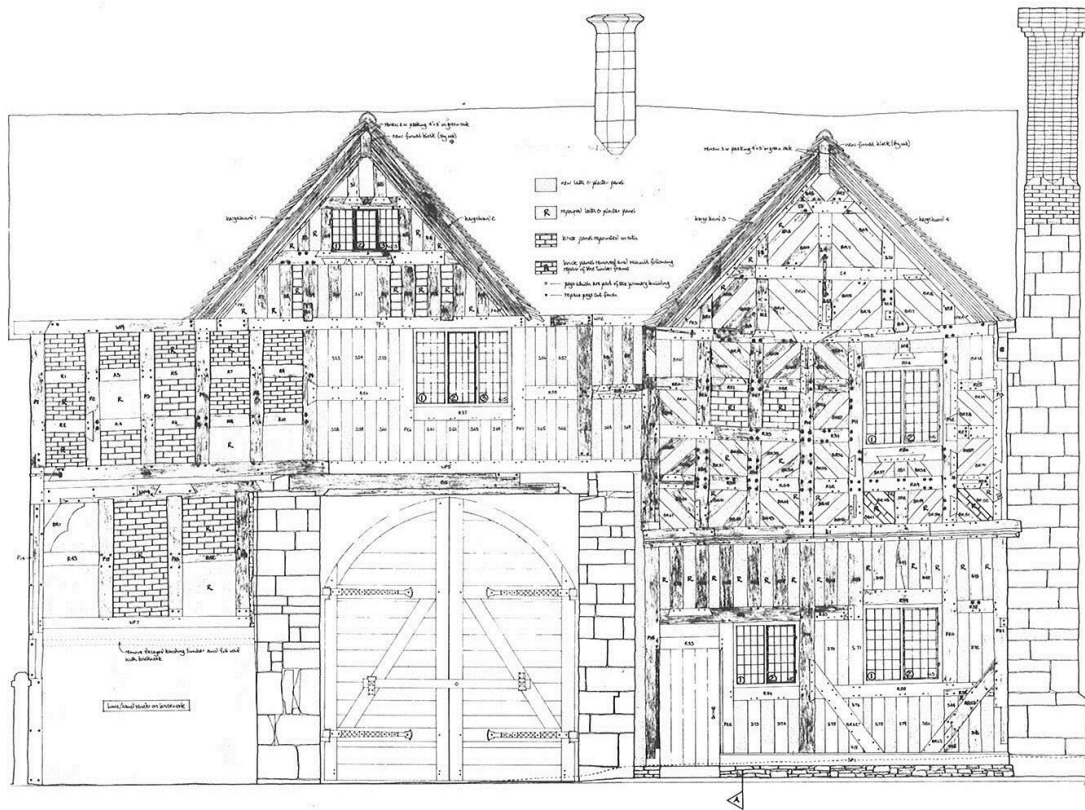
East elevation. Proposals

ations over the gate arch but with held objection for the sake of the overall project and the future welfare of the building. This is a good example of conflict between the requirements of a building which will remain unoccupied and the requirements of one which, to find a secure future, has to be converted for domestic use. A degree of compromise is often necessary when such situations arise.

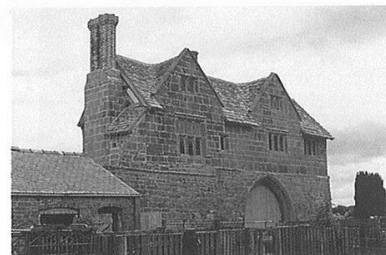
The repaired west elevation.

A surviving fragment of the original lead came matrix enabled us to reproduce the leading illustrated in a drawing of the west elevation dating from 1789. The provision of some opening lights was a practical necessity.

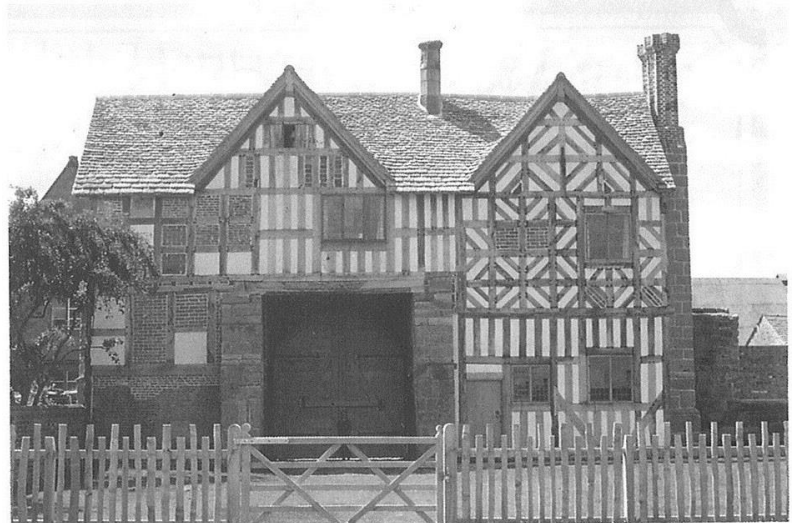
The east elevation after repairs were complete.

The derelict condition of the gatehouse necessitated replacement of missing floor joists, floorboards, staircase, doors and windows. The small room over the gate arch contained evidence indicating that it was lined with panelling at some time. We repanelled this room using painted softwood framed and detailed in the traditional manner.
