# The Landmark Trust

## MARGELLS

### History Album

**1976, updated 1998**

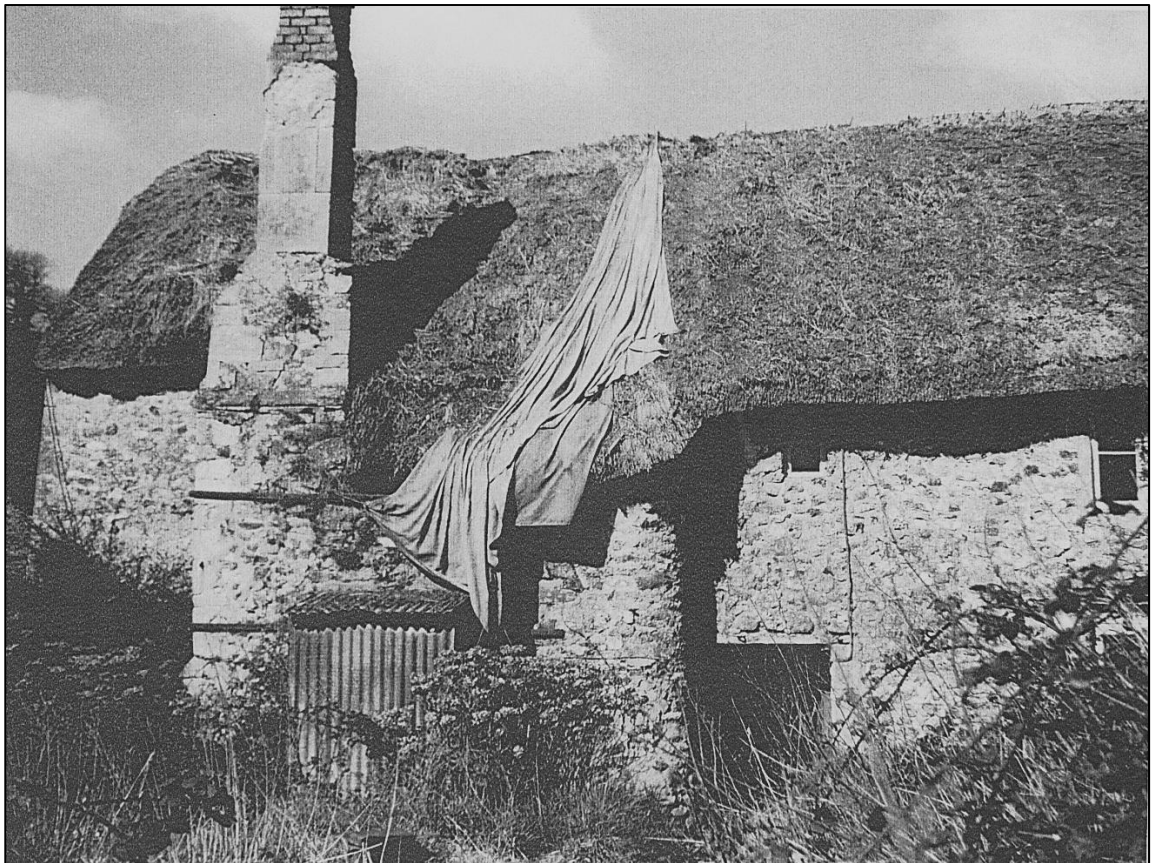
The south elevation

Since the end of the 16th century Margells has been altered very little. But it looks as though, at one time, the wall on to the road had to be rebuilt. This would explain why the timber frame at that end of the house is different from the rest; it does not come down to the first floor, and the wall painting has disappeared from that end of the bedroom. It was probably when this was being done that the big fireplace in the sitting room was made deeper. If you look at the wall below the chimney from the outside, you can see the original roofline quite clearly, about a foot further in than the present wall.

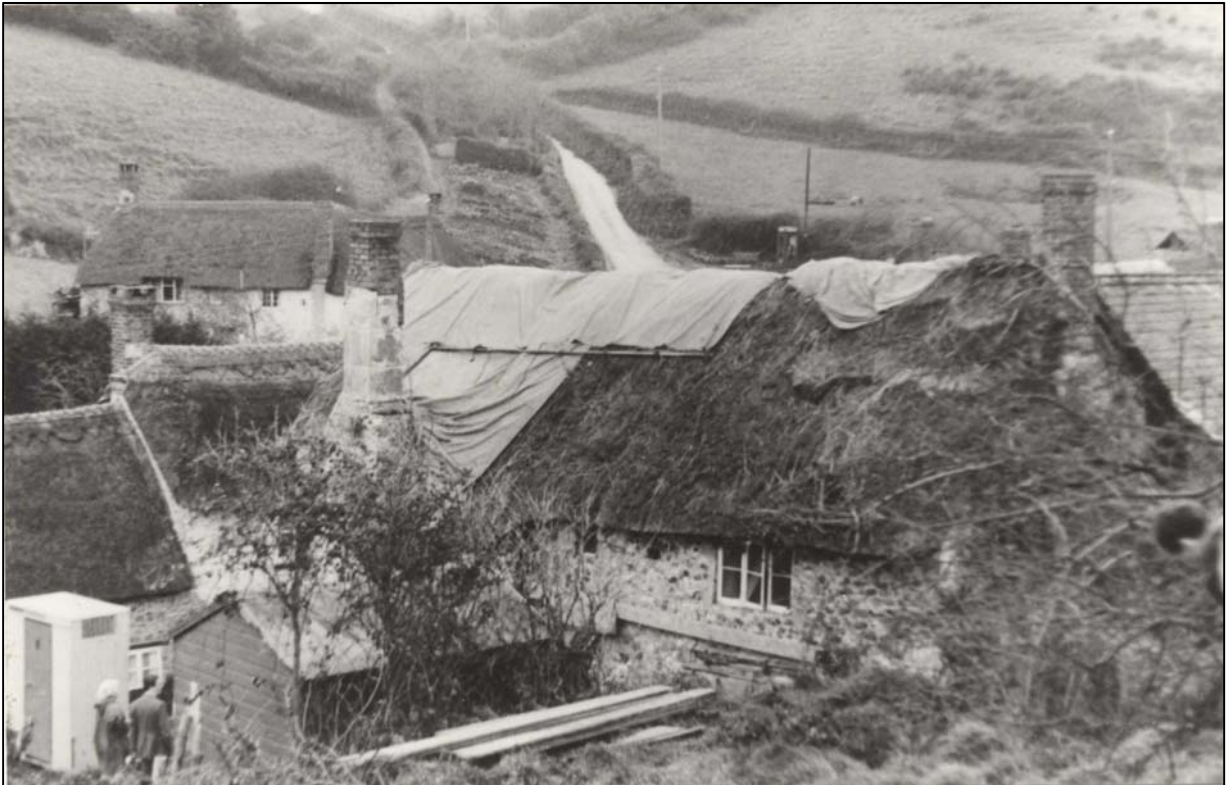
Work starting in 1975.

But most of the work was concerned with masonry repairs, including stabilisation of the wall by underpinning, repair of the timber screens and roof trusses, opening up of the fireplaces, treatment of timber infestation and inserting an electro-osmotic damp-proof course. The small window in the east bedroom wall was reinstated. The existing ground floor, of lime-ash construction, was in poor condition and in spite of the architects' extensive researches it was not found practicable to repair and reinstate in to match the existing. Instead, second-hand paving slabs of Blue Lias (a local stone) was brought from a farm nearby and laid on a new base, retaining the lime-ash finish as an edging. The link between Margells and the adjoining cottage was found to be open in the roof space, and

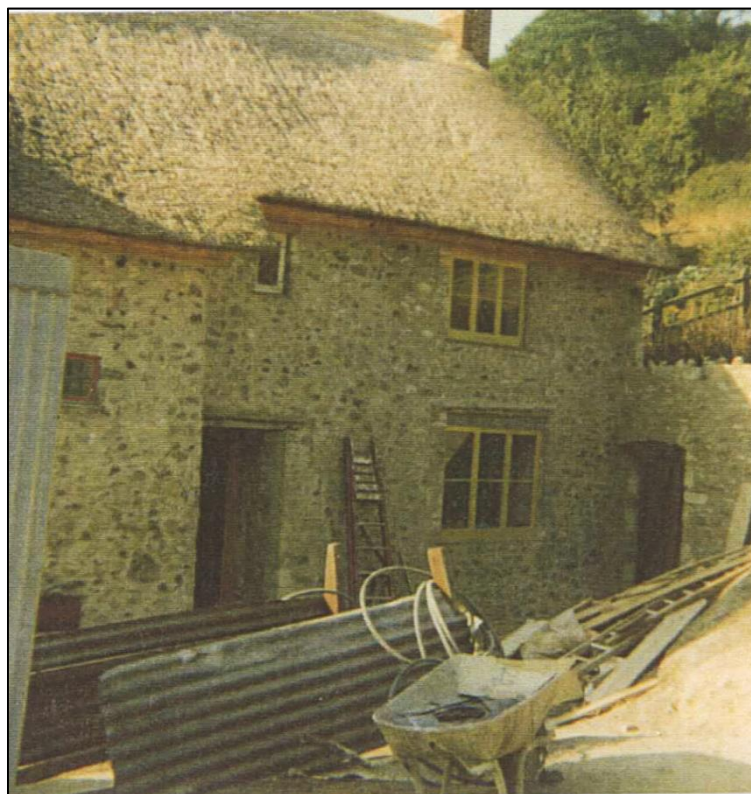
**Margells with its new Austrian reed thatched roof.**

As ever, Landmark aimed to keep alterations to the minimum. Our architect, Paul Hearn, quickly arranged for a temporary cover for the roof, before it was rethatched by Mr Turbitt of Sidmouth using imported Austrian reed as there was no local reed available at the time. A major part of the work was concerned with masonry repairs, including stabilisation of the walls by underpinning. The timber screens and the roof trusses were repaired, and as all the old door openings were still in the screens, it was possible to re-make the doors to the old shape. The fireplaces were opened up, and the external porch and lavatory removed. Rising damp was treated by inserting an electro-osmotic damp-proof course. The window in the east elevation was re-instated.

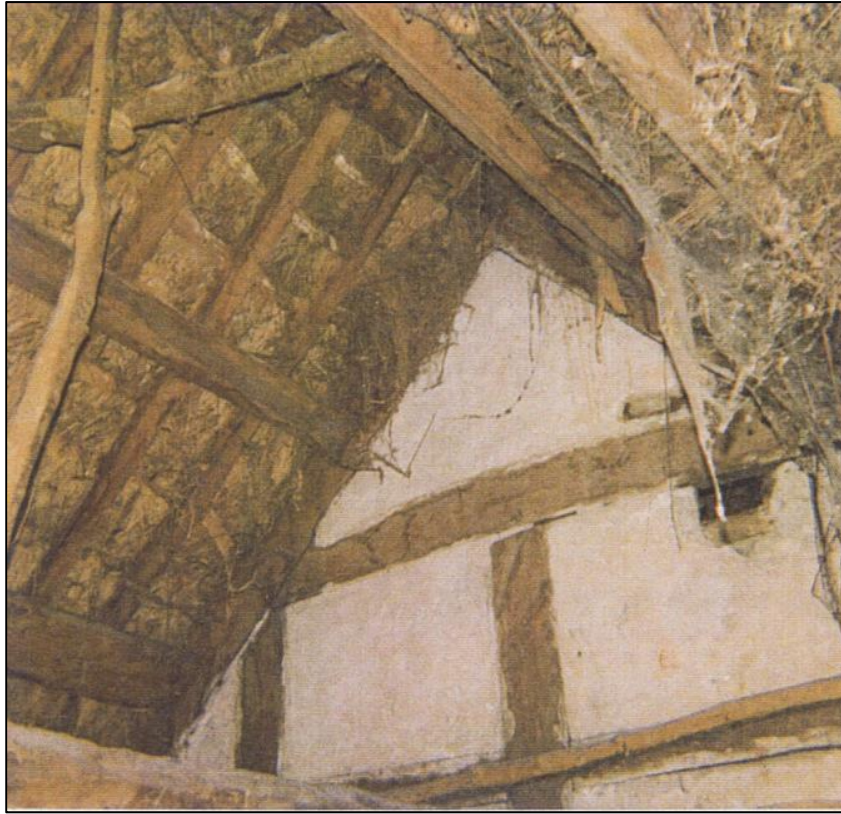
**The underside of the thatched roof.**
