THE MACKINTOSH BUILDING History Album

Written by Charlotte Haslam 1986

Updated 2015

The Mackintosh Building

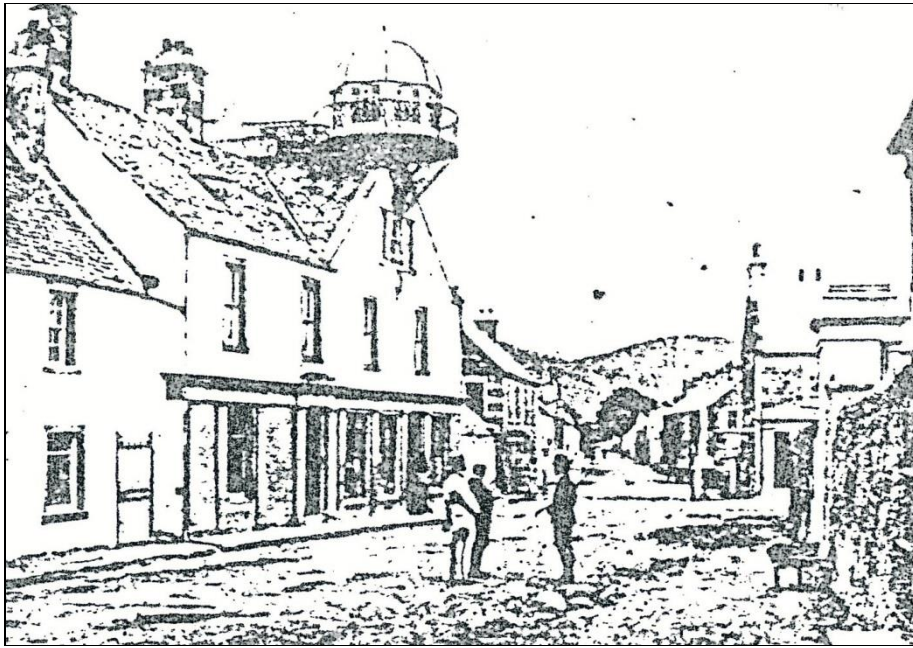
(1.1(a)) View from Dunira Street taken around 1860 (above).
(1.1(b)) View of Melville Square from the old bridge (below).

An early photograph, taken around 1860, looking down the village main street shows a large, white harled building occupying the site of today's Mackintosh building. It comprised of three-storeys, the top storey, as in today's building, accommodated in the roof space. Near the corner, a large gable dominated the facade and rose to ridge height to support a glazed observatory with balcony. The shop, which at that time was owned by Mr Peter MacFarlane, the postmaster, had a very elegant shop front with bold fascia and a series of pilasters. The scale of this building was large when compared with the other buildings situated in the main street, and it was obviously a powerful landmark in Comrie at that time.

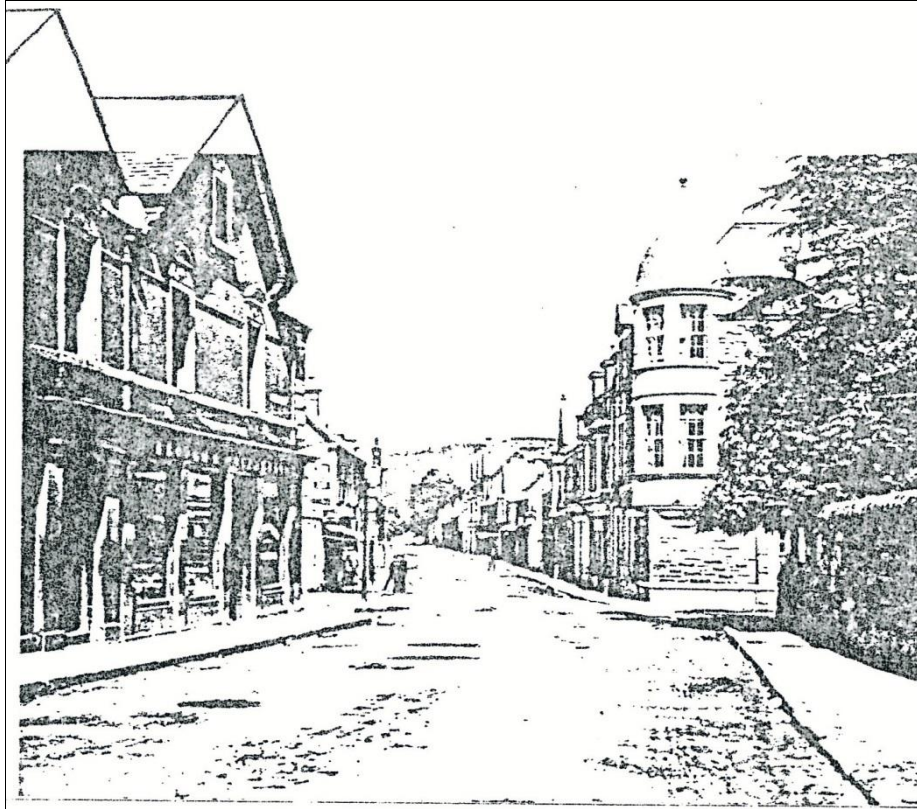
(1.2(a)) View from Dunira Street taken around 1900 featuring the refaced Victorian Building (above).

(1.2(b)) View of Melville Square with the Crieff / St Fillans coach (below).

A later photograph of around 1900 shows a Victorian building occupying the site, the shop now called 'Brough & Macpherson'. Mr. Peter Macpherson became the sole proprietor in 1896 although the building was still owned by the Brough family. This building has a smooth facade which sets off moulded architraves to all the windows, string mouldings and rusticated quoins. Comparing this building with the earlier one, we see that the shop front is unchanged, and closer examination reveals that the first floor fenestration is identical. The window on the gable has been altered to match those of the first floor and it would appear from the photograph that another gable has possibly been added to the left of the original one, as shown by the pencil markings on the photograph. It would appear that the original building has, therefore, been refaced in smooth ashlar and many detailed alterations carried out on the facade. No factual evidence has come to light regarding these alterations but it would seem likely that these changes were carried out for aesthetic reasons which were fashionable in the late 19th century. To understand the extent of these feelings one has only to compare this photograph with that taken 40 years earlier to see how the buildings in the main street had changed during that period. By the turn of the century many of the earlier buildings had been replaced by truly Victorian buildings of a larger scale, faced in coursed ashlar and intricately detailed. Nowhere is this change more noticeable than the corner building erected diagonally opposite Brough & Macpherson's with its large two-storeyed corner turret and domed roof. Compare this with the previous building! These changes are an indication of the prosperity which existed during that period and the 'spirit' of this age was probably the reason behind the alterations to the Brough & Macpherson building.

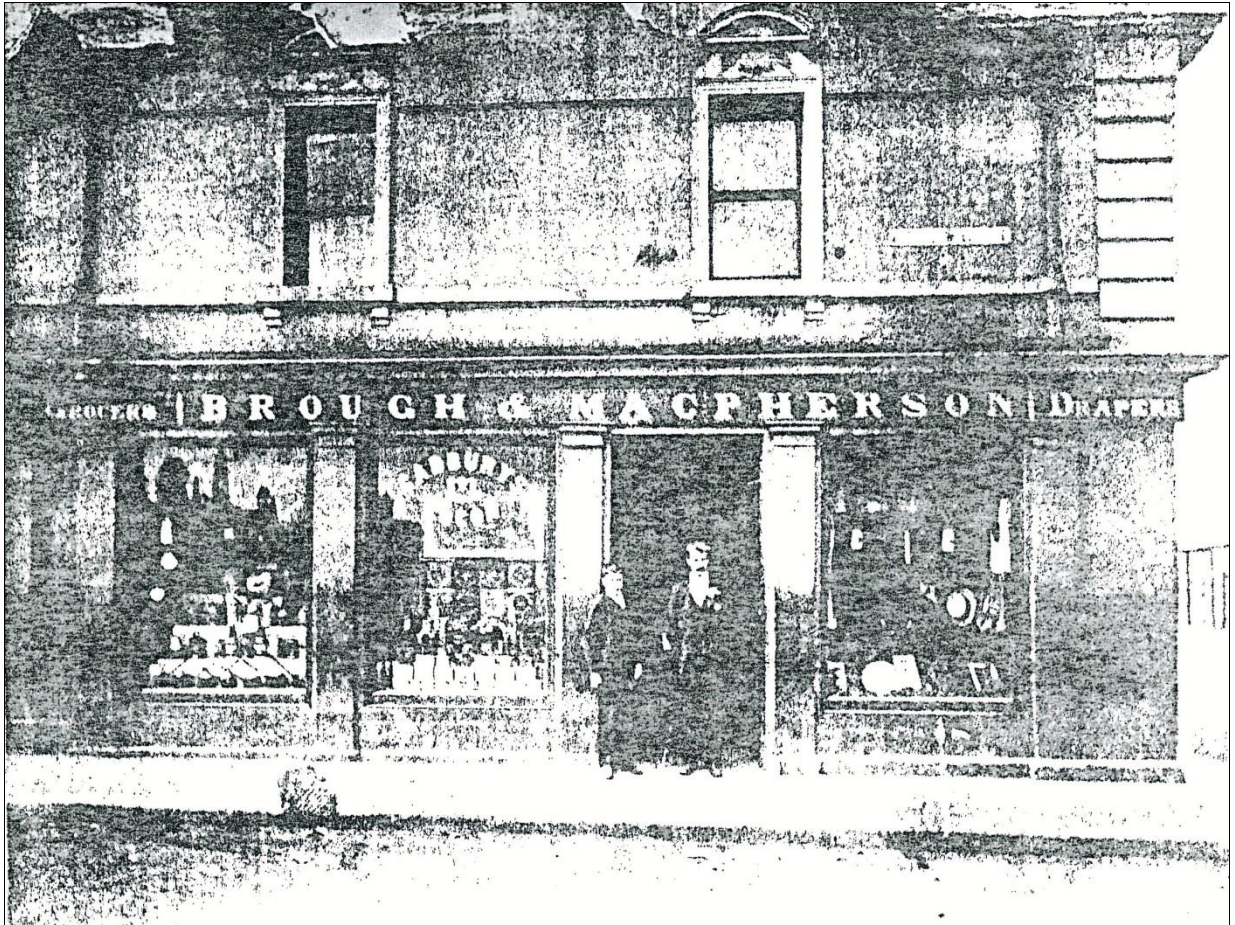
(1.2(c)) Detail of shopfront.

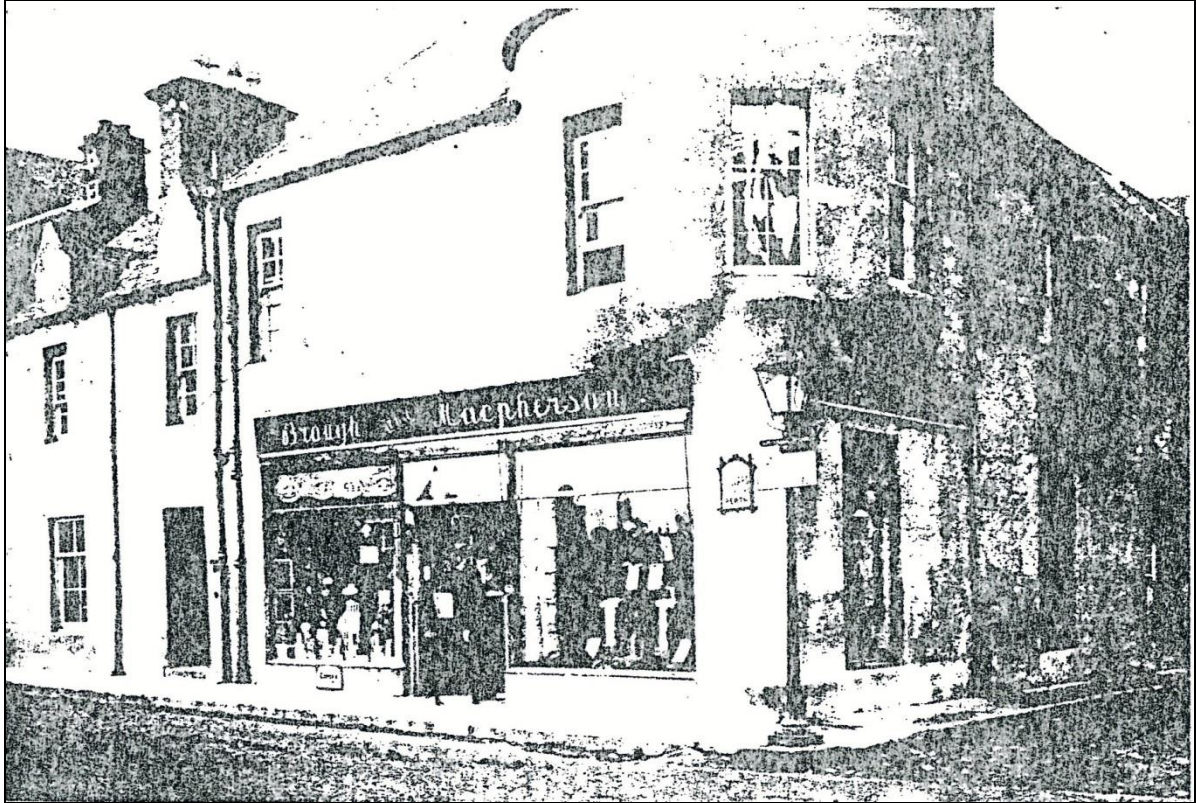
(1.3(a)) Early photograph of building (above).
(1.3(b)) General view from across the river Earn (below).

- i. The very light appearance of the woodwork. Examination of the early photograph (1.3(a)) shows that the woodwork was, in fact, stained dark at that time, and the present appearance is probably not as Mackintosh had intended.
- ii. The wrought iron entrance gates. These are certainly not Mackintosh features being far too detailed and over-played, yet they appear in the same early photograph. They must either have been replacements for

Whilst examining photograph (1.3(a)) there are a couple of additional points worth noting with regard to the shopfront and facade. The first is to note the sun blinds which are shown in the photograph, fitted over the shopfront. They are included in the Job Books of Honeyman & Keppie but have since been removed from the building. The second point is that at the time the photograph was taken, the building had not been white-washed, but had a natural harled finish. Today, the harling has been white-washed and finished at base level with a painted black band to the shop-window sill height. Although practical, this destroys the unity of the facade and the appearance of the shopfront; compare the appearance of the building today with that shown in the photograph. The appearance of the building would be greatly improved by continuing the white-wash down to ground level.

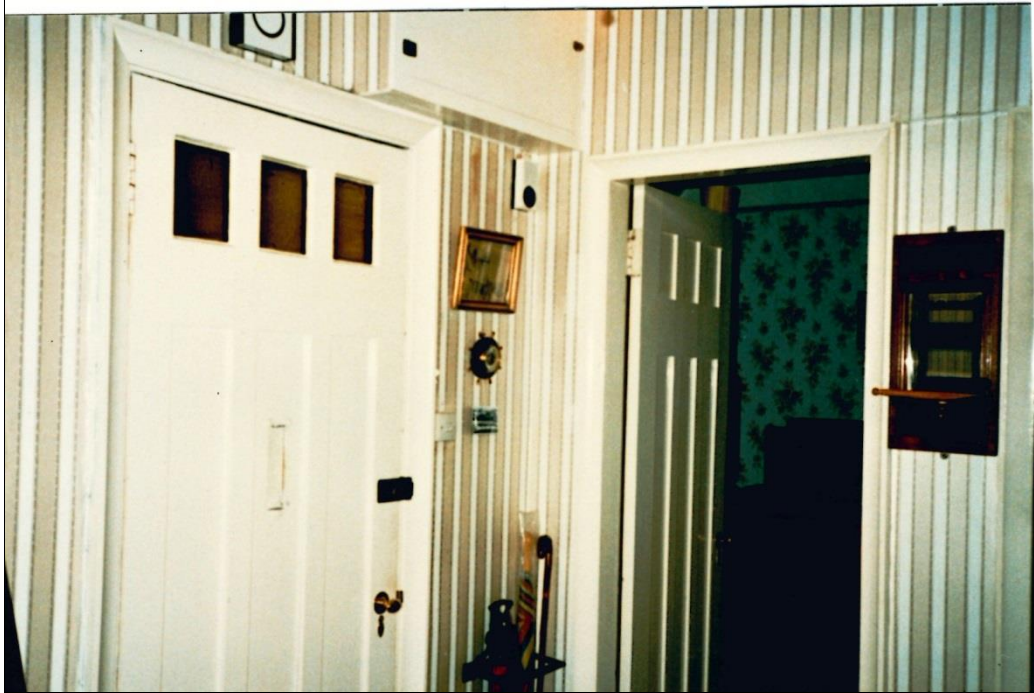
In the hall, the original doors had been painted white.

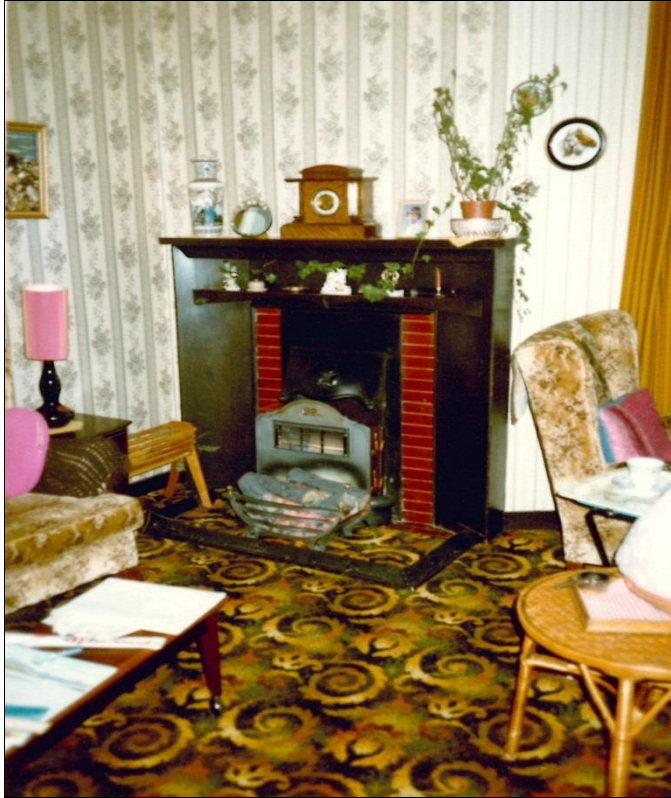
**On the sitting room fireplace
and the inner side of the
door, the original dark green
stain survived.**

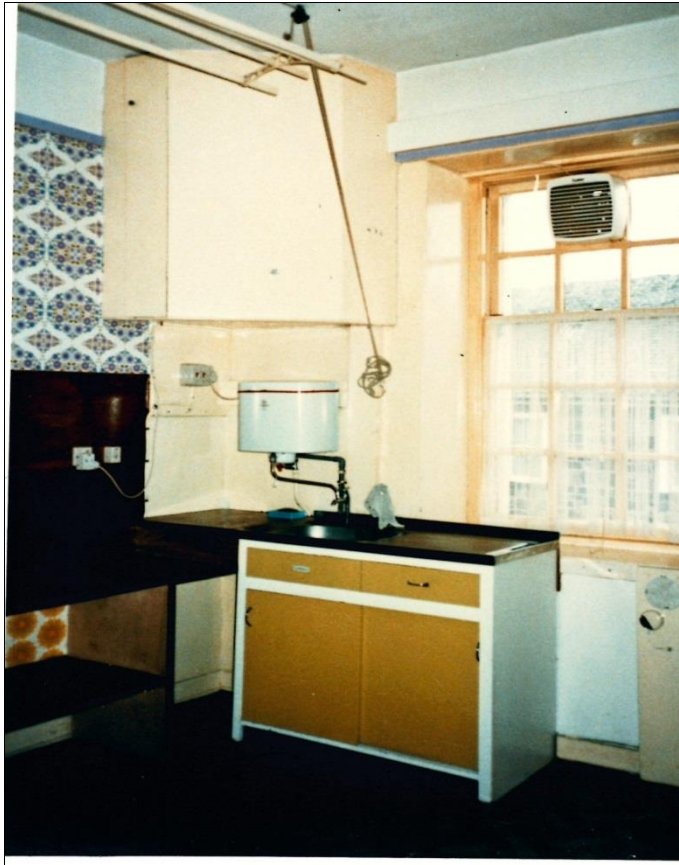
In the kitchen, some original wallpaper and distemper was uncovered in the kitchen.

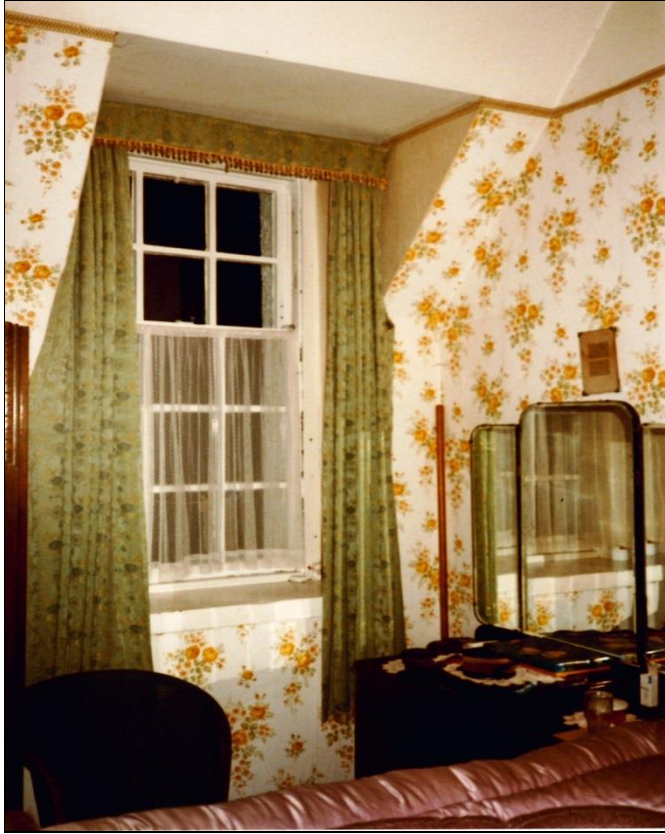
The bedrooms – an original fireplace had survived in the larger bedroom below.
