The Landmark Trust

MARGELLS History Album

Researched and written by Clayre Percy

1976, updated 1998

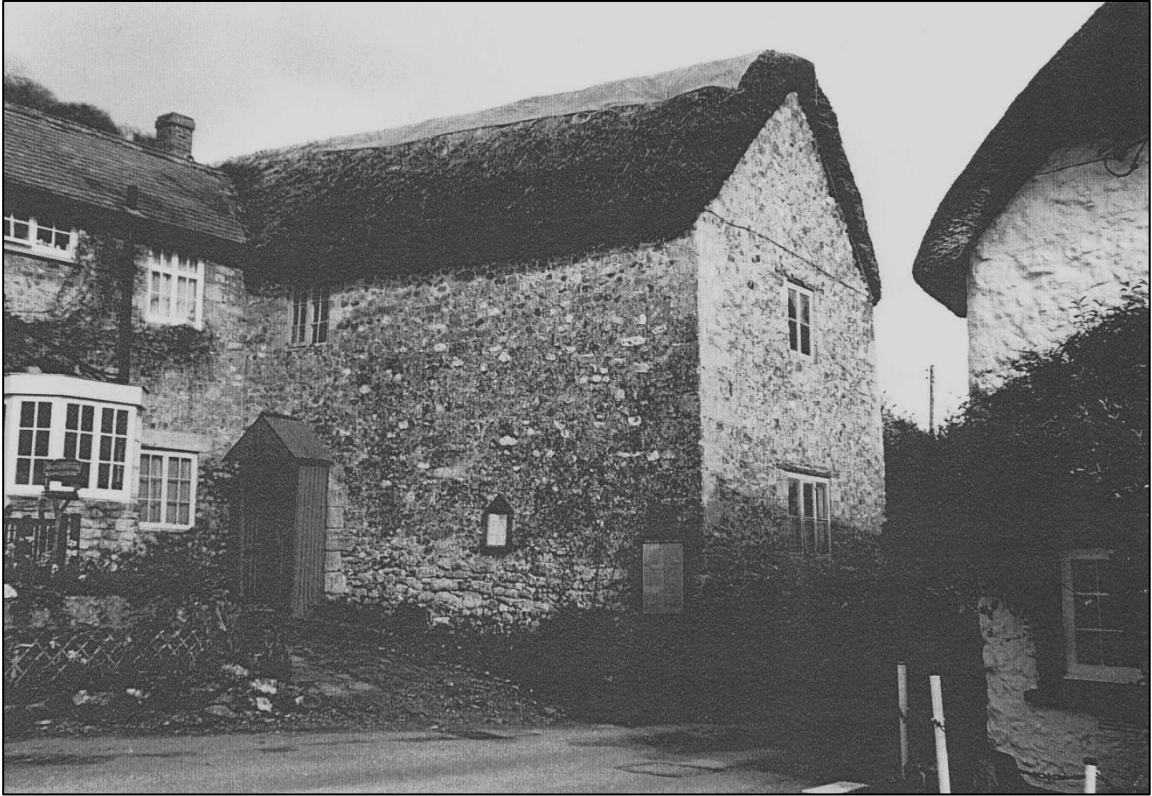
From the north west. The corrugated iron porch was removed.

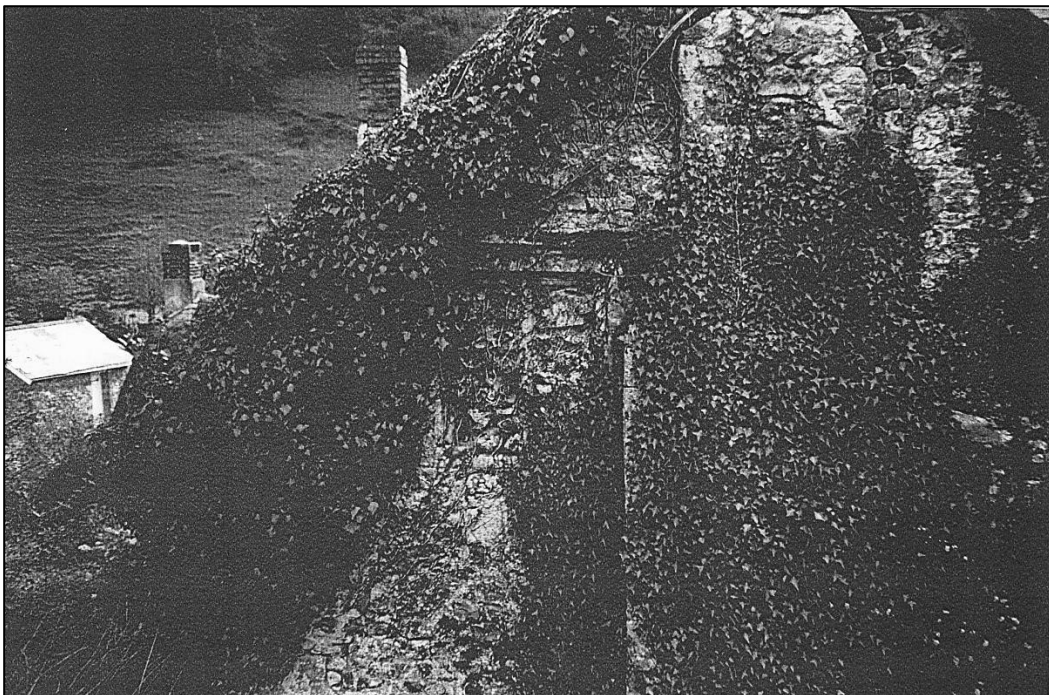
The blocked up east window

But most of the work was concerned with masonry repairs, including stabilisation of the wall by underpinning, repair of the timber screens and roof trusses, opening up of the fireplaces, treatment of timber infestation and inserting an electro-osmotic damp-proof course. The small window in the east bedroom wall was reinstated. The existing ground floor, of lime-ash construction, was in poor condition and in spite of the architects' extensive researches it was not found practicable to repair and reinstate in to match the existing. Instead, second-hand paving slabs of Blue Lias (a local stone) was brought from a farm nearby and laid on a new base, retaining the lime-ash finish as an edging. The link between Margells and the adjoining cottage was found to be open in the roof space, and

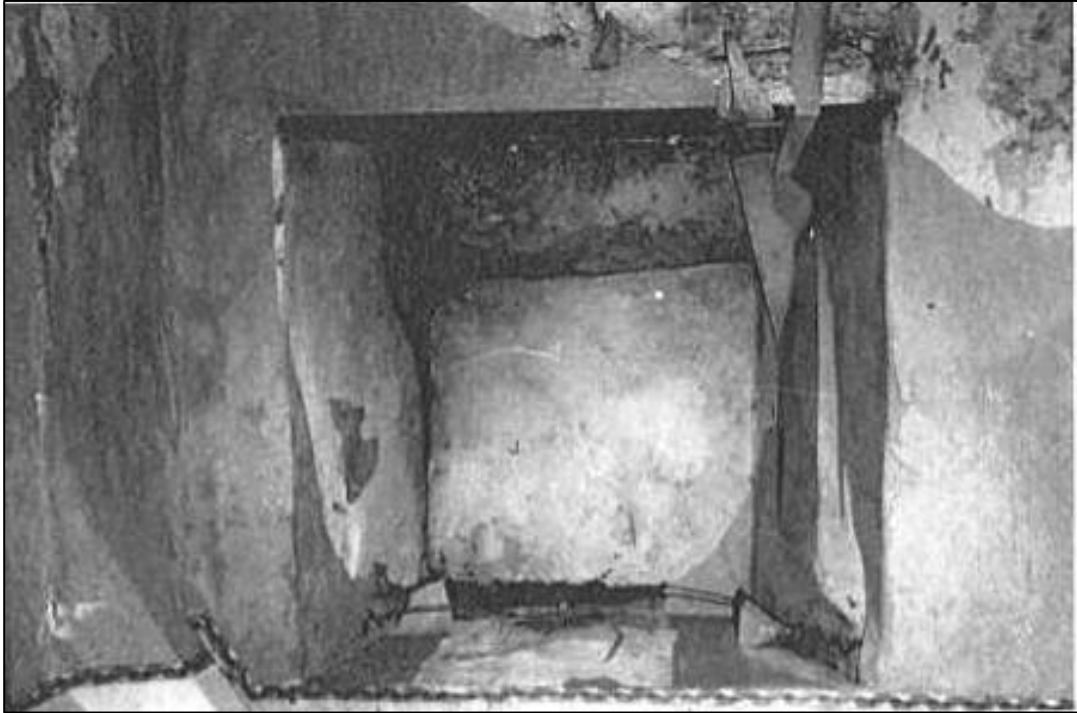
The blocked up east window from inside

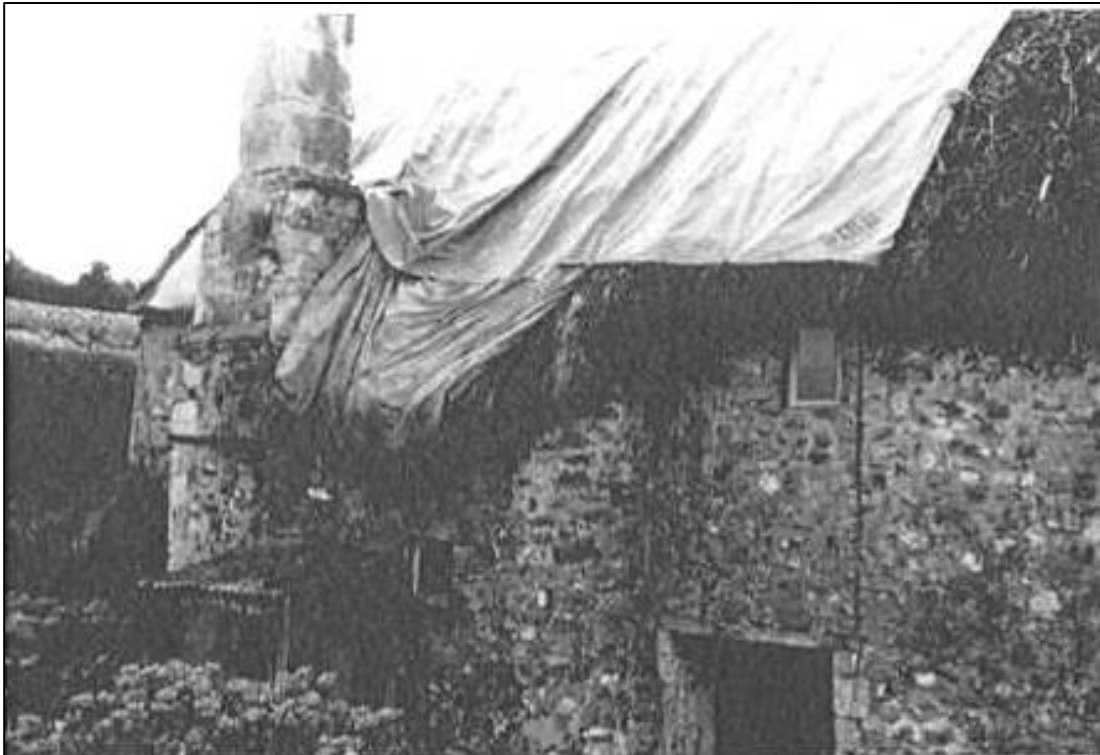
This lean-to hut (the WC) was removed

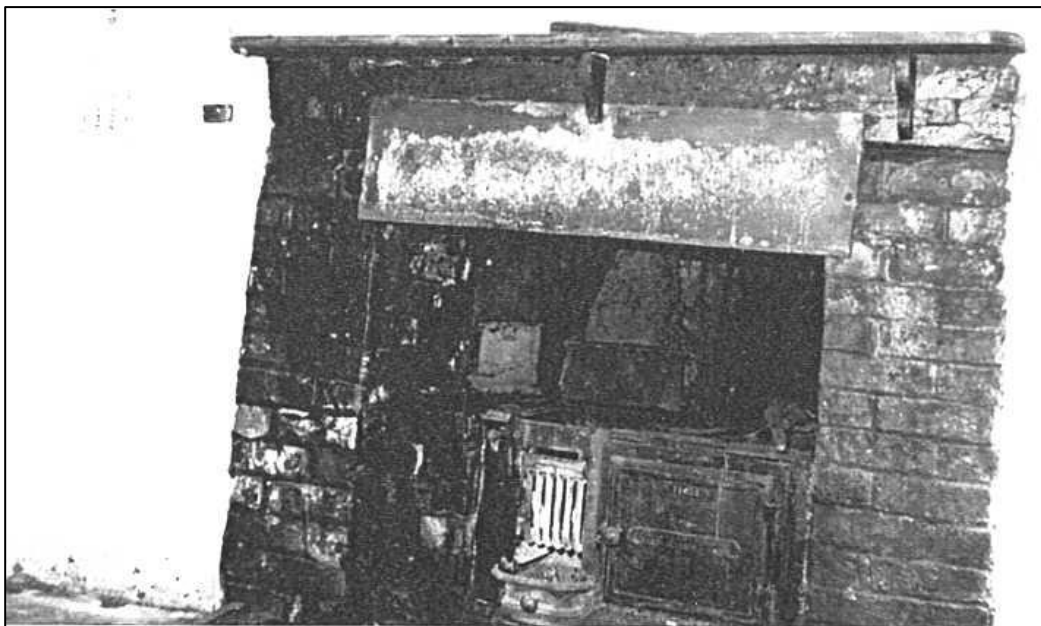
The old range in the kitchen fireplace.

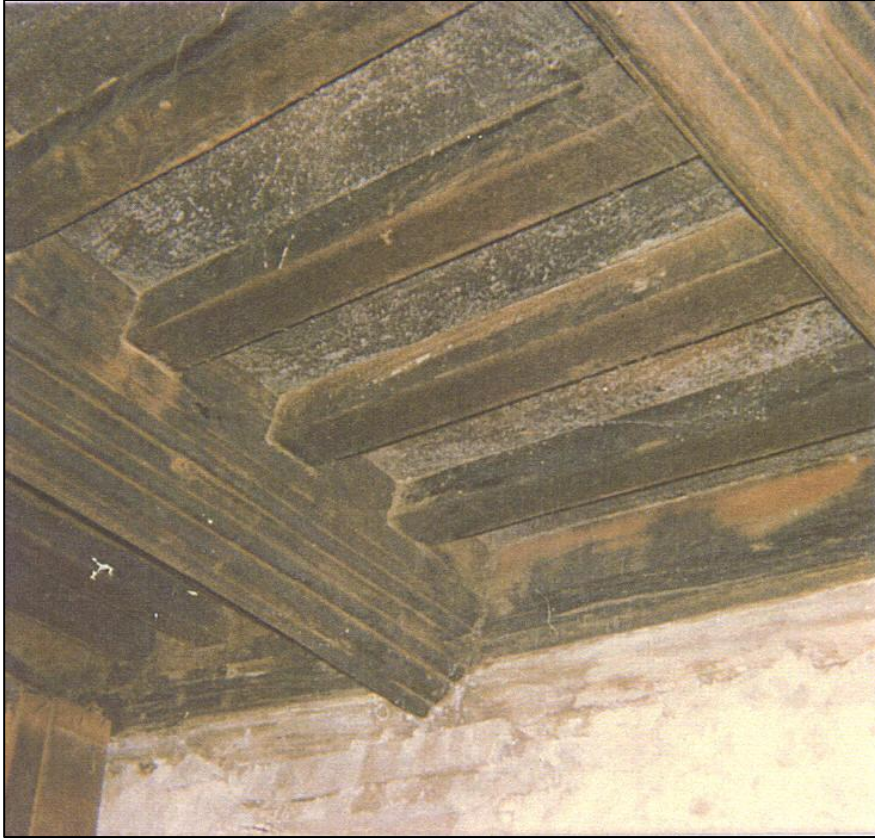
The sitting room ceiling

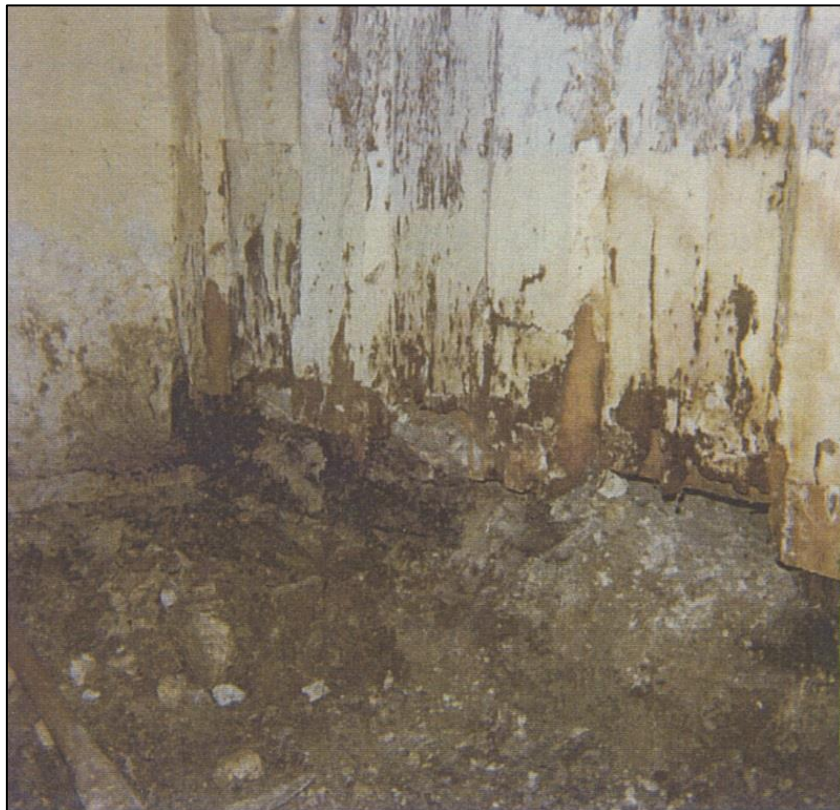
The bottom of the plank and muntin screen had rotted.

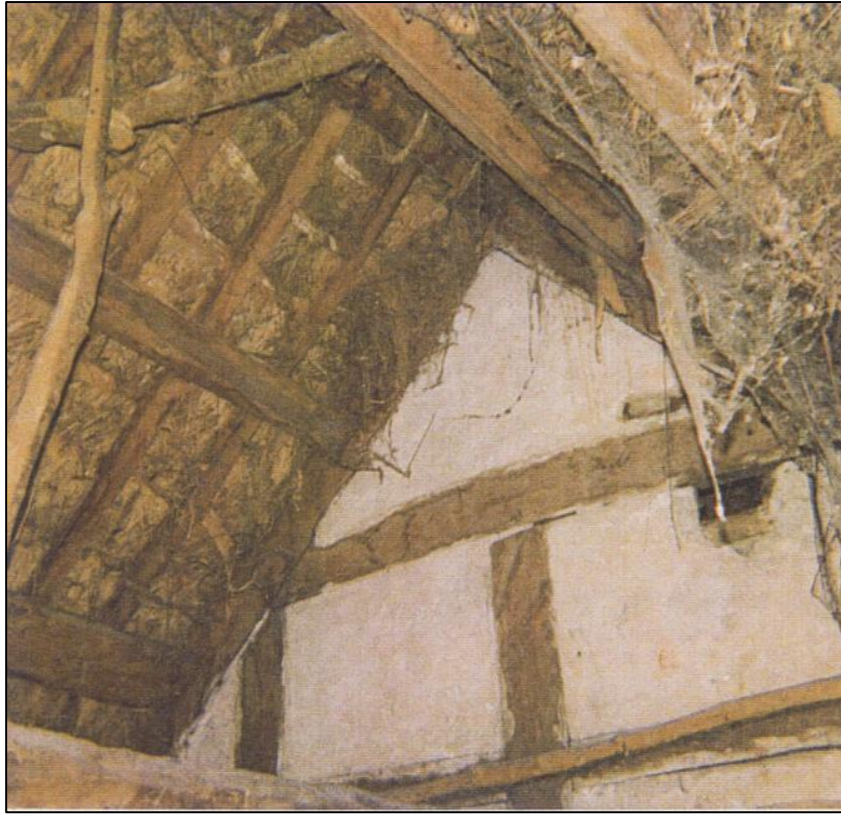
The underside of the thatched roof.

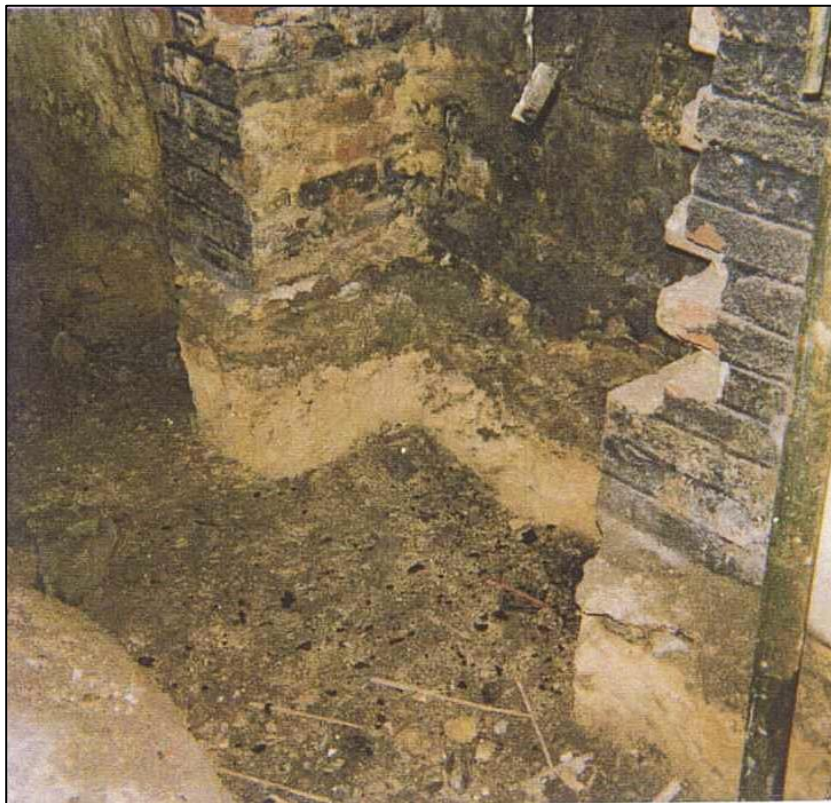
Opening up the kitchen fireplace.

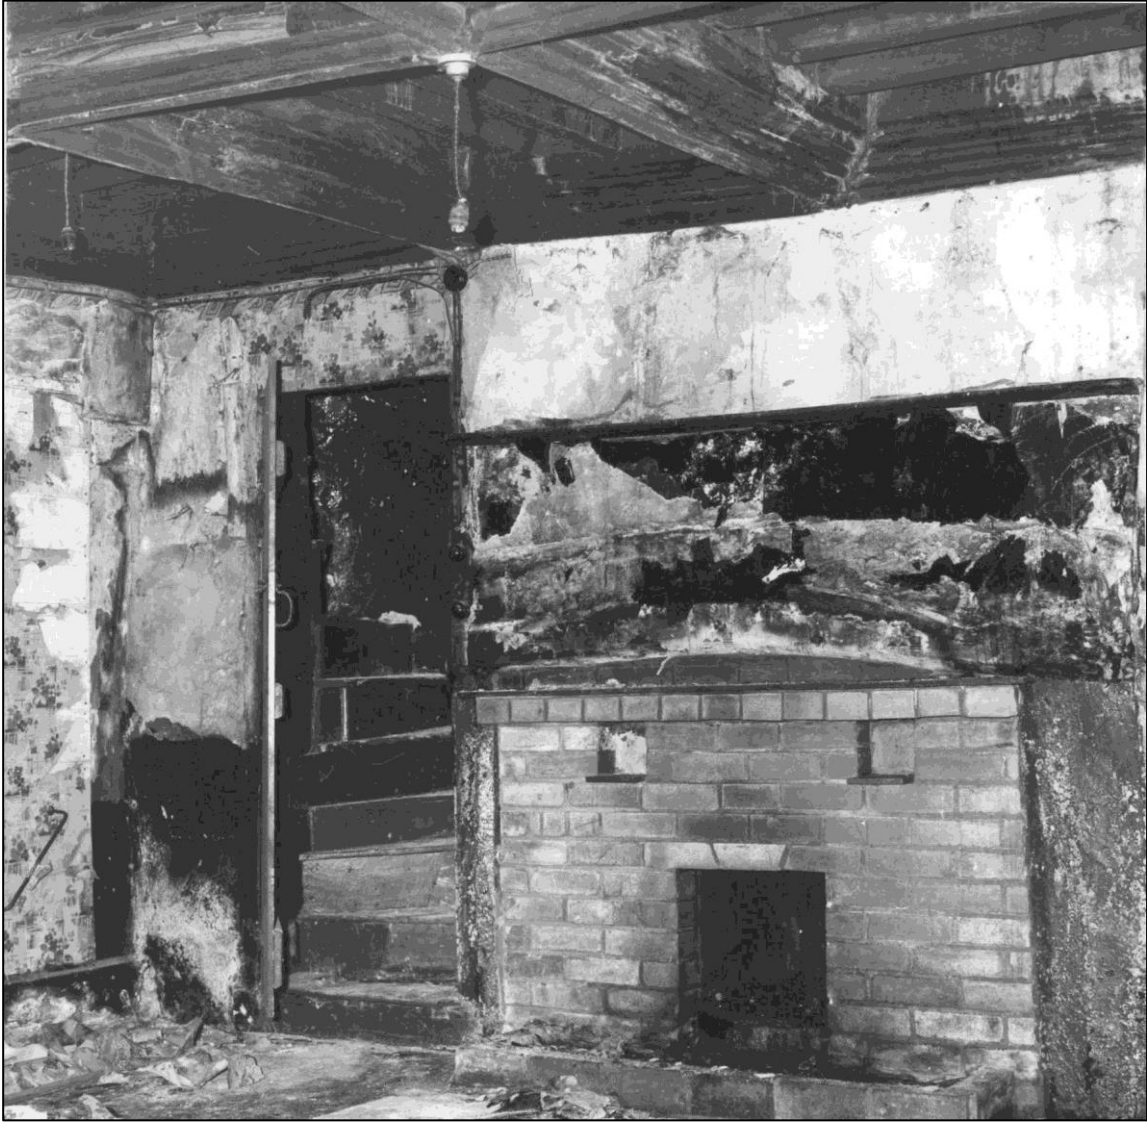
The bricked up fireplace in the sitting room.

Over the years, a few superficial additions and alterations were made. Outside, a small porch was added, and also a galvanised iron W.C. Inside, a staircase was put into what is now the kitchen. The big fireplace in the sitting room was partially bricked up. Ceilings were put into the bedrooms: they have now been removed to leave the bedrooms open to the roof, but you can see indentations where the rafters were laid on top of the partition between the middle bedroom and the passage. The old floors on the first floor were boarded over in softwood, and the east window in the bedroom above the kitchen was blocked up.

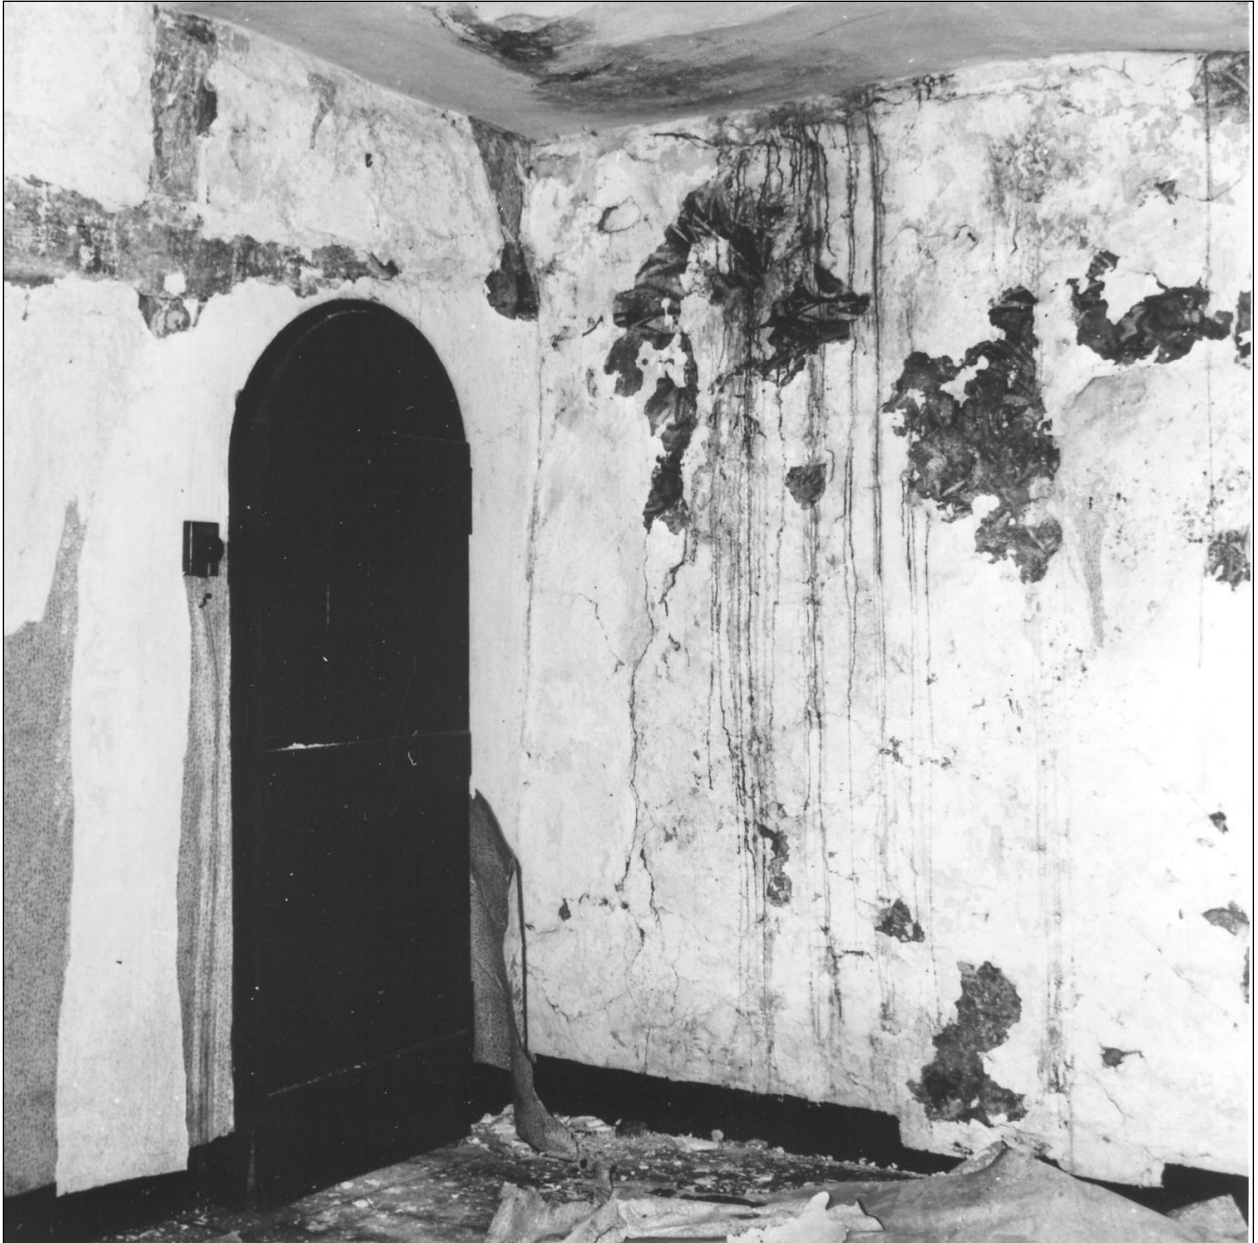
The painting in a first-floor room is painted in a lime and skimmed milk medium with dry colour directly on to the lime and sand support of the wall, covering an area of approximate 7 feet square. It has been covered by a number of layers of colour wash and finally by layers of wall paper. The painting, which is typical of the late sixteenth century, consists of a foliated pattern in several colours including red, black, green and white, with a chevron patterned border and frieze. There are some badly damaged areas at the bottom near the floor level and several cracks which need attention, also one or two places where the facing layer of plaster has become detached from the main support of the wall.

The painting is in reasonably good condition and the removal of the layers of colour wash etc. would reveal a large proportion of the painting in good condition. It is possible that the whole room was decorated in this way, but the remaining areas of wall surface appear to have been re-plastered at some later date.

Traces of the wall painting in the south bedroom before restoration. The ceiling is visible at the top. (C L Hines).

I feel that this area of most interesting painting of the period should be restored and made a feature of the room.

The wall painting was restored in 1976 for the Landmark Trust by Mrs. Krystyna Barakan, in such a way as to ensure that the new infill pieces can be clearly distinguished from the original.

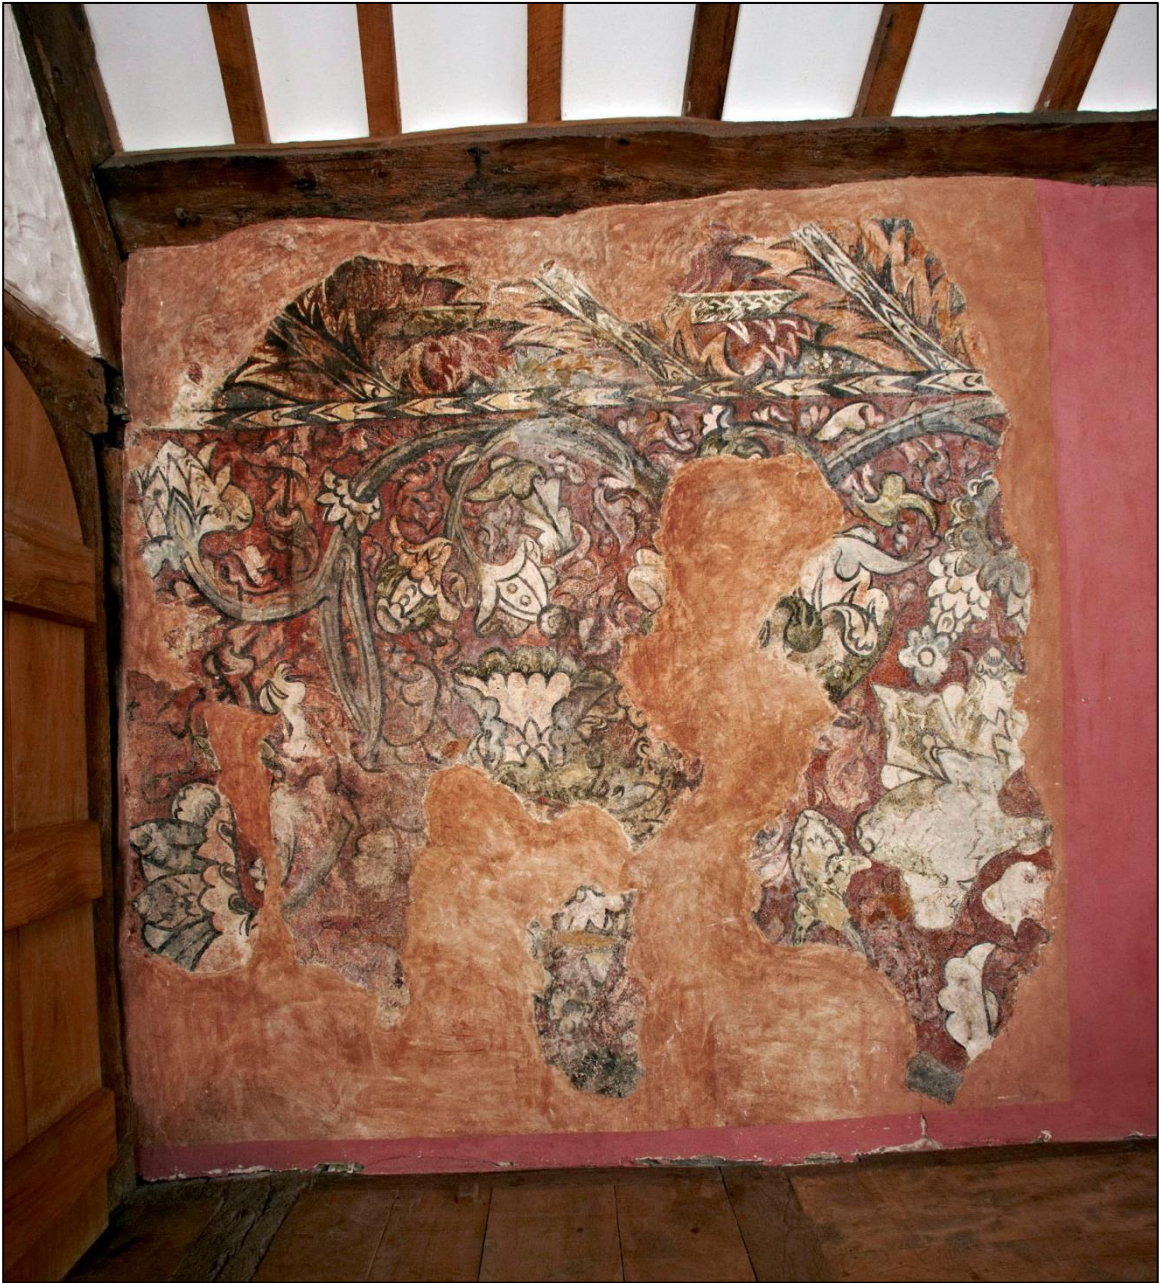
The wall painting after restoration and with the ceiling removed.
